Premature Storm Drainage System Repairs and Replacement

Stewart Edwards
Program Manager
Design Management Team
Charlotte-Mecklenburg Storm Water Services

April 8, 2015

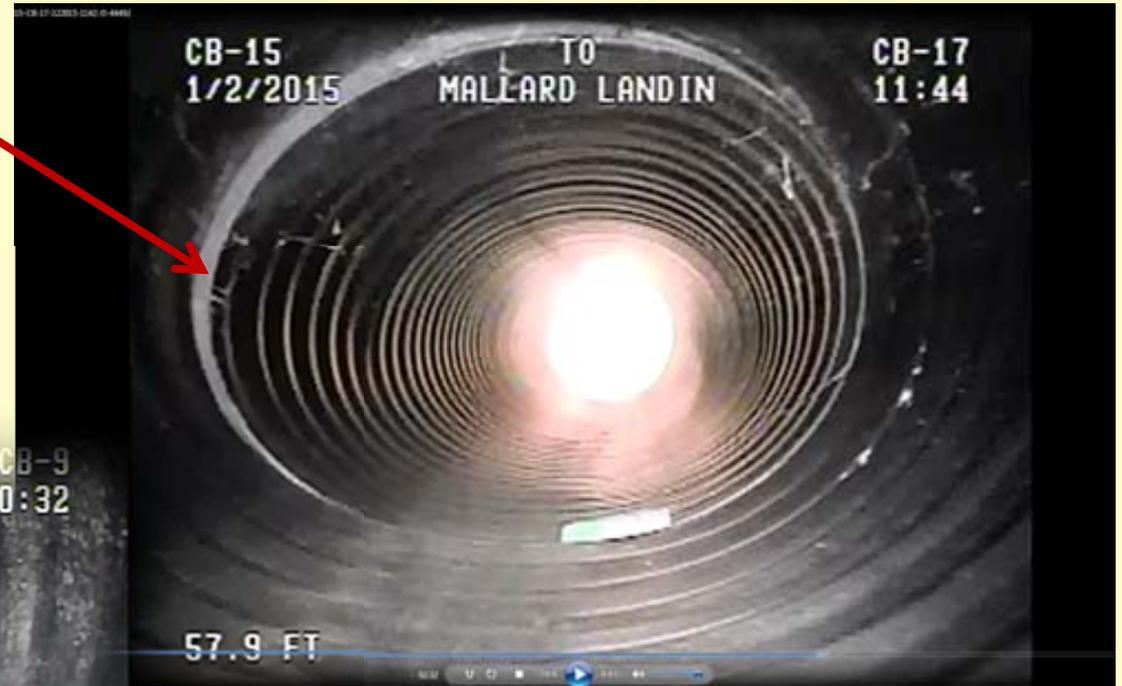
*Images from Mallard Landing Road
Built 2006*

- HDPE (plastic pipe egged shaped) loss of structural integrity

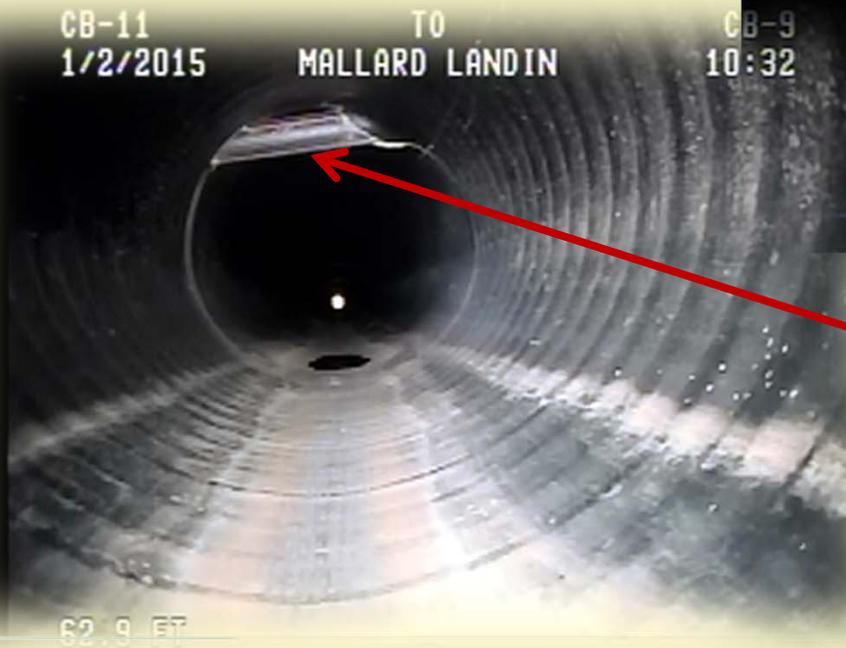
- Sanitary sewer punched through the storm drain

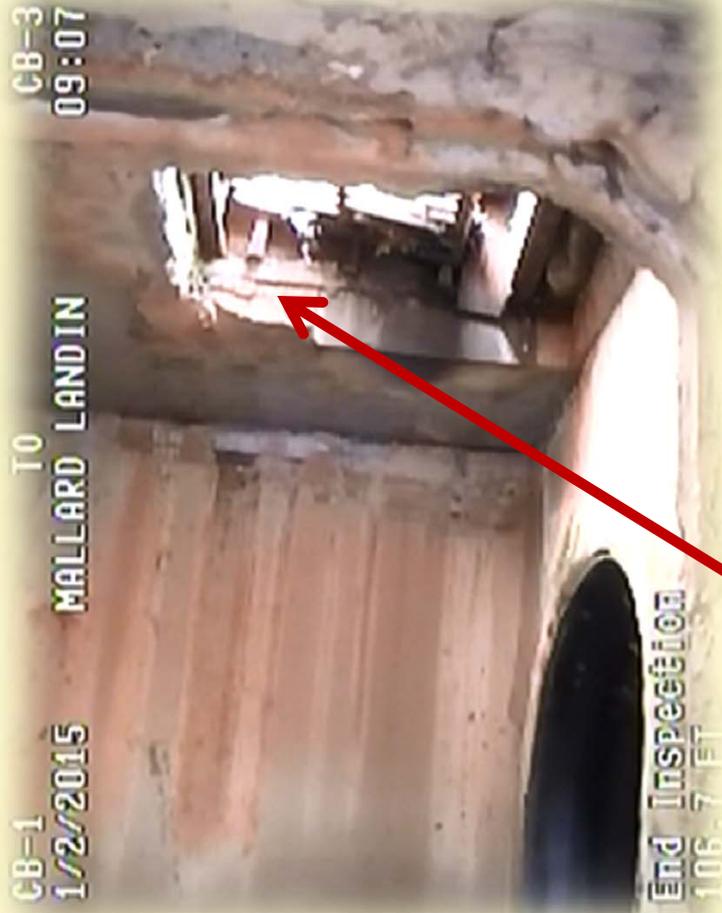
*Images from Mallard Landing Road
Built 2006*

- Reinforcing steel used to support frame and grate

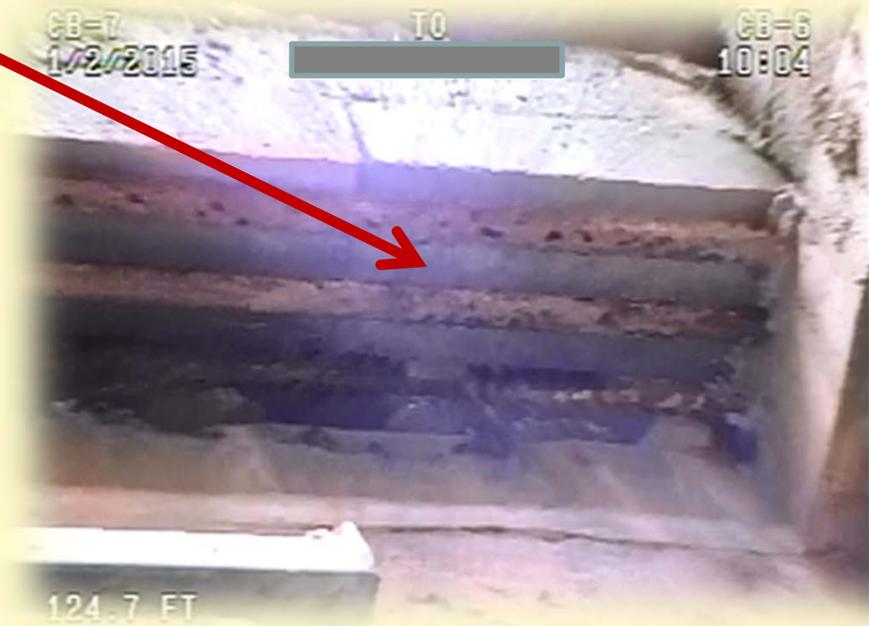
Slab cut to move inlet position

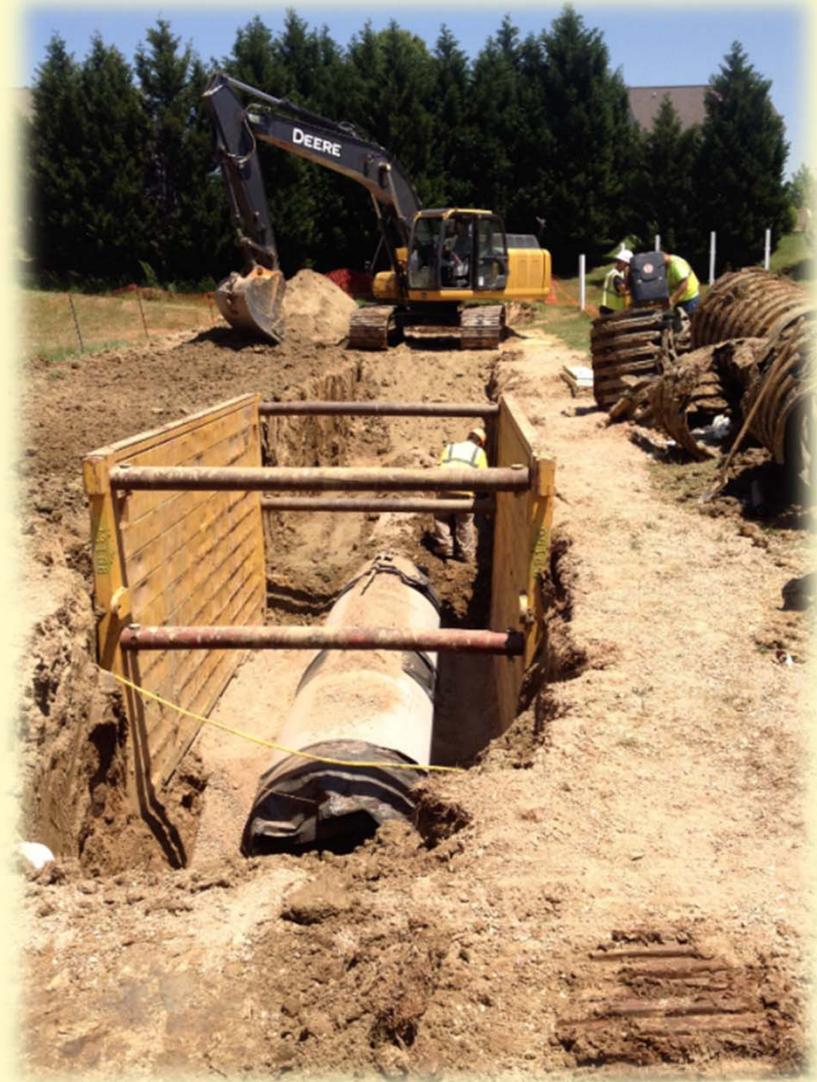
Haines Mill Road The Villas at Laurel Valley Built 2006

- Precast catch basin leaking around joints
- Sinkholes formed
- System is in backyards and access is limited
- Shoring will be needed to protect the foundations of nearby homes

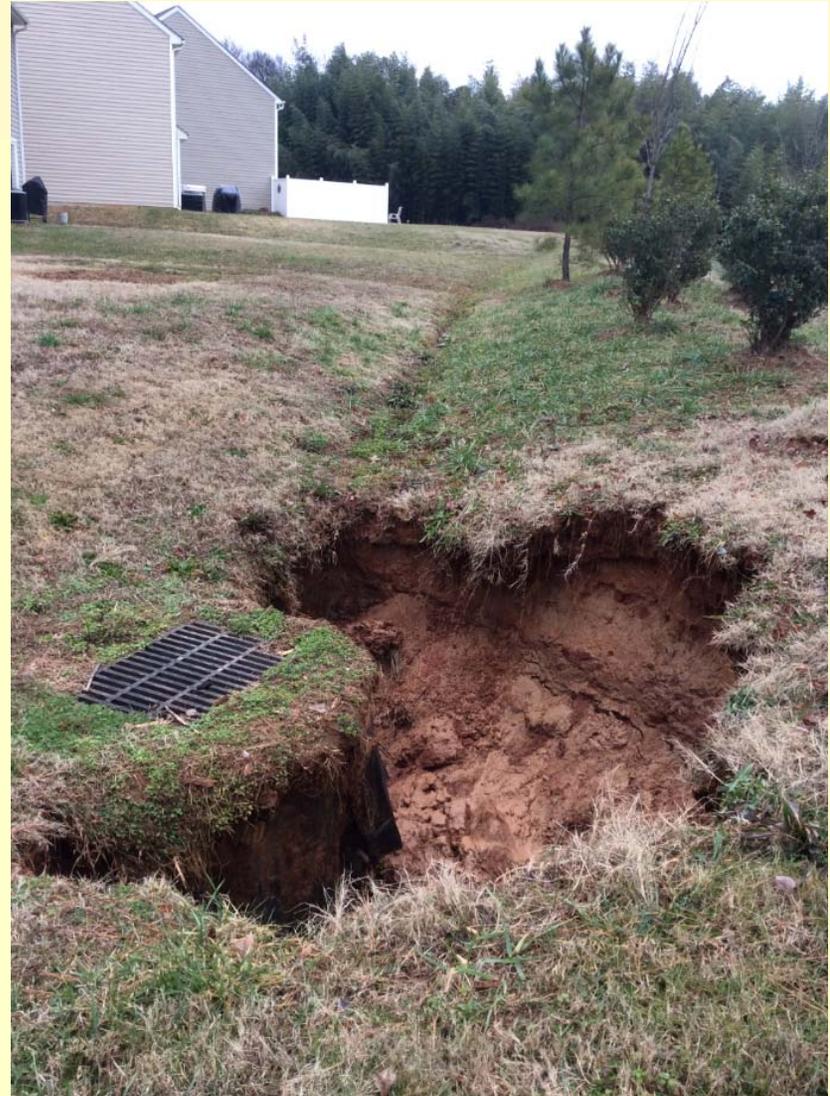
Provincetowne Drive Reavencrest Built 2001

- Separated pipe joints
- Sinkholes formed
- Shoring will be needed to protect the foundations of nearby homes

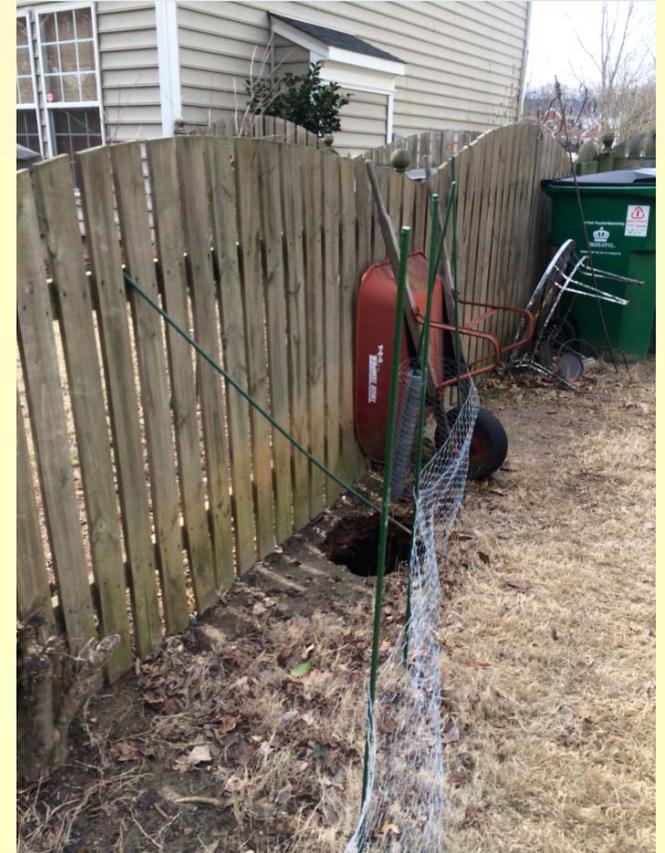
Cozen Way Drawley Farms Built 2004

- Sinkholes formed
- Non-standard structures
- Poor pipe installation
- Public safety and liability concerns for the City

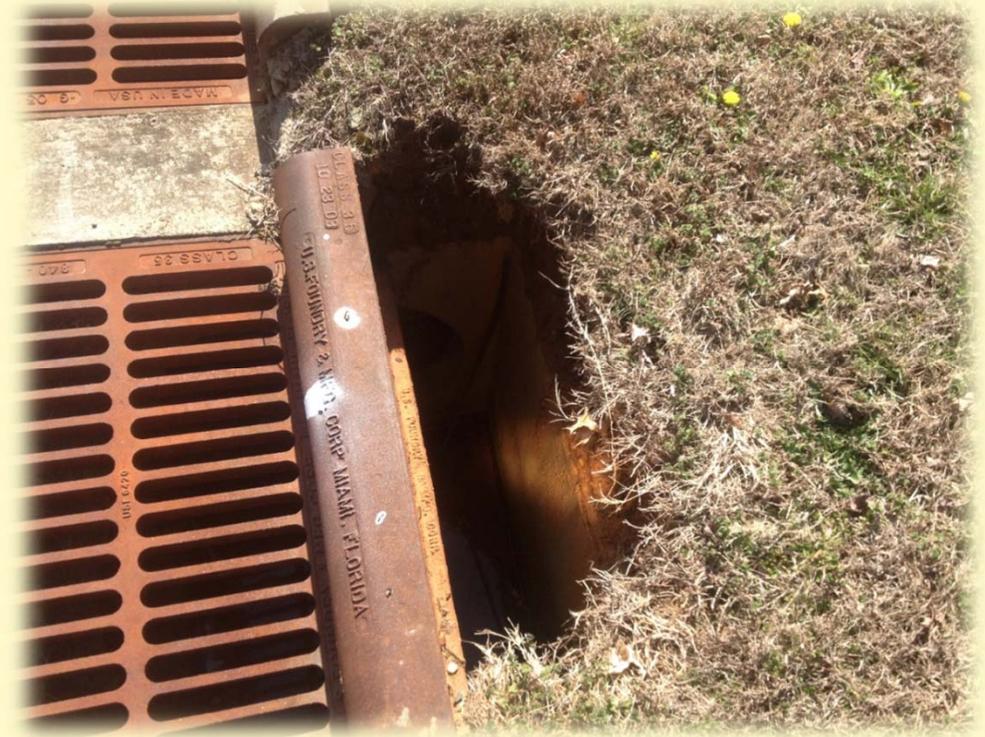
Clementine Court Providence Pointe Built 2002

- Missing brick in catch basin
- Sinkholes formed
- Precast structures leaking
- Presents a public safety concern to the property owner
- Limited access to enter and repair system
- Shoring will be needed to protect the foundations of nearby homes

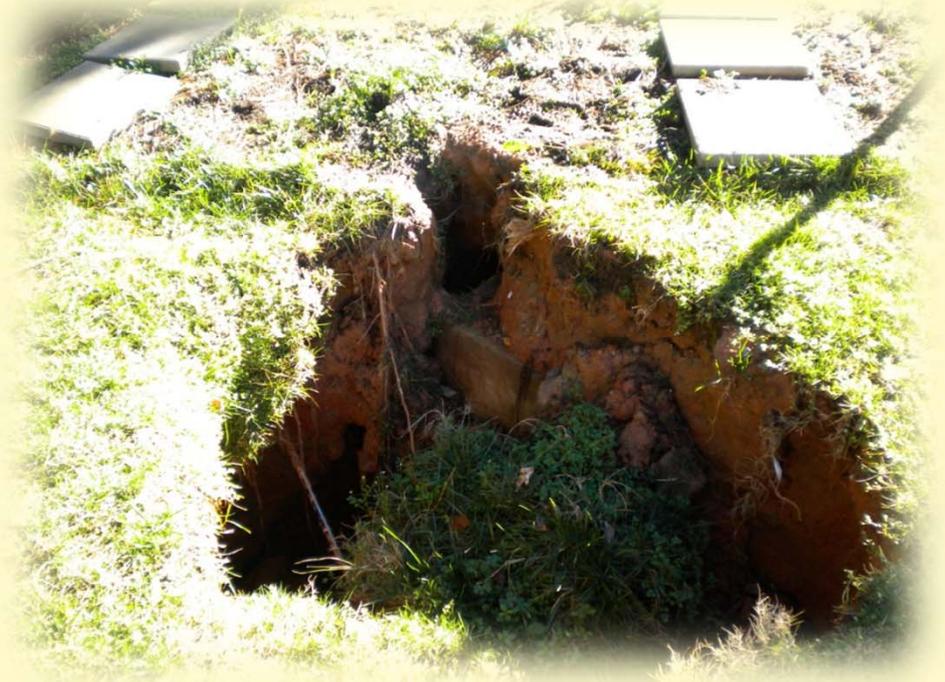
Sahalee Lane Claiborne Woods Subdivision Built 2000

- Sinkhole formed due to pipe being damaged (egged shaped and joints failed) during installation
- Pipe damage allowed backfill material to migrate away and created a sinkhole
- Shoring will be needed to protect the foundations of nearby homes

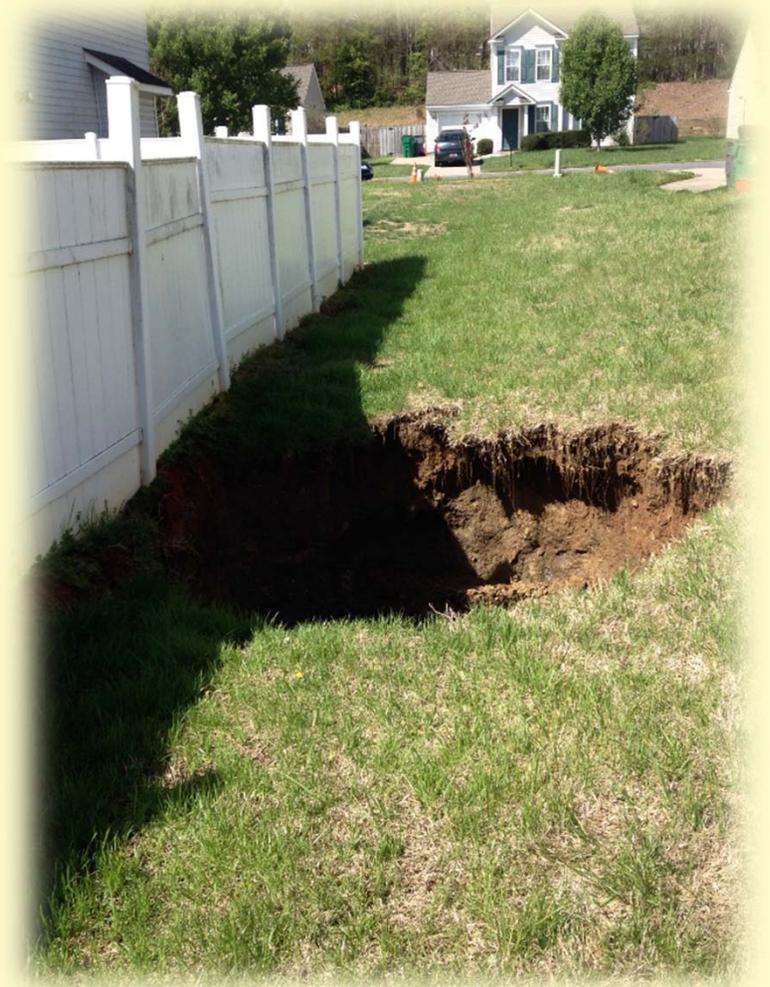
Astonboro Drive Chastain Parc Built 2002

- Broken and cracked pipe
- Road is settling and rutting
- Potential cavities under the road
- Estimated \$100,000 repair

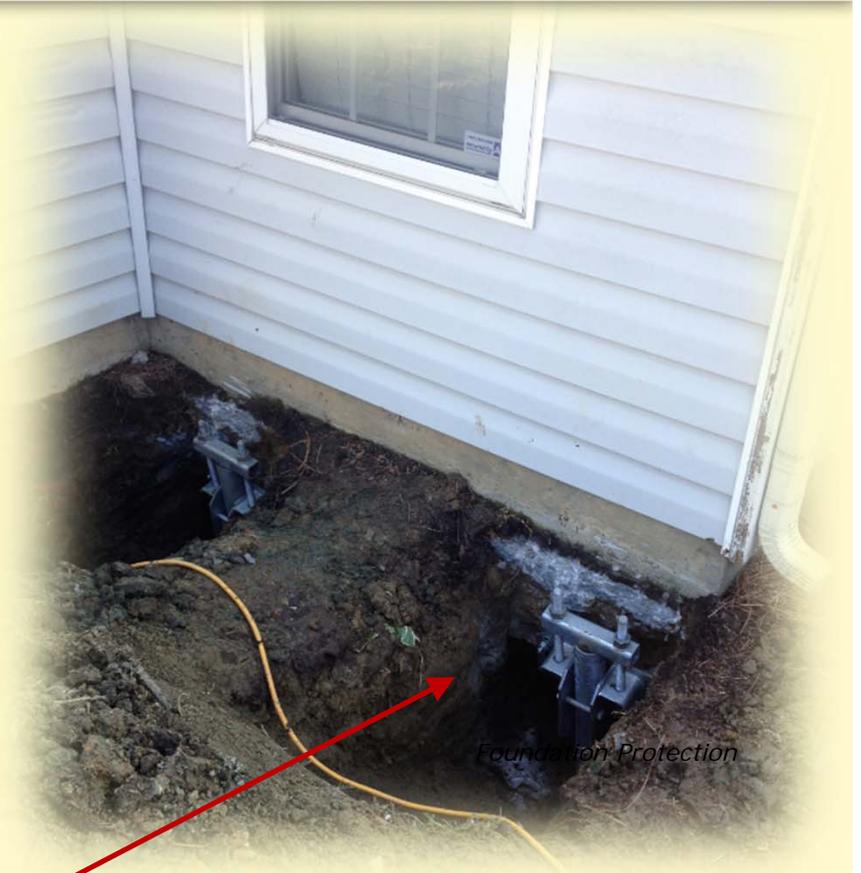
Shoring is not installed during the development phase, but is required during repairs.
