Feasibility Study Report

Reedy Creek Watershed Enhancement

Contract Number: 1100719

Charlotte, North Carolina

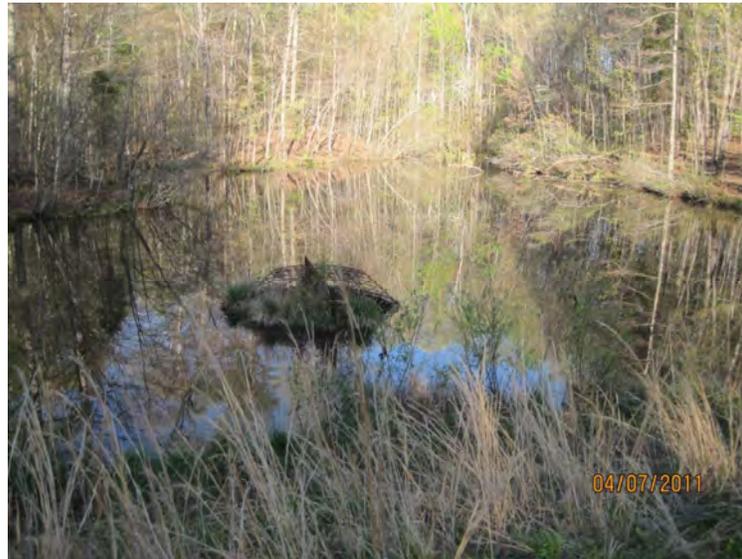
Photo. Slider Pond

Removing the pond would not provide a high level of connectivity because there are in-line ponds below and it is near the top of the watershed.

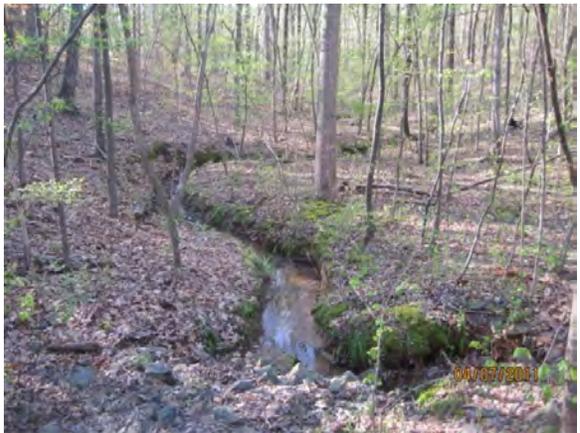
Photo. Less mature emerging buffer lacking understory.

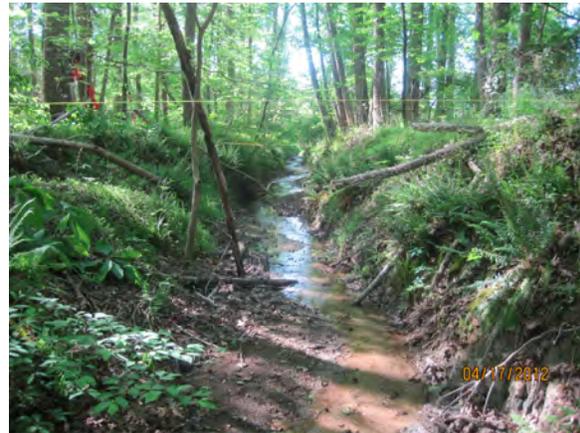
Photo. Mature forested buffer (Reach 8).

The hardwood species range in age from less than 5 to over 30 years old depending on the location in the preserve. Reach 8 has the most mature forested community with many trees over 36" in diameter. The Reaches outside the preserve have less mature vegetation and some Chinese Privet (*Ligustrum sinense*) was observed. Napalese Browntop (*Mictostegium vimineum*) was covering almost the entire floodplain floor along Reach 8 and in Reach 11 (but was less prevalent in the latter).
