## Invitation to Bid HNS 24-33

<p><b>Project Address: 4201 Anita Ct Charlotte, NC 28215</b></p> <p><b>Lead Safe Program</b></p>	
Bid Walk: 7/12/2024 @ 10am	
Bid Opening: 7/19/2024 @2pm	
Client Name: Vivian Adams	Contact Number:
Project Manager: Daniel Edwards	Contact Number: 980-214-4133

**LEAD-BASED PAINT INSPECTION AND  
RISK ASSESSMENT REPORT  
4201 ANITA COURT  
CHARLOTTE, NORTH CAROLINA 28208**

**Prepared by:  
ROY CONSULTING GROUP CORPORATION  
PROJECT #28-082722**

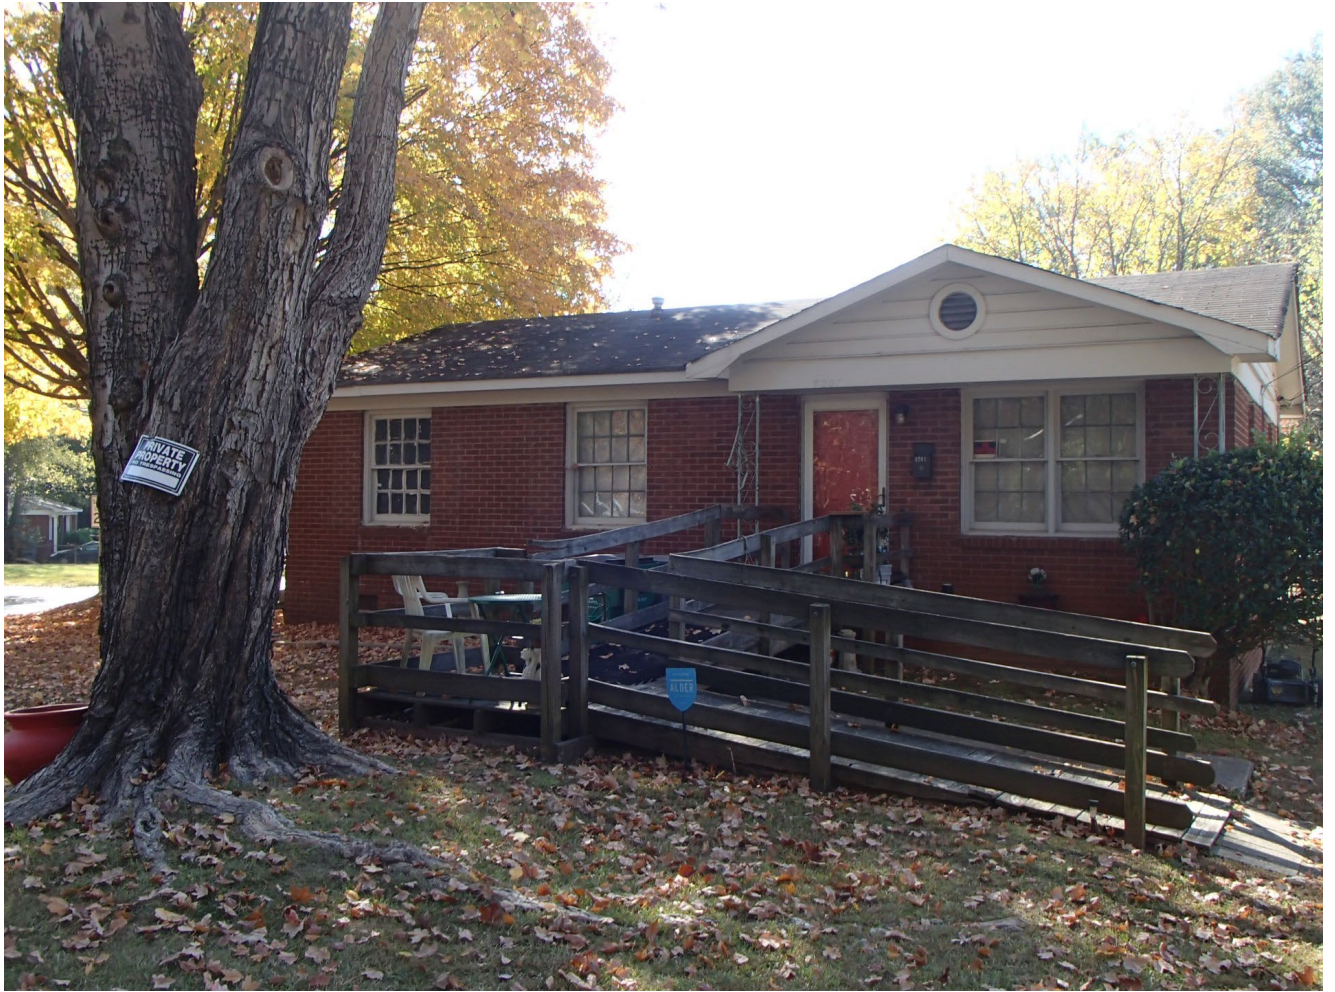
**Photo 1 – House – Side A**

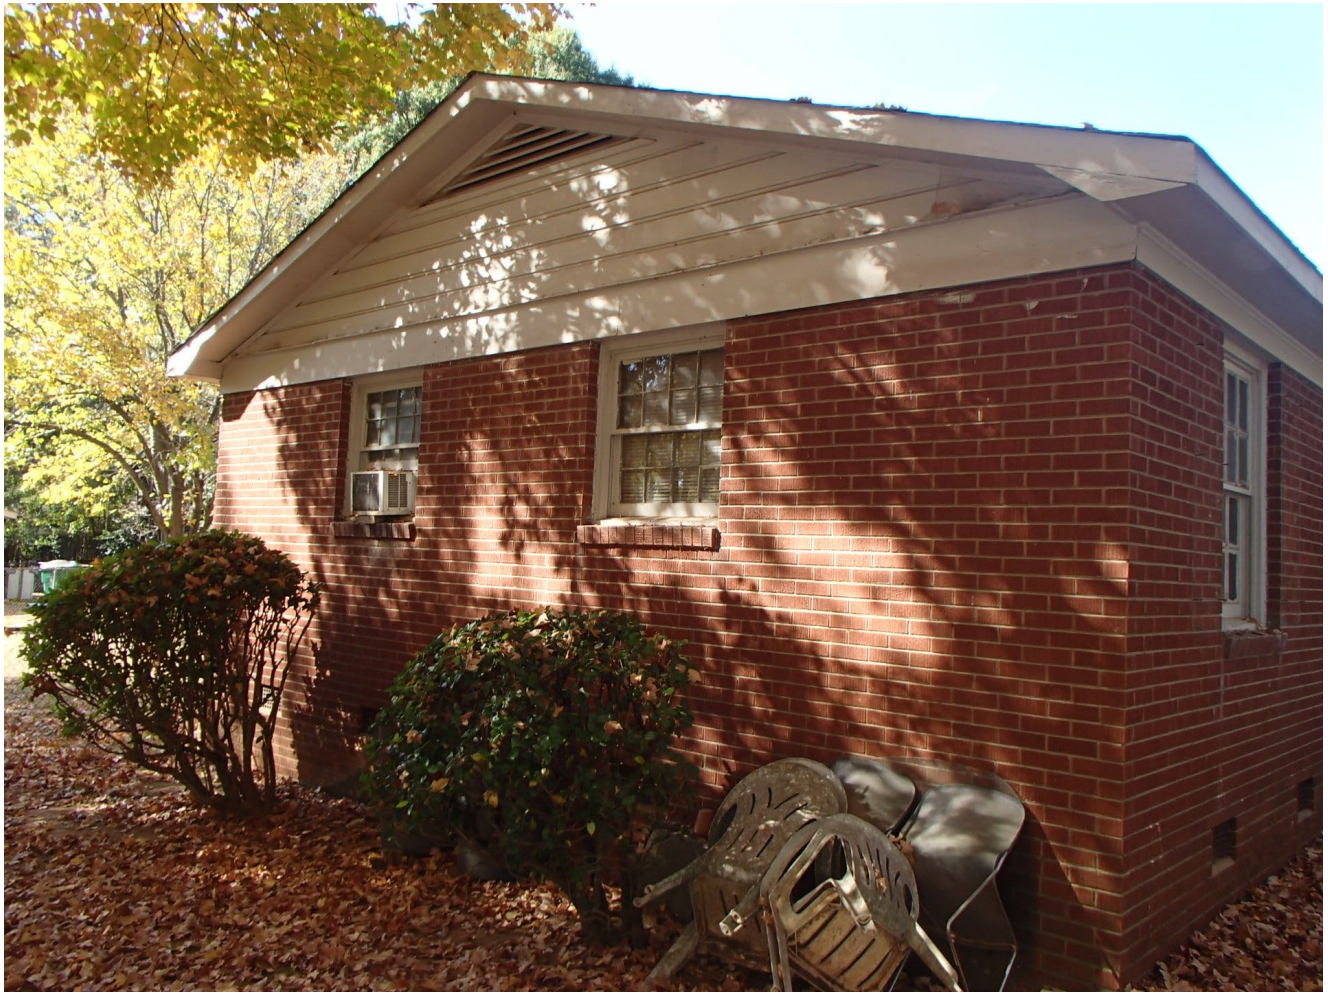
**Photo 2 – House – Side B**

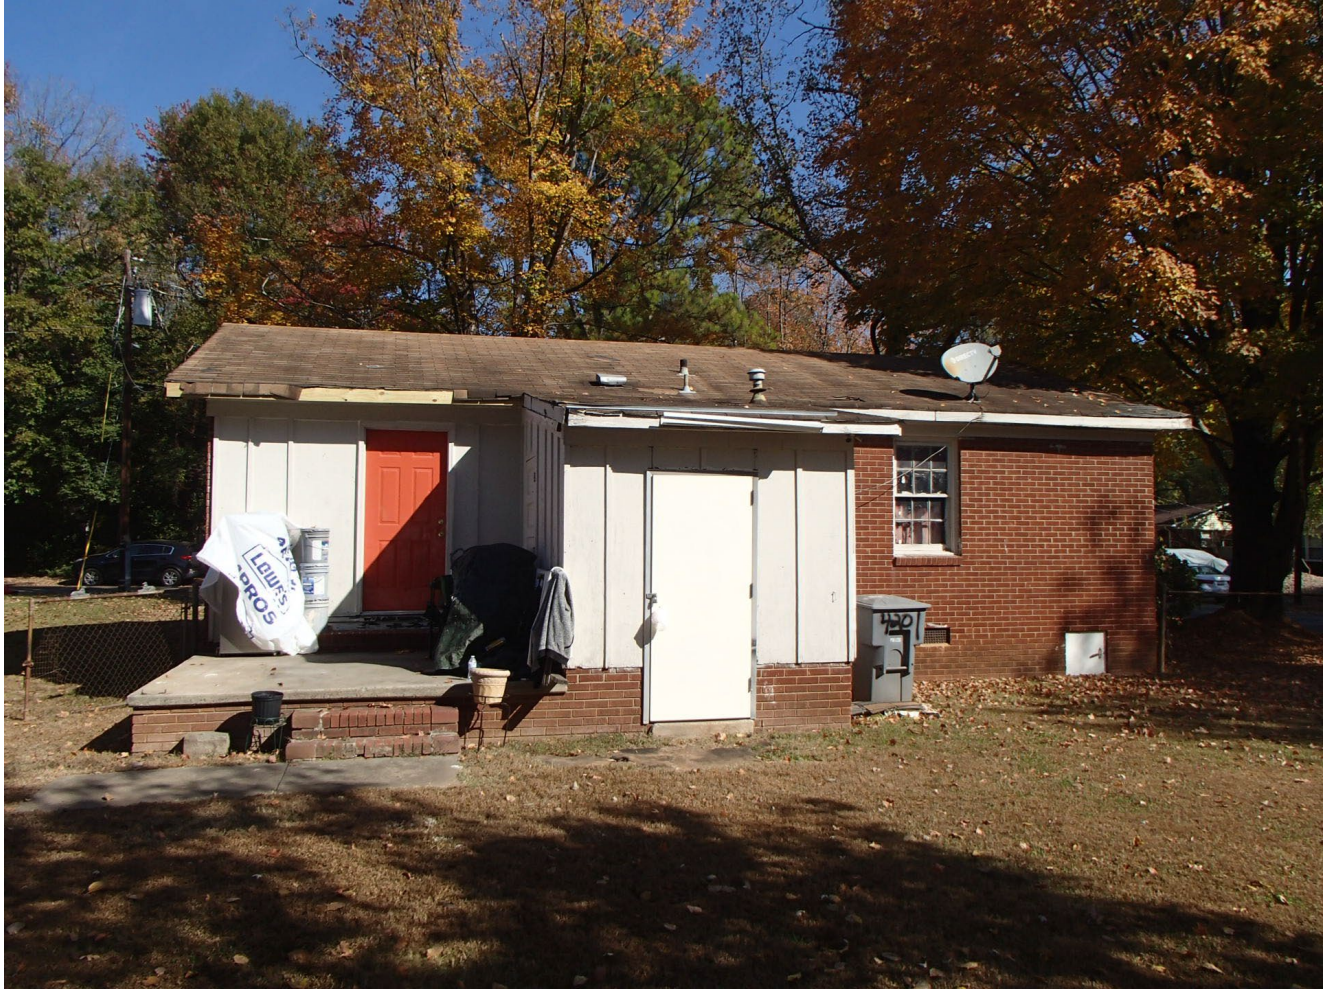
**Photo 3 – House – Side C**

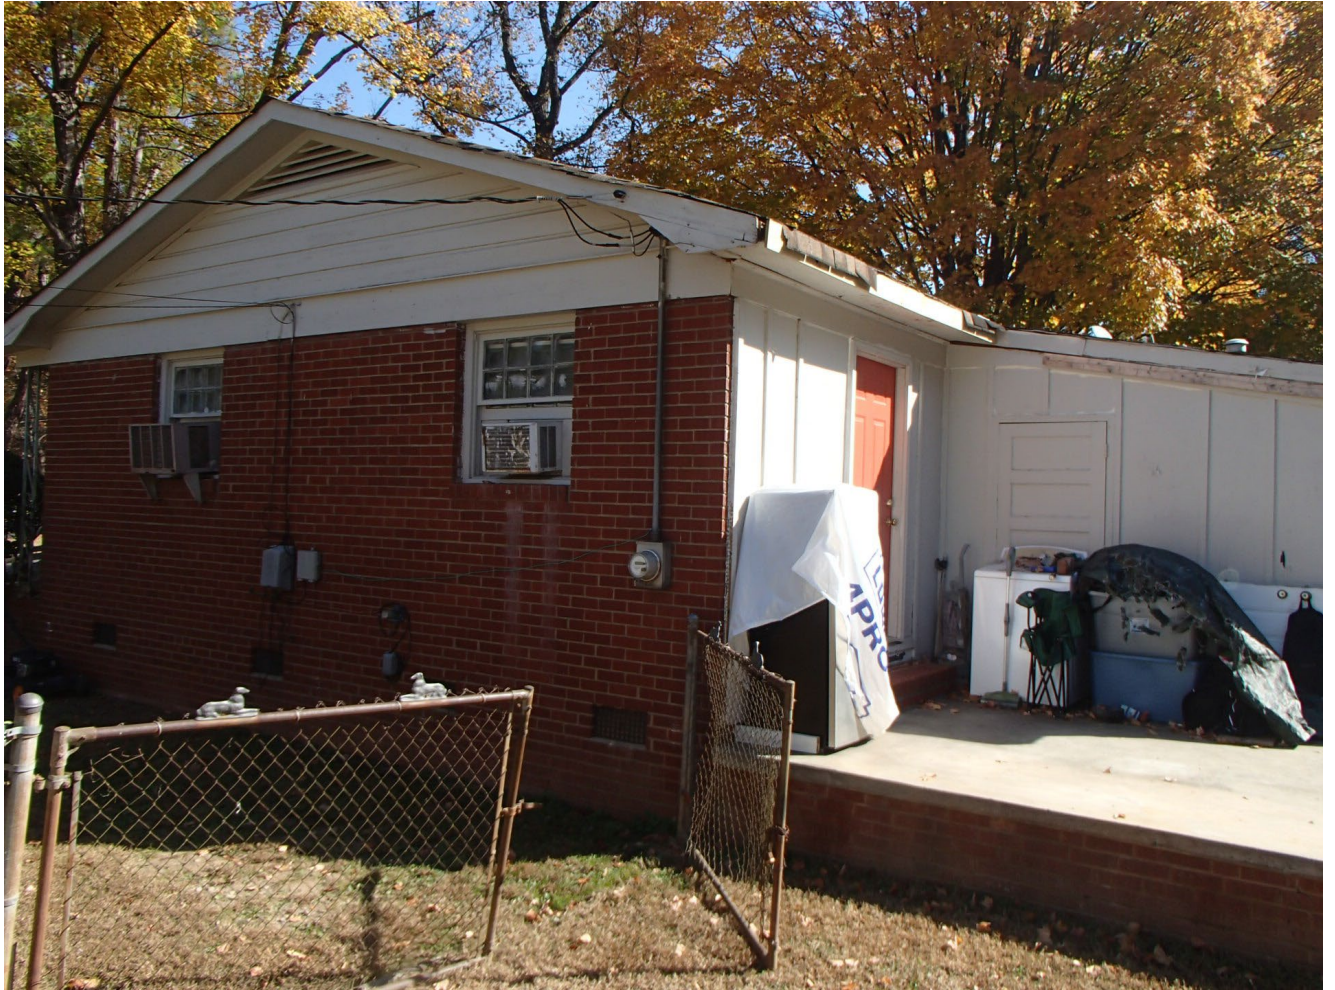
**Photo 4 – House – Side D**

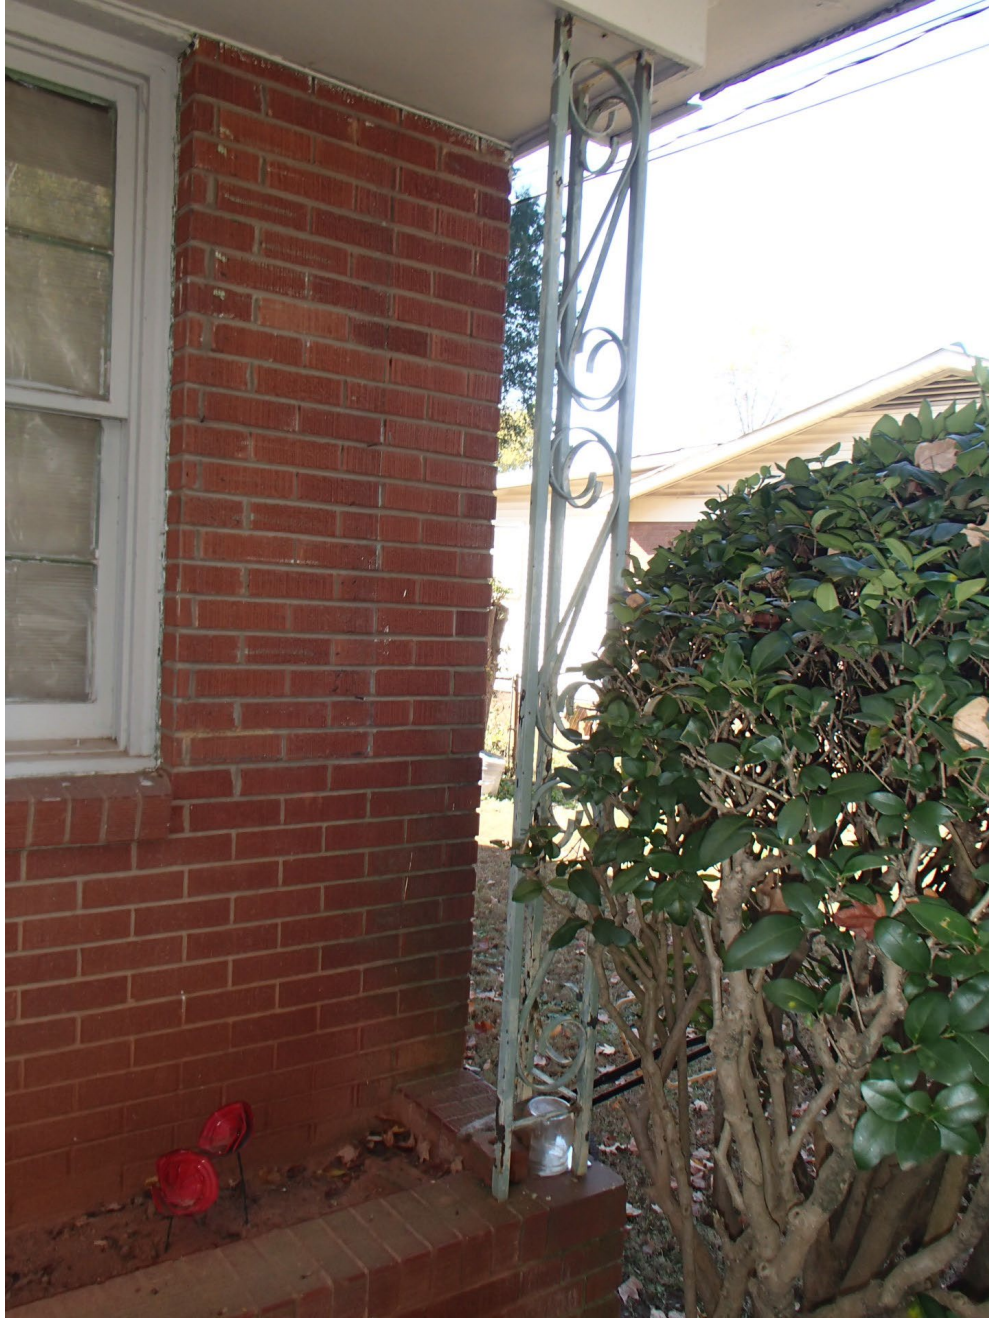
<b>LOCATION AND DESCRIPTION OF DETERIORATED LEAD-BASED PAINT – EXTERIOR (WORK REQUIRED AT THIS TIME – SEE SECTION 4.0)</b>
<u>Side A through Side D</u> – light brown/gray wood walls, seam boards, trim boards and drip boards including closet/storage area
<u>Side A through Side D</u> – light brown/gray wood fascias, soffits, crown moldings, trim boards and attic air vents and frames including closet/storage area
<u>Side A</u> – light brown wood ceiling/overhang and green metal support columns
<u>Closet Door D1</u> – gray wood closet door, casings, header, jambs and stops

**Photo 5 – Side A Ceiling/Overhang and Support Column**

LOCATION AND DESCRIPTION OF DETERIORATED LEAD-BASED PAINT – EXTERIOR (CONTINUED)	RECOMMENDED ACTION
Side A through Side D – light brown/gray wood fascias, soffits, crown moldings, trim boards and attic air vents and frames including closet/storage area	1/Cover with Tyvek and aluminum or vinyl.
	2/Scrape loose paint and re-paint.
Side A – light brown wood ceiling/overhang and green metal support columns	1/Cover ceiling with Tyvek and aluminum or vinyl and replace columns.
	2/ Scrape loose paint and re-paint.
Closet Door D1 – gray wood closet door, casings, header, jambs and stops	1/Replace.
	2/Make smooth and operable, scrape loose paint and re-paint.

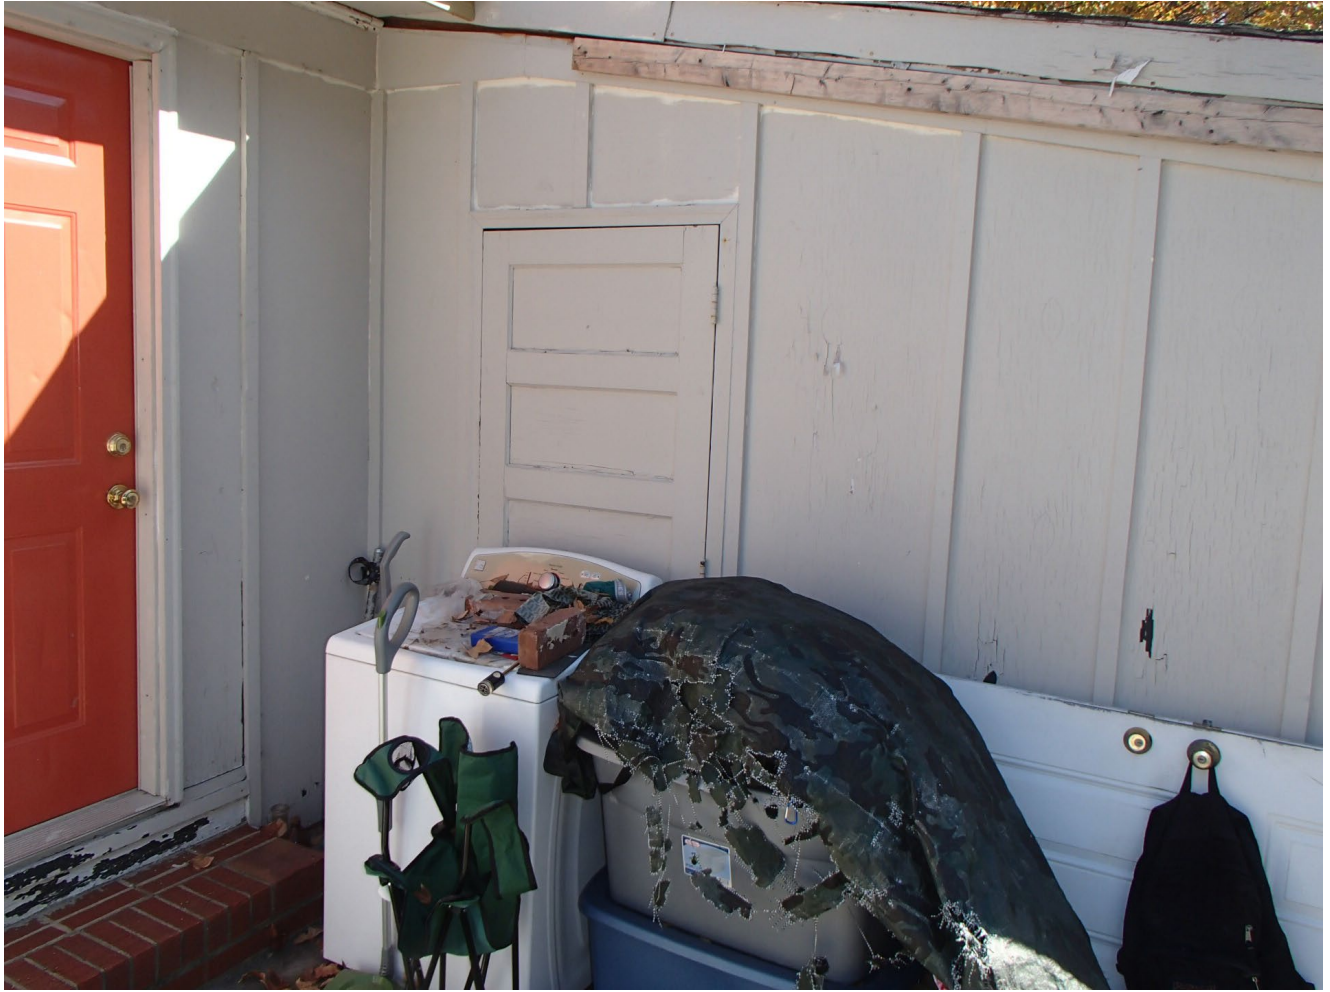
**Photo 6 – Side C Wall (left), Side D Wall (right) and Closet Door D1 (right door)**

LOCATION AND DESCRIPTION OF DETERIORATED LEAD-BASED PAINT – EXTERIOR	RECOMMENDED ACTION
Side A through Side D – light brown/gray wood walls, seam boards, trim boards and drip boards including closet/storage area	1/Cover wood with Tyvek and aluminum or vinyl.
	2/Scrape loose paint and re-paint.

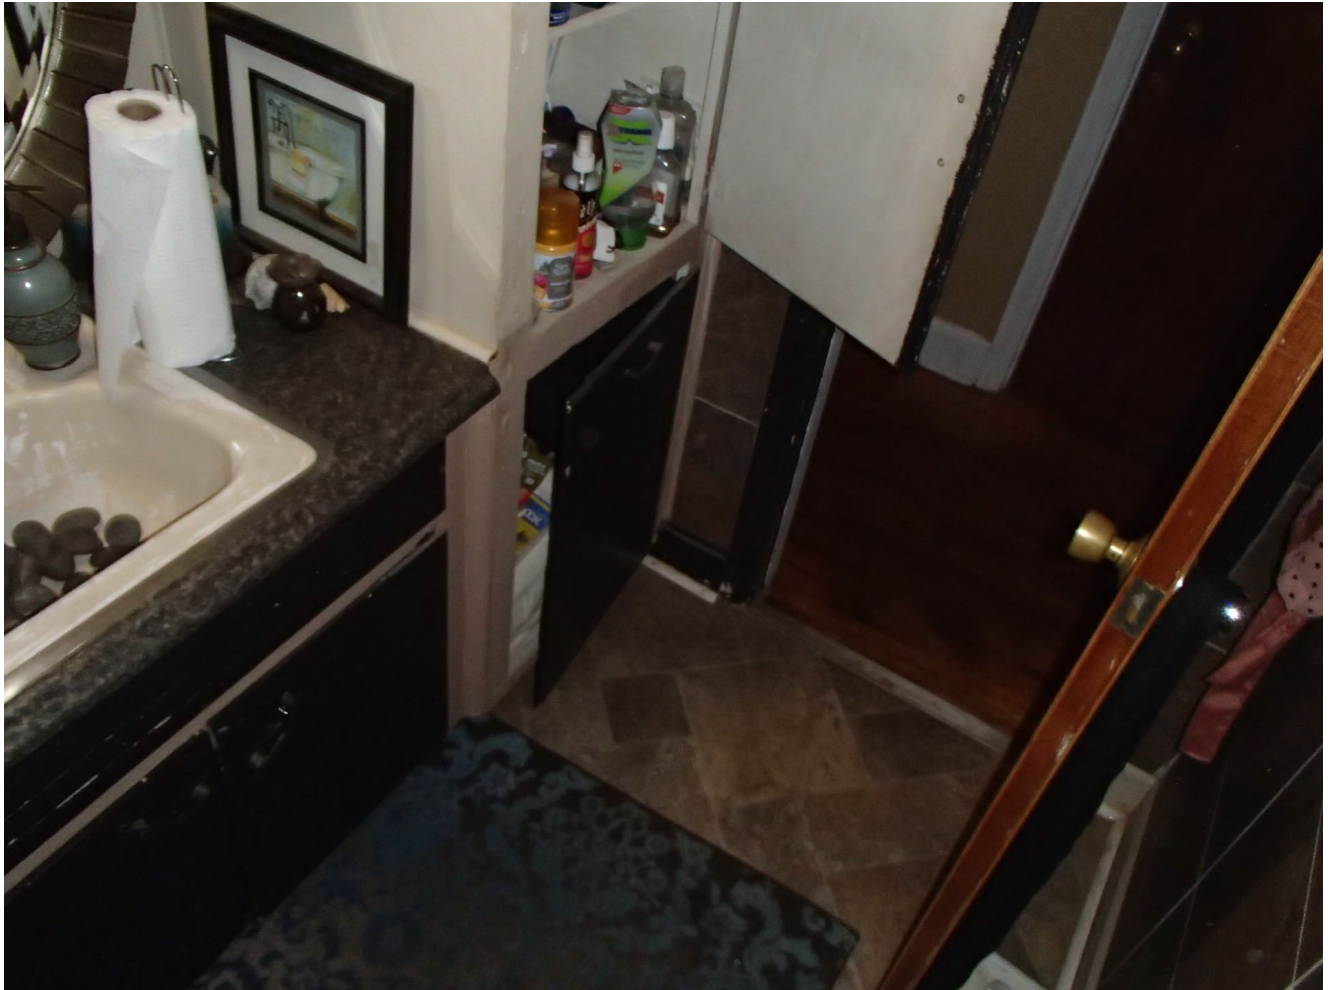
<b>LOCATION AND DESCRIPTION OF DETERIORATED LEAD-BASED PAINT – INTERIOR (WORK REQUIRED AT THIS TIME – SEE SECTION 4.0)</b>
<u>Room 5 – Bath – Side D</u> – beige and black wood cabinet frames, cabinet doors, cabinet shelves and shelf supports and interior cabinets (including sink cabinet)

**Photo 7 – Room 5 – Bath – Cabinet Frames, Cabinet Door and Associated Components – Side D**

LOCATION AND DESCRIPTION OF DETERIORATED LEAD-BASED PAINT – INTERIOR	RECOMMENDED ACTION
Room 5 – Bath – Side D – beige and black wood cabinet frames, cabinet doors, cabinet shelves and shelf supports and interior cabinets (including sink cabinet)	1/Replace.
	2/Make smooth and operable, scrape loose paint and re-paint.
Elevated lead dust level in Room 1 and Room 5	1/Complete specialized cleaning throughout house. (elevated lead dust level on windowsill is likely from lead-containing paint on exterior windows)
