# Feasibility Study Report

## Reedy Creek Watershed Enhancement

Contract Number: 1100719

Charlotte, North Carolina

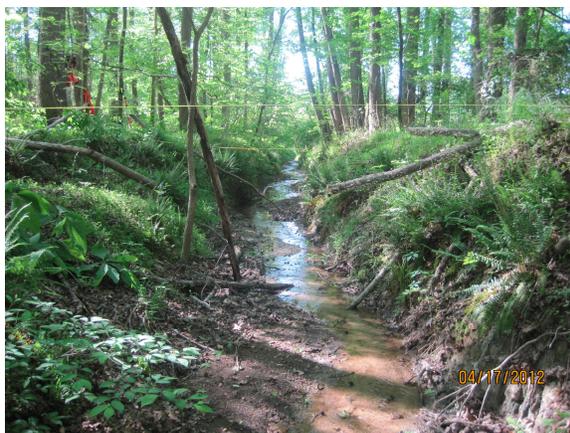
Photo. Mature forested buffer (Reach 8).

The hardwood species range in age from less than 5 to over 30 years old depending on the location in the preserve. Reach 8 has the most mature forested community with many trees over 36" in diameter. The Reaches outside the preserve have less mature vegetation and some Chinese Privet (*Ligustrum sinense*) was observed. Napalese Browntop (*Mictostegium vimineum*) was covering almost the entire floodplain floor along Reach 8 and in Reach 11 (but was less prevalent in the latter).

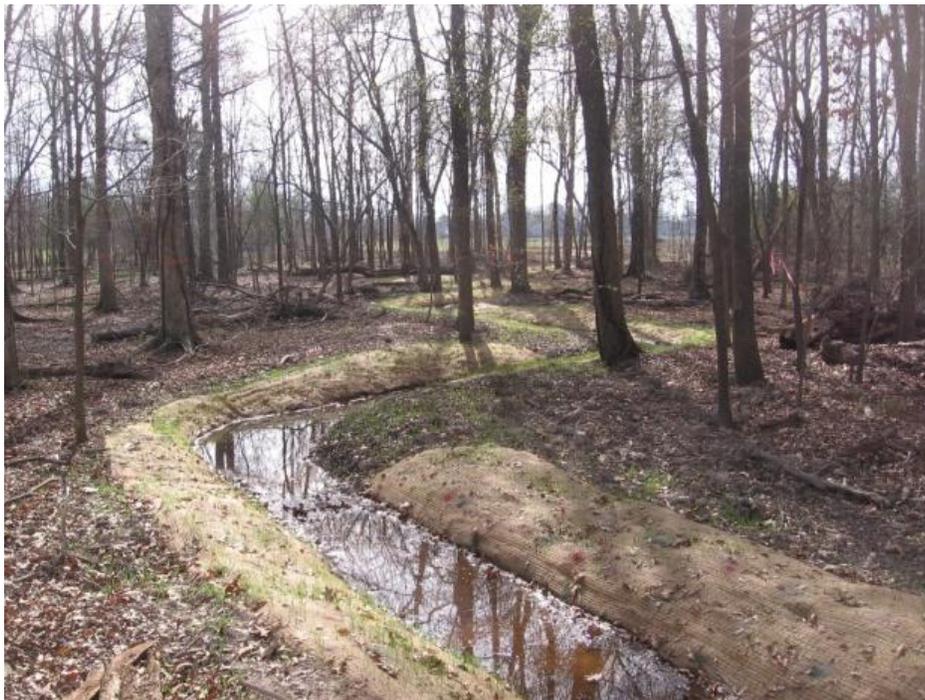
6, 6-A, upper Reach 7, 7-A, and 11-A. A Rosgen Priority 1 restoration is the process of re-establishing an incised channel back onto the previous floodplain by constructing a new bankfull/channel-forming discharge channel. The new channel dimension, pattern, and profile could be based on a stable/reference form found in the Park. The existing incised channel could be filled or partially backfilled to create oxbow lakes or vernal pools level with the new floodplain. The Priority 1 approach would start at a nick point/headcut or similar location conducive to bringing the channel up onto its historic floodplain. For lower Reach 2 and Reach 4 the restoration would start at outfall of the pond(s). These pond outfalls may need to be modified to allow for a Priority 1 restoration below. For Reaches 3, 6-8, and 10-C the restoration could start at the bedrock or vegetation feature that has stopped the head cut and separates the restoration (unstable) reach from the preservation (stable reach). Reaches 1, 9, and 10 also could be restored using Priority 1 if Priority 1 is chosen for the reaches above them. Reach 11 would be a transition reach (i.e., Priority 1 transitioning to Priority 2) to tie the upstream Priority 1 restoration to the existing culvert elevation at Plaza Road Extension at the downstream end of the project.

The location and pattern of the new channel would be based on reference conditions as well as constraints (mature trees, topography, pedestrian bridges, and utility easement). The channel could be woven around/between the trees to maximize tree preservation. There is an opportunity on lower Reach 8 to utilize the abandoned relic stream channel for the lower 750 feet.

*Photo. Example of Priority 1 – Shortly after construction*

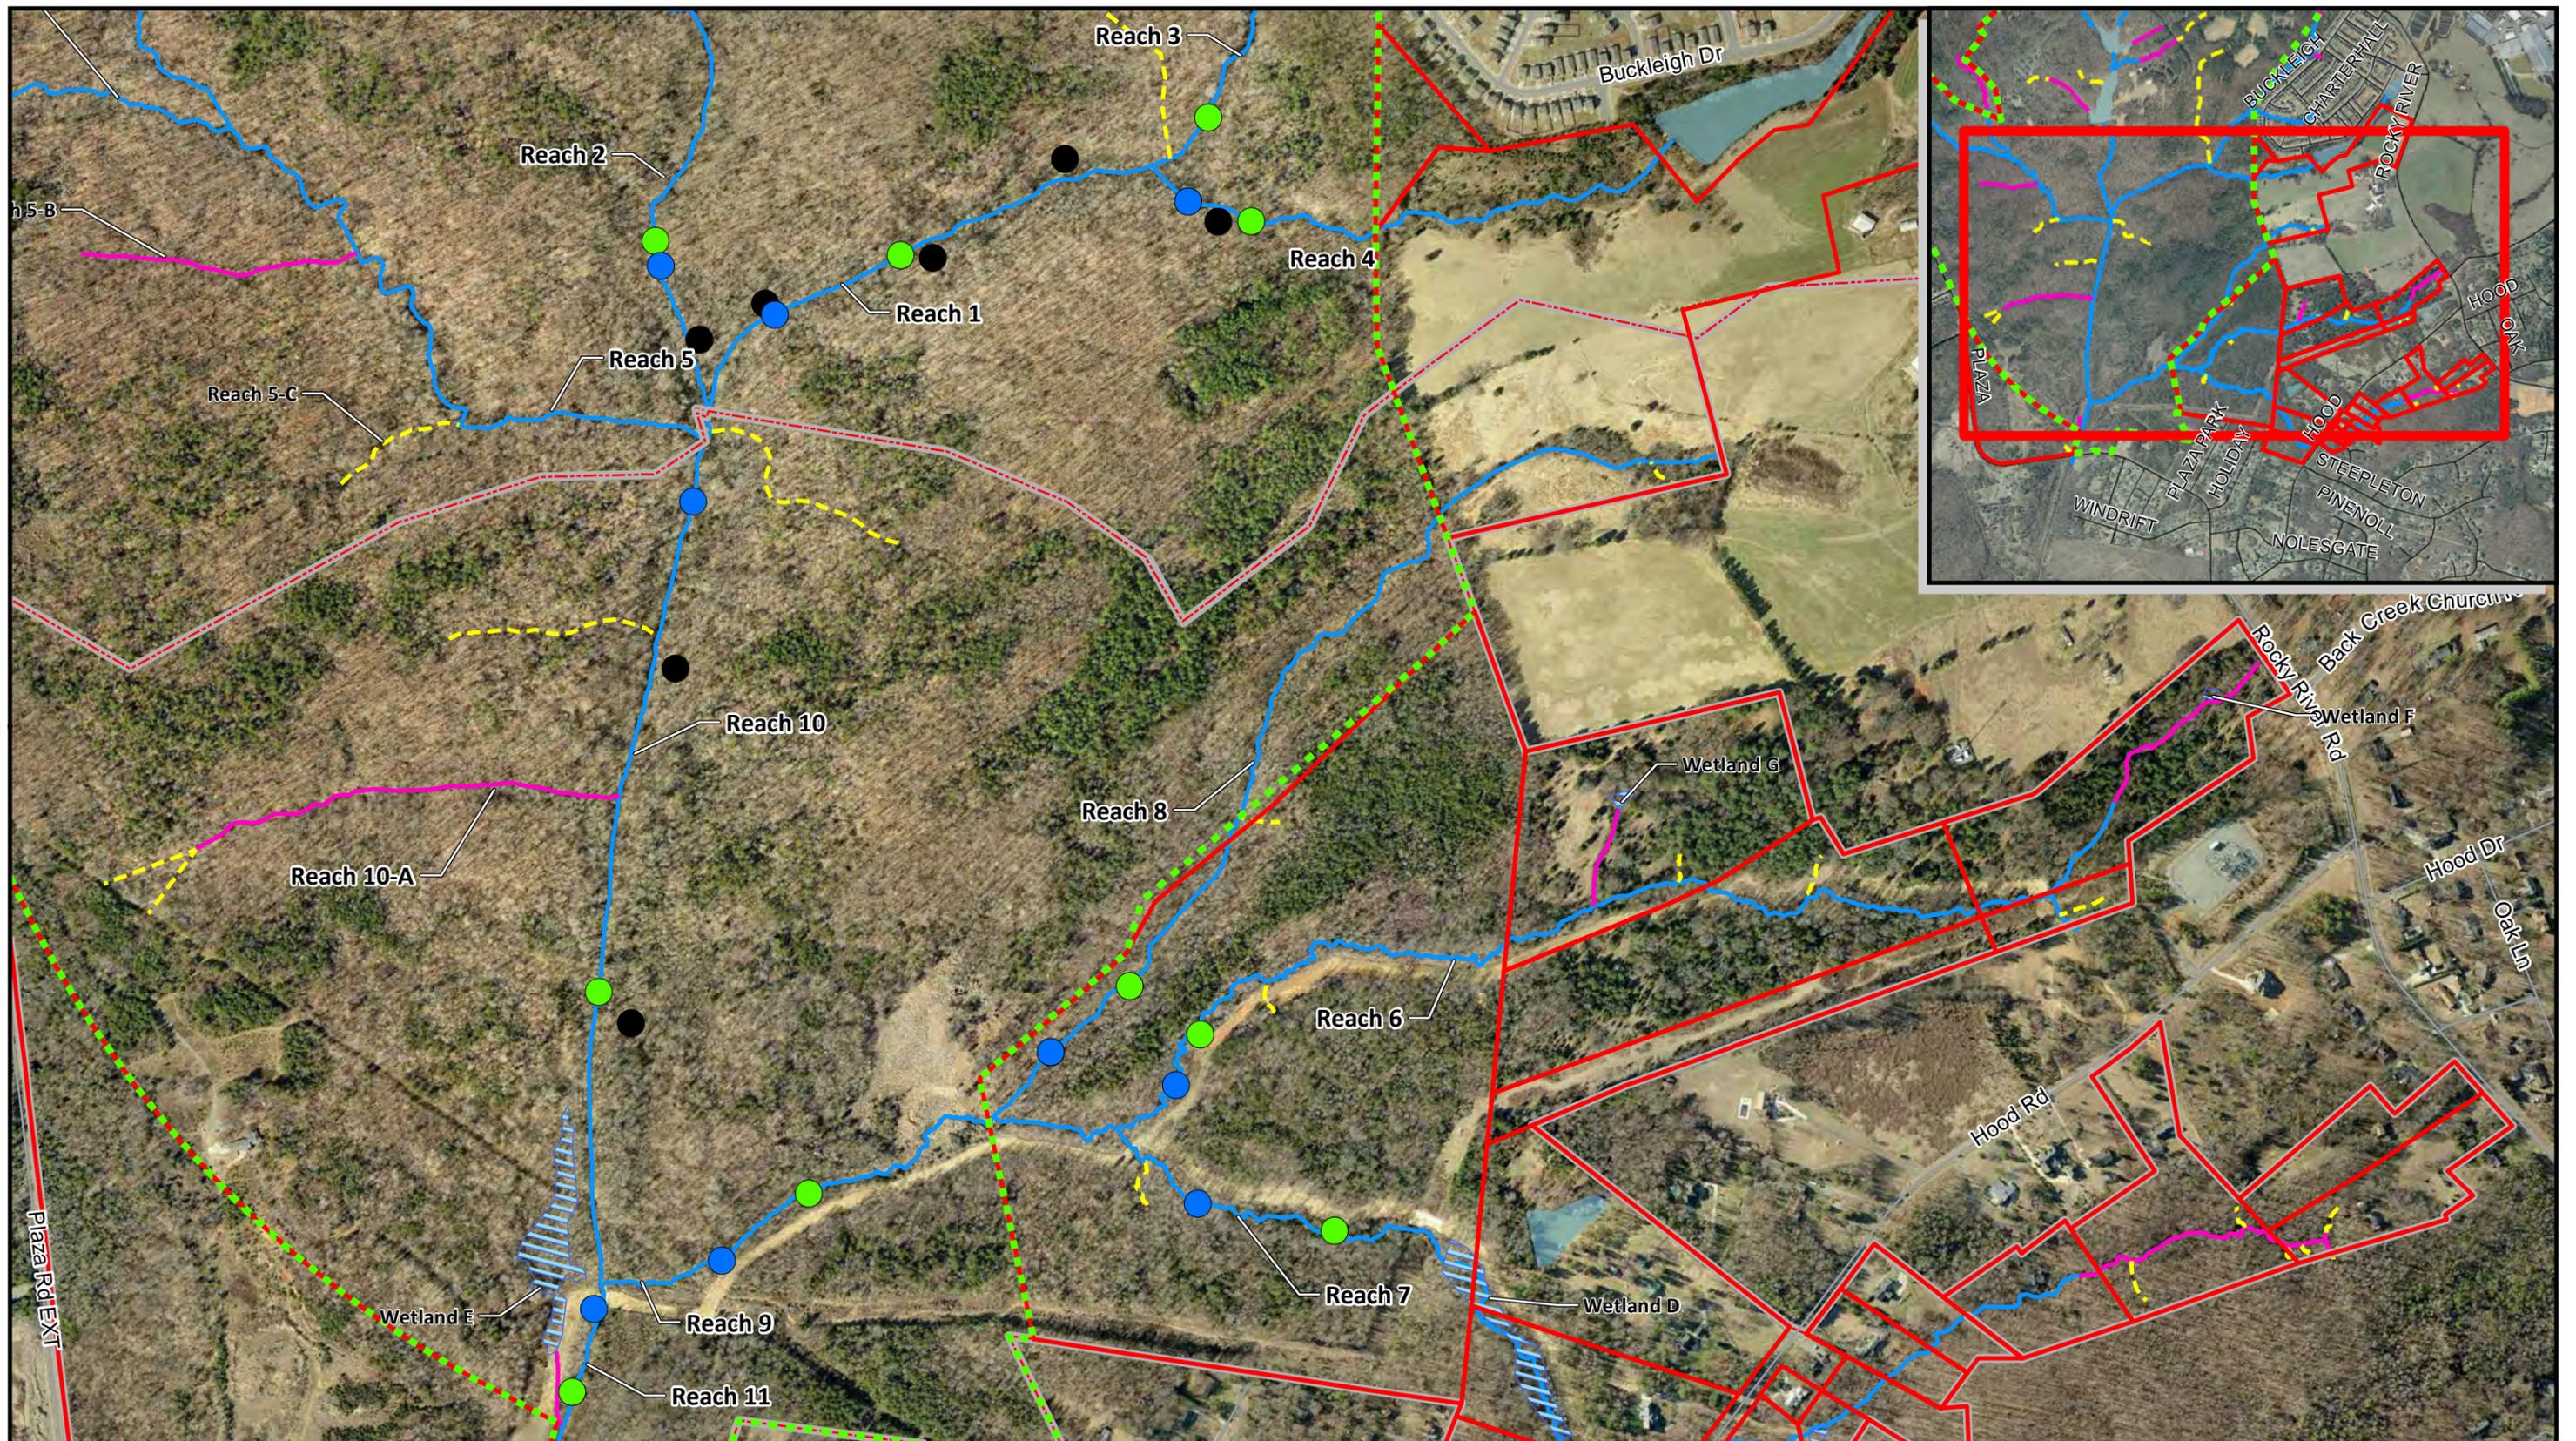
Title: Figure 3 - Data Collection

- Wetlands
- Perennial RPW
- Seasonal RPW
- Ephemeral
- Reedy Creek Nature Preserve Forest
- Soil Boring Locations
- Geomorphic Data Collection Location
- Water Quality Sampling Locations
- Ponds

- Bank Erosion Hazard Index (BEHI) and Near Bank Stress (NBS)
  - Geotechnical and soils
    - Soil strata and classification
      - Collection locations shown on Figure 3

- Modified Qual-4 collection method
    - Monitoring locations shown on Figure 3
  - Physiochemical
    - Same monitoring location as biological
    - Physical conditions measured using a calibrated handheld water quality sonde

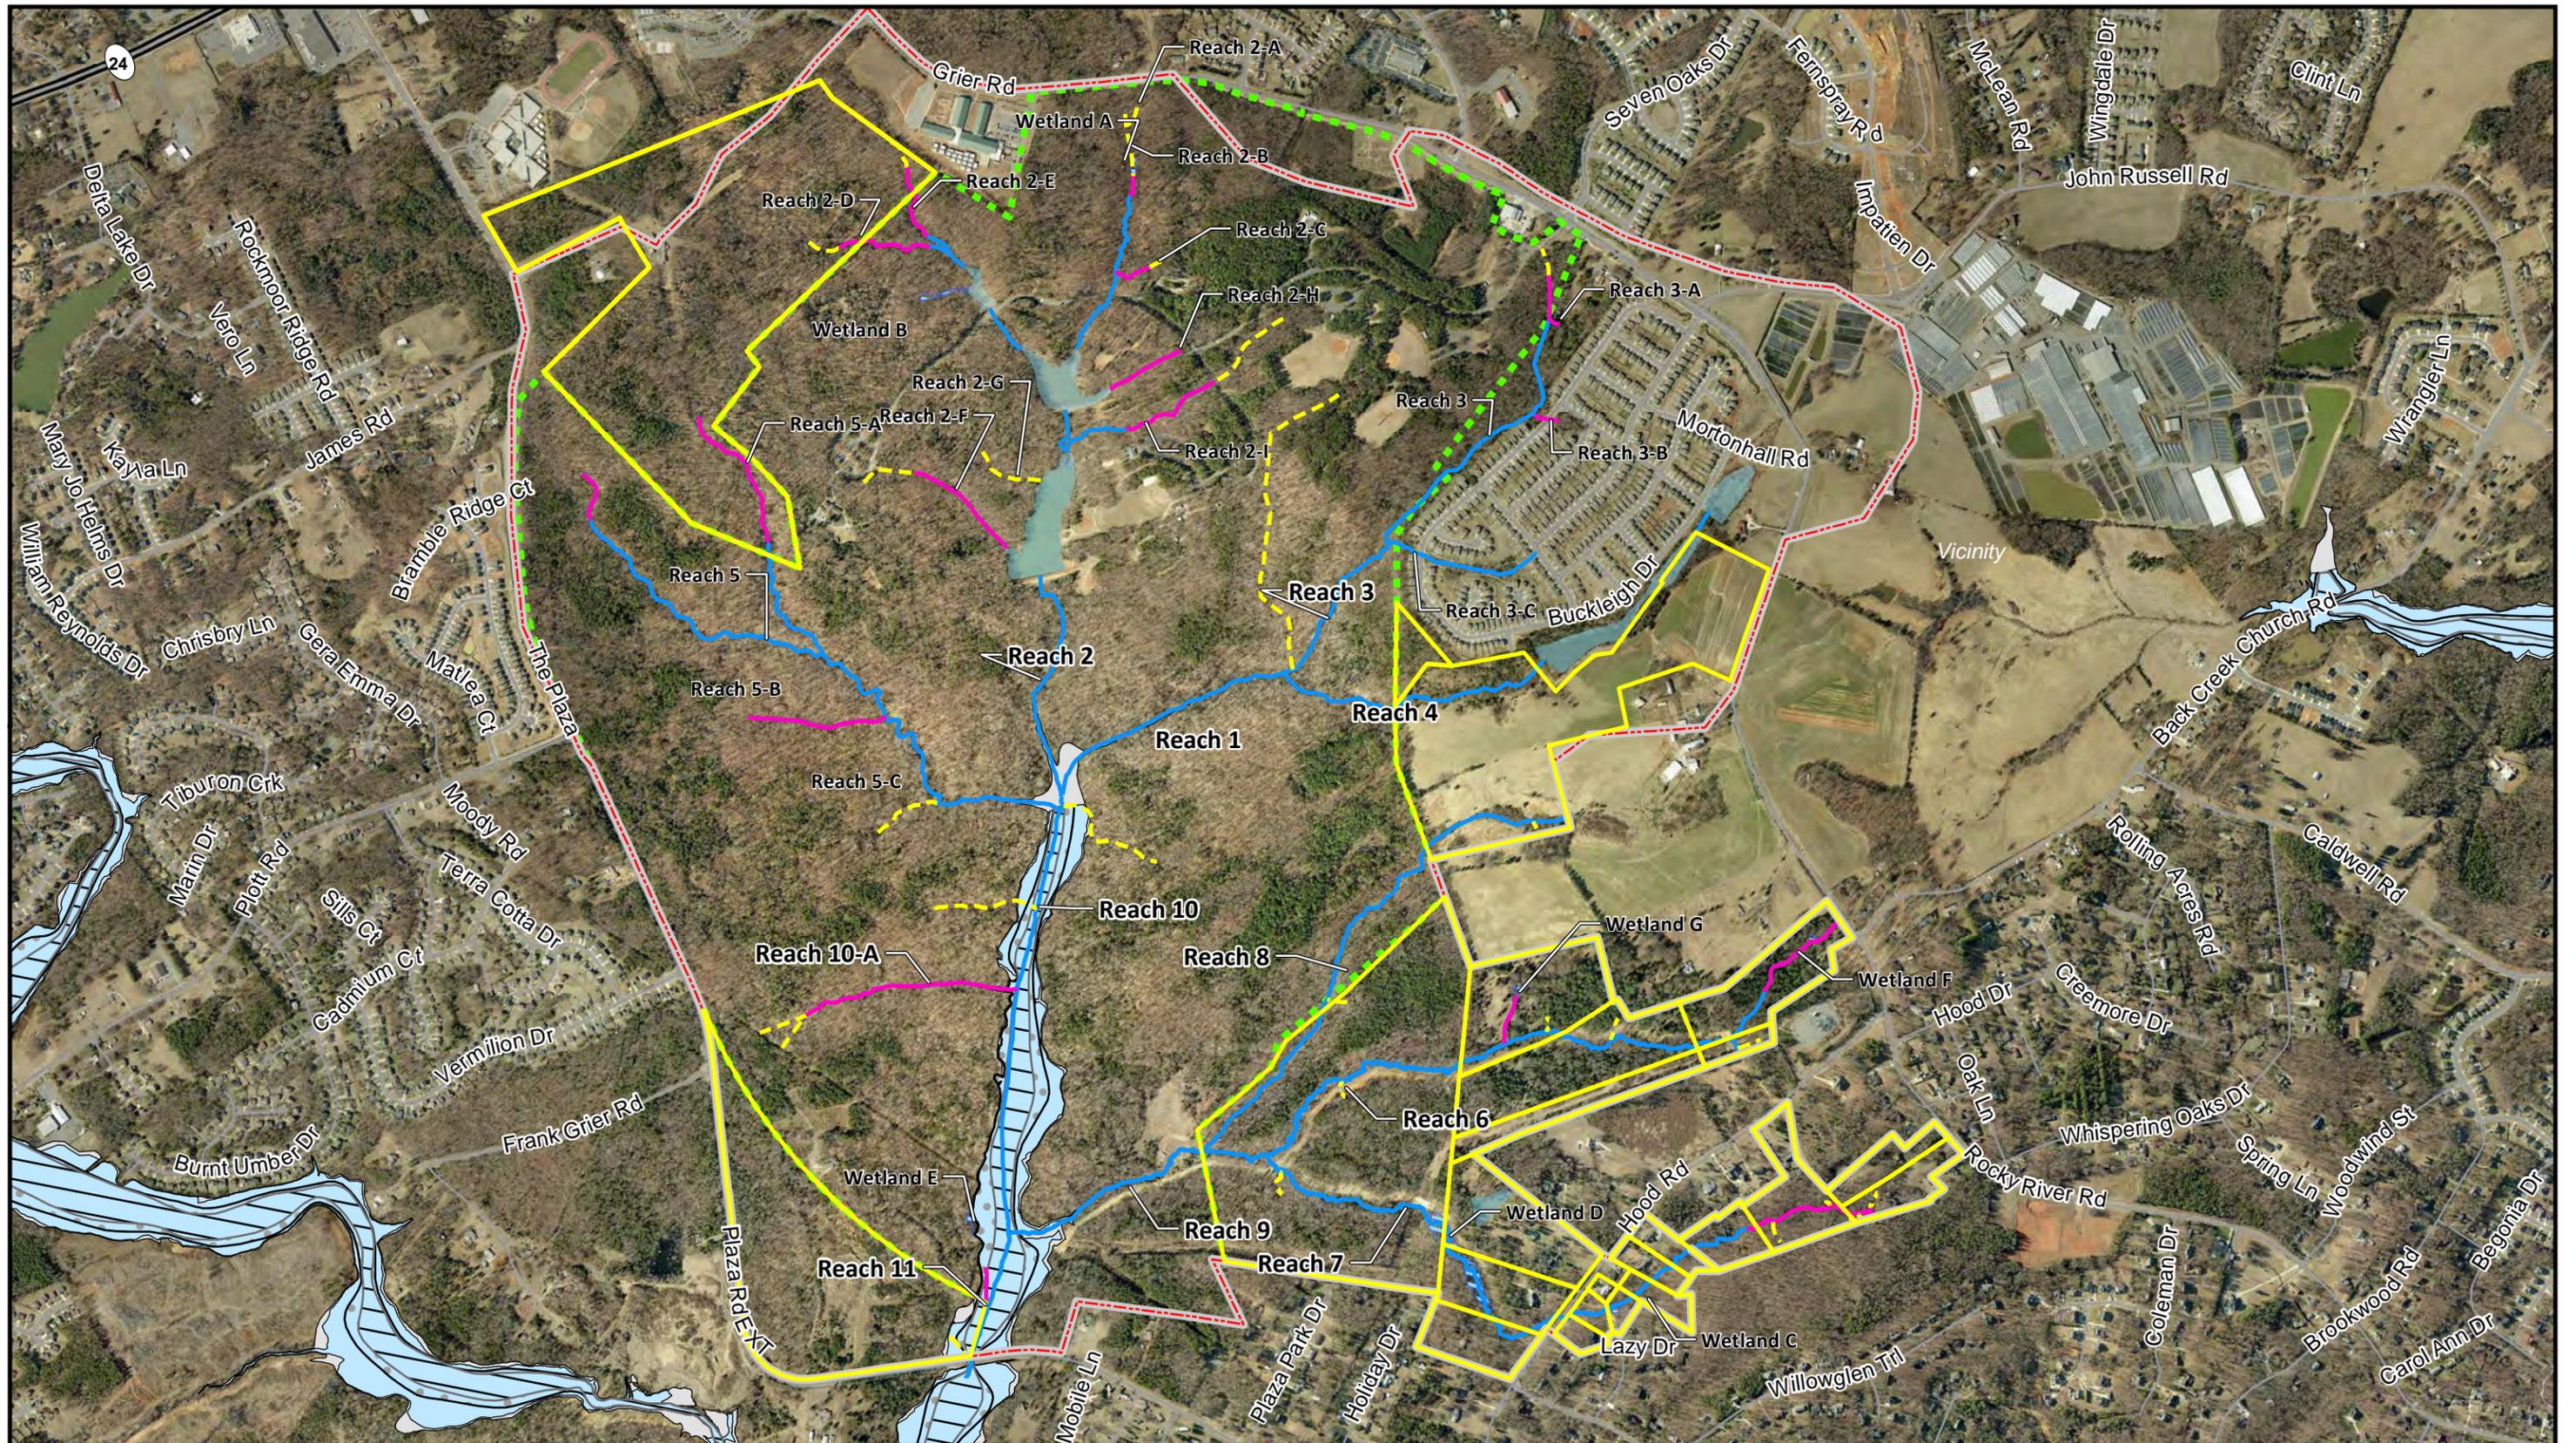
Title: Figure 4 - FEMA Flood Boundaries

- RDYCK feas\_study\_area
- Meck. Co. Owned Parcels
- Wetlands
- Ponds
- FEMA Floodway
- Community Floodway
- Existing FEMA 1% Annual Chance Flood
- Future FEMA 1% Annual Chance Flood
- Reedy Creek Nature Preserve
- Perennial RPW
- Seasonal RPW
- Ephemeral

The Mecklenburg County Digital Flood Insurance Rate Map (DFIRM) panel 4585 (effective March 2, 2009) shows that Reach 10 and 11 inside the Study Area are included in detailed studied streams or mapped within any floodplain or floodway areas. Work within this study area will require a floodplain development permit from Mecklenburg County and a corresponding flood impact study (FIS). The FIS will require detailed (HEC-RAS) modeling and if changes to base flood elevations or floodplain boundaries occur a Conditional Letter of Map Revision (CLOMR) will be required by FEMA/Mecklenburg County prior to construction. A Letter of Map Revision (LOMR) also will be required post construction.

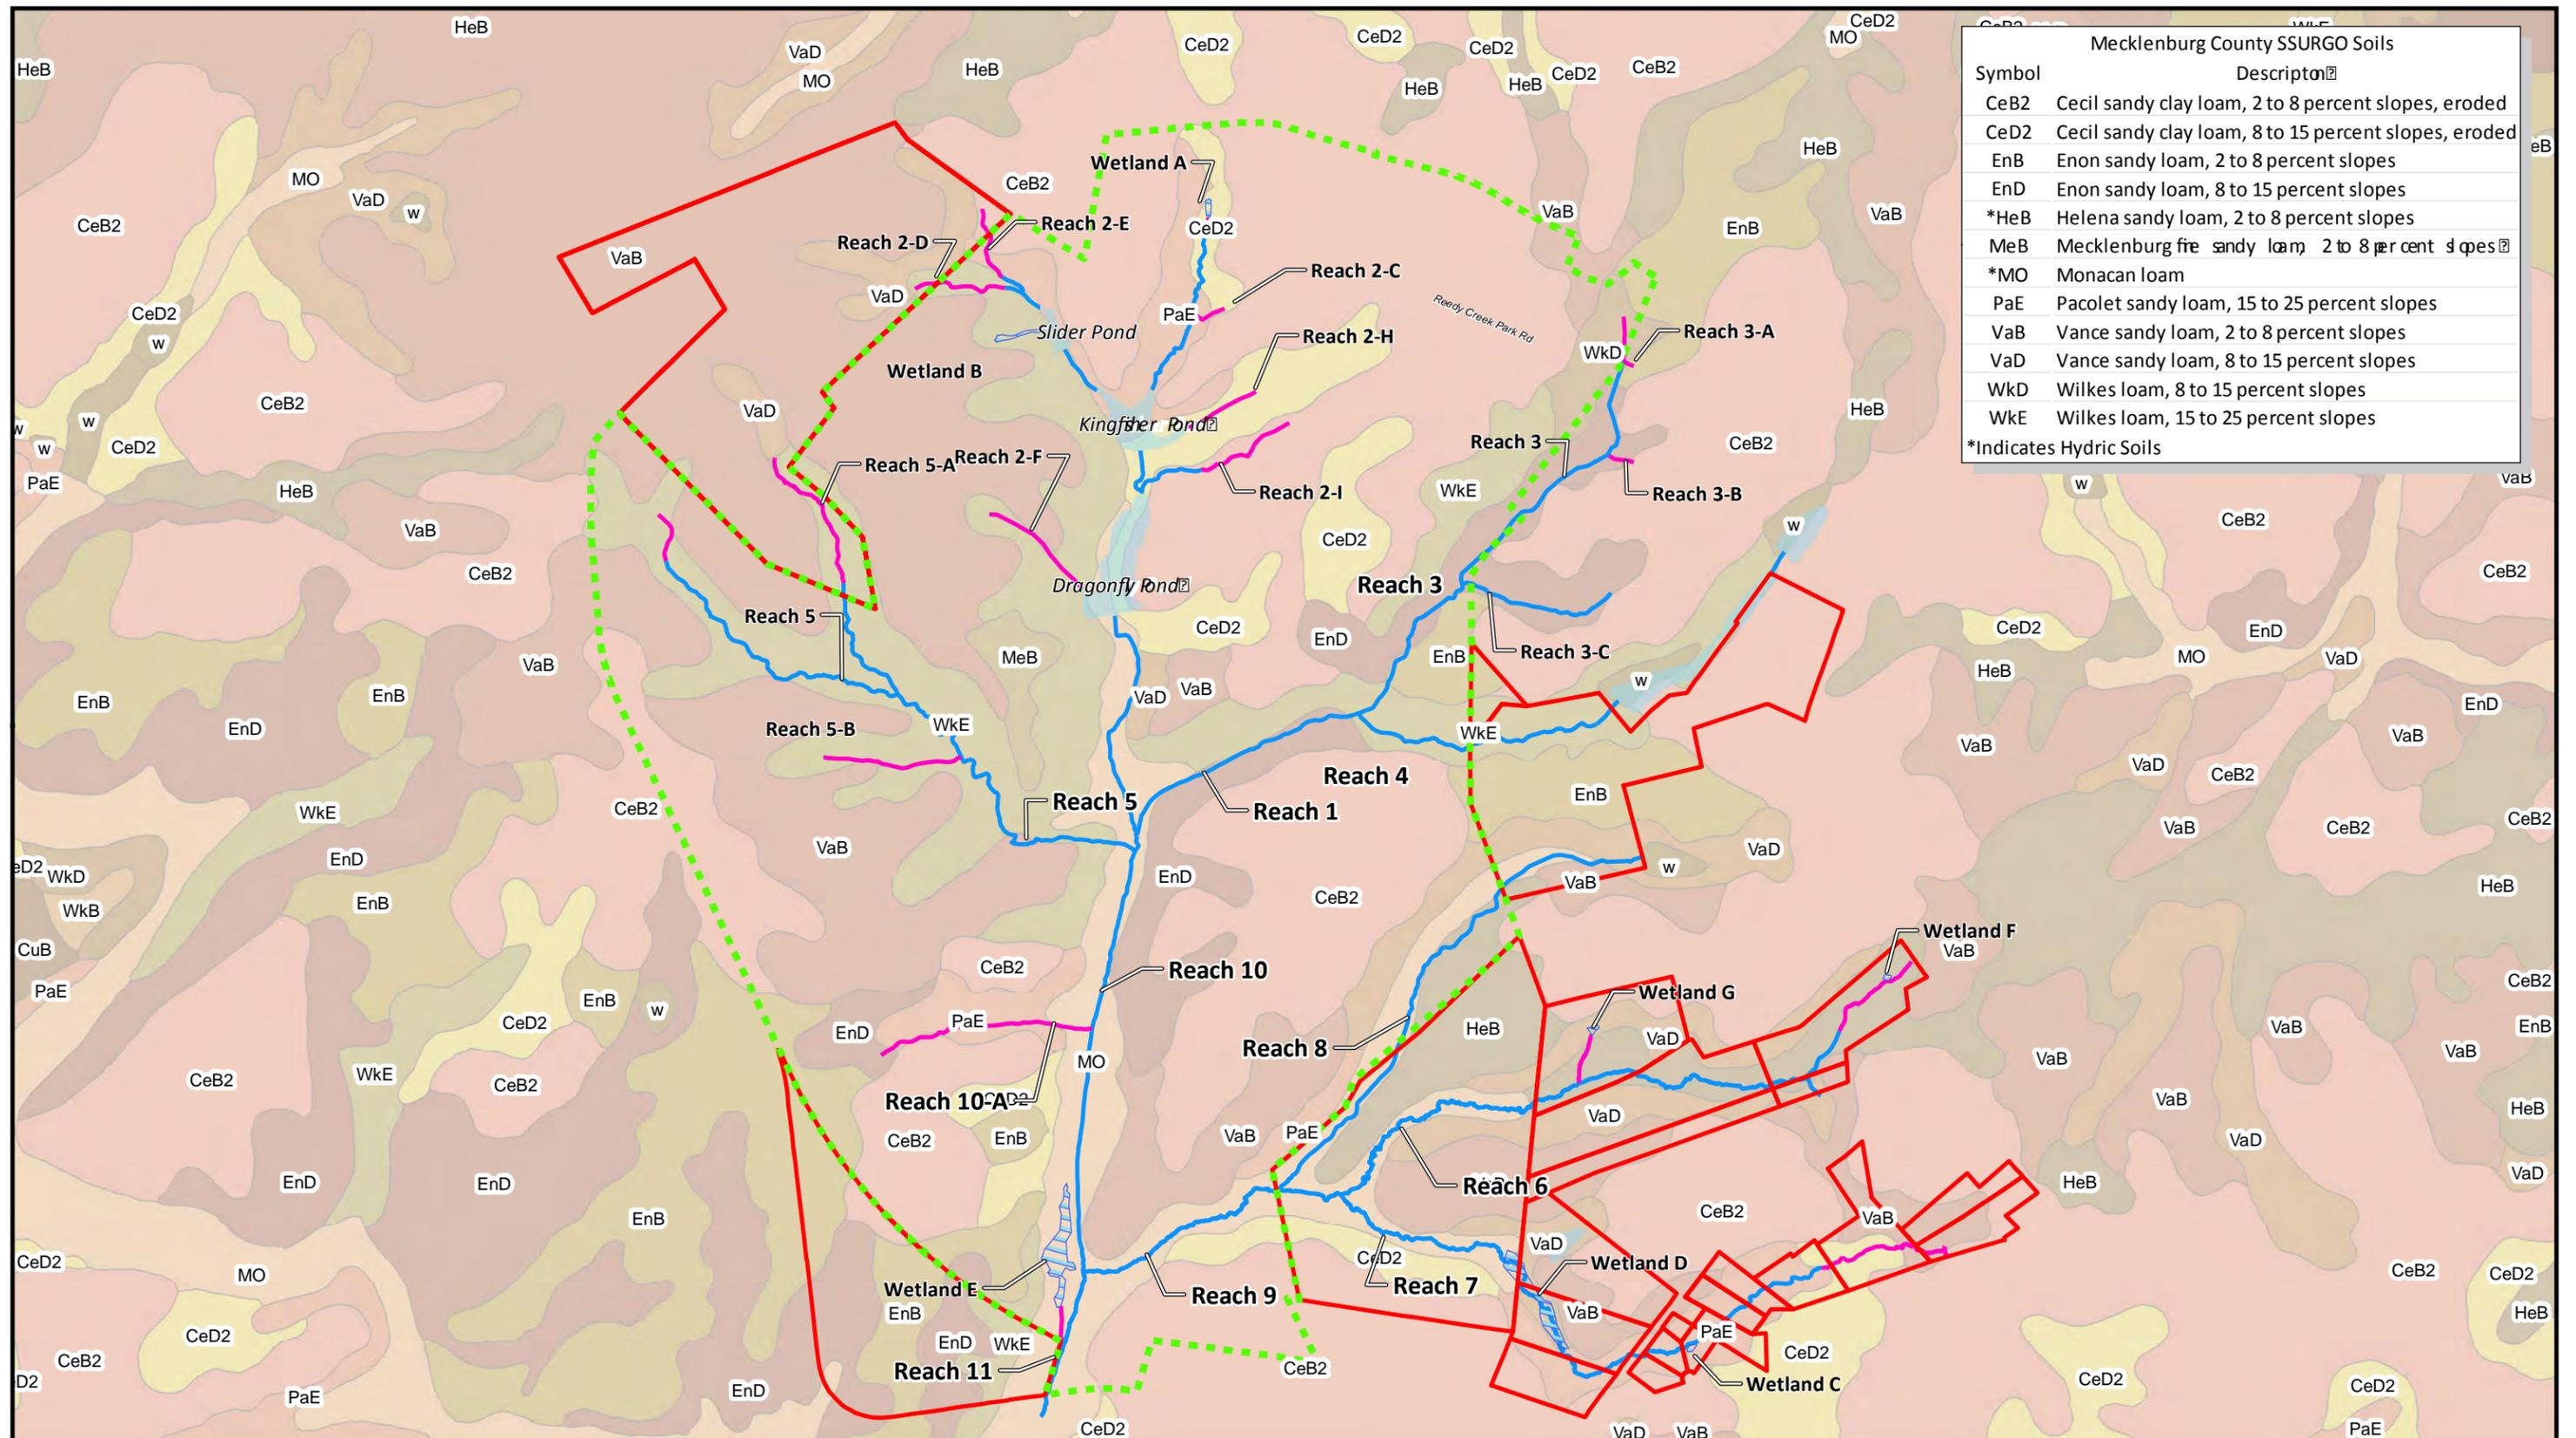
Title: Figure 5 - NRCS SSURGO Soils Figure

Mecklenburg County SSURGO Soils	
Symbol	Description
CeB2	Cecil sandy clay loam, 2 to 8 percent slopes, eroded
CeD2	Cecil sandy clay loam, 8 to 15 percent slopes, eroded
EnB	Enon sandy loam, 2 to 8 percent slopes
EnD	Enon sandy loam, 8 to 15 percent slopes
*HeB	Helena sandy loam, 2 to 8 percent slopes
MeB	Mecklenburg fine sandy loam, 2 to 8 percent slopes
*MO	Monacan loam
PaE	Pacolet sandy loam, 15 to 25 percent slopes
VaB	Vance sandy loam, 2 to 8 percent slopes
VaD	Vance sandy loam, 8 to 15 percent slopes
WkD	Wilkes loam, 8 to 15 percent slopes
WkE	Wilkes loam, 15 to 25 percent slopes
*Indicates Hydric Soils

The *Soil Survey of Mecklenburg County, North Carolina* (USDA, 1980) indicates that the floodplain of the project area contains Monacan loam (MO), Helena sandy loam (HeB), Vance sandy loam (VaD), Wilkes loam (WkE), Pacolet sandy loam (PaE), Enon sandy loam (EnB and EnD), and Cecil sandy clay loam (CeB2 and CeD2) soils. Monacan (MO) and Helena soils, classified as having hydric inclusions, are somewhat poorly drained and nearly level-typical characteristics of soils found on floodplains along streams and drainage ways. Wilkes loam (15-25% slopes) and Pacolet sandy loam (25-45% slopes) are well drained soils on the side slopes adjacent to drainage ways. The organic content for both is low and permeability is moderate. Cecil (CeB2) soils are well drained and typically found on eroded slopes ranging between 2-8%, defined as interfluves or uplands. The soils were classified using the Unified Soil Classification System. There were no observed relic Hydric soils. Soils identified as Hydric per NRCS mapping were inspected for relic indicators but were observed to be uniform alluvial piedmont floodplain soils with no indicators of a relic Hydric condition. A soils map of the project area is shown in Figure 5.

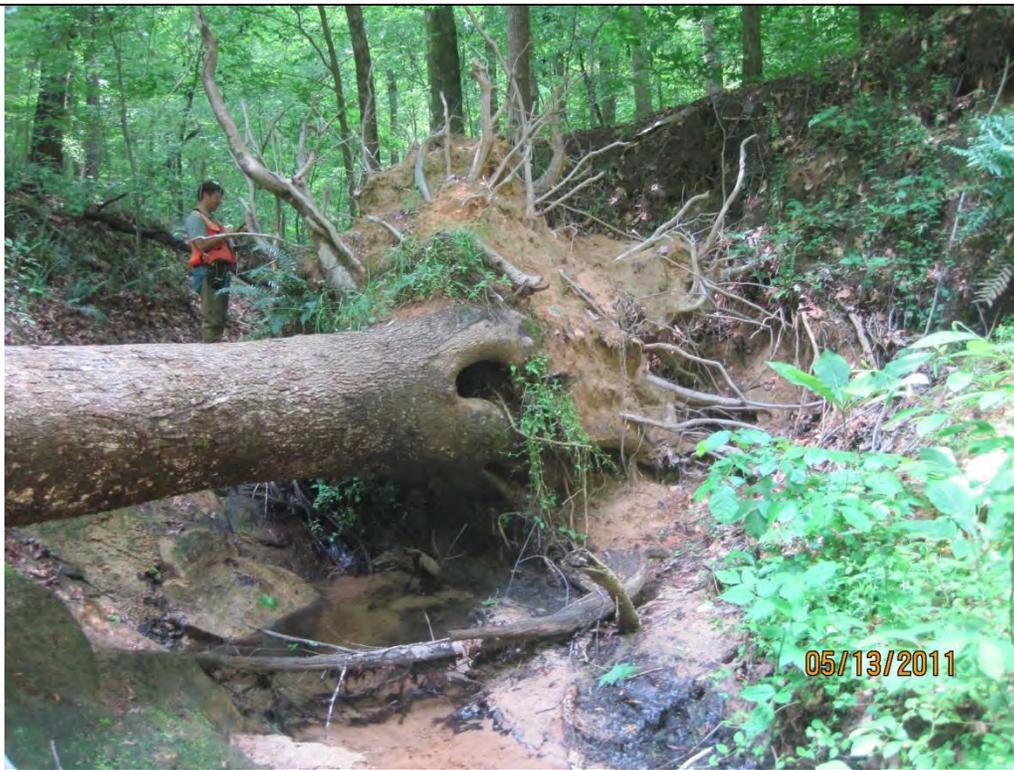
Photo 9: Reach 5 – Unstable degraded area looking upstream

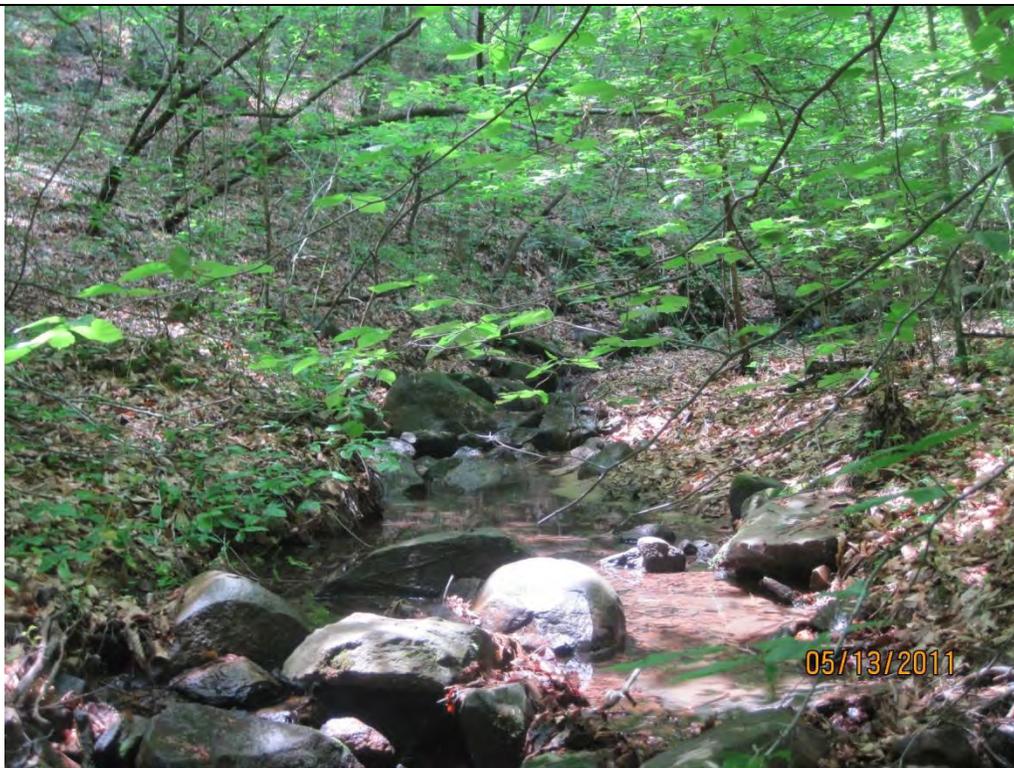
Photo 10: Reach 5 – Preservation area (Potential Reference)

On Reaches 2 and 6, the dam/embankment of Dragonfly Pond and a relic pond has prevented the headcut from migrating upstream respectively, and on reach 5 and 7 a large bedrock outcrop and dense root mass has done the same. Above these points, reaches are visually stable. Much of the upstream areas of reach 5 and 7 are in a reference condition (Photo 10 and 15, Appendix 2).

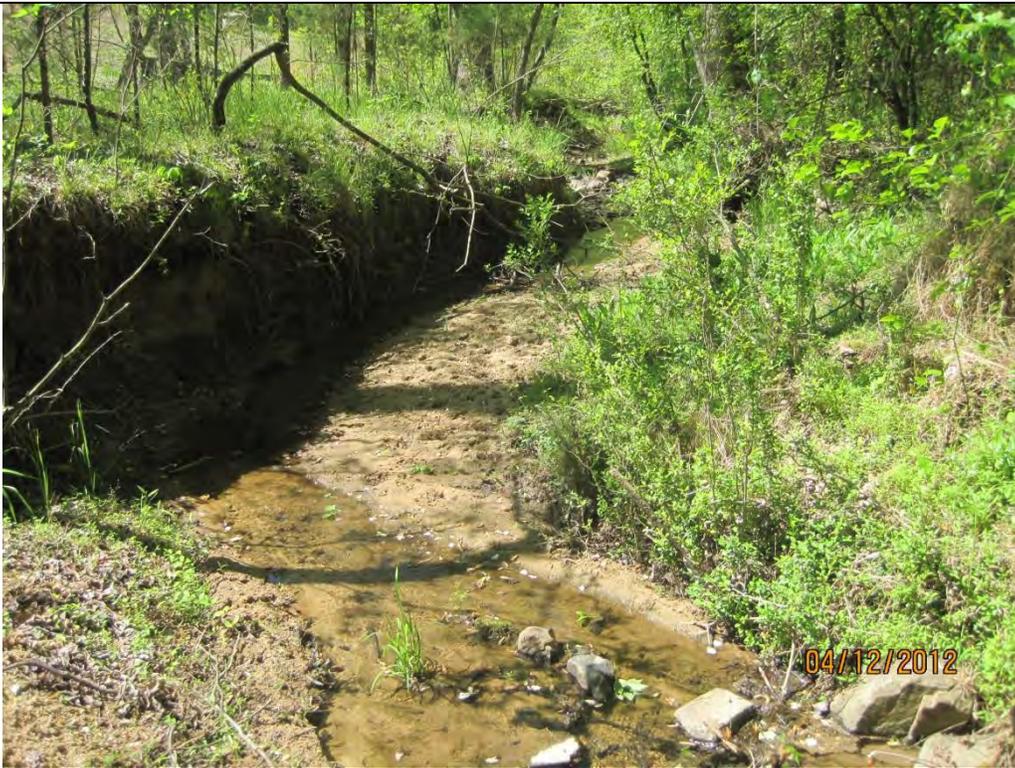
Photo 11: Reach 6 – Unstable degraded area looking downstream

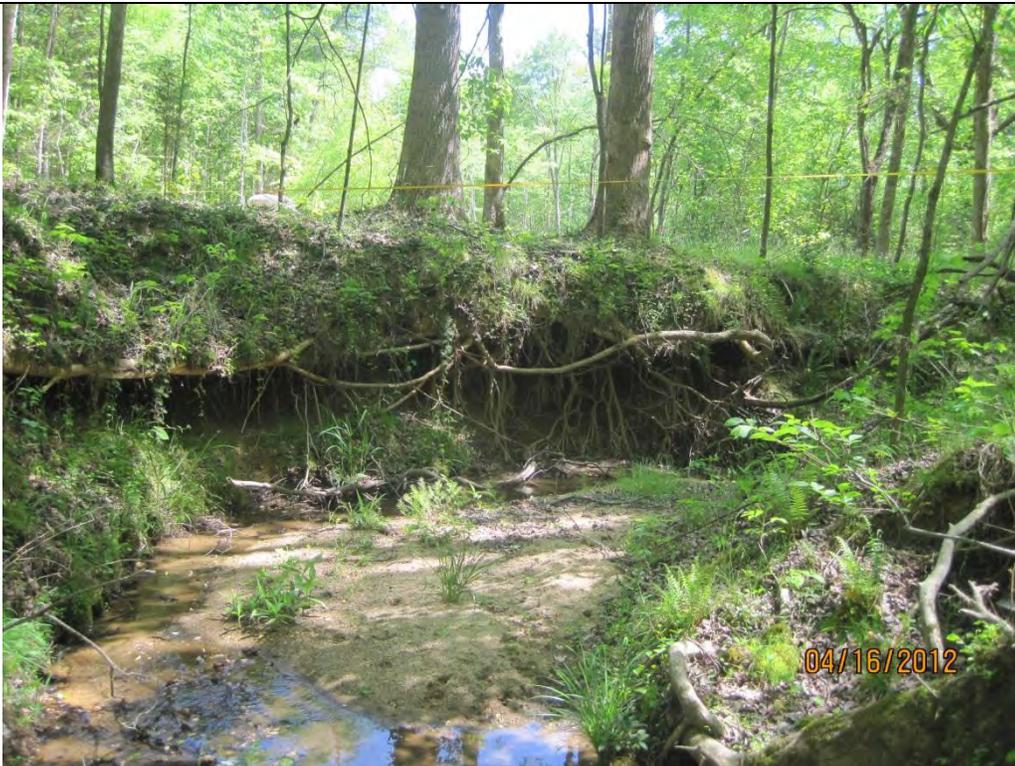
Photo 12: Reach 7 – Unstable degraded area looking downstream

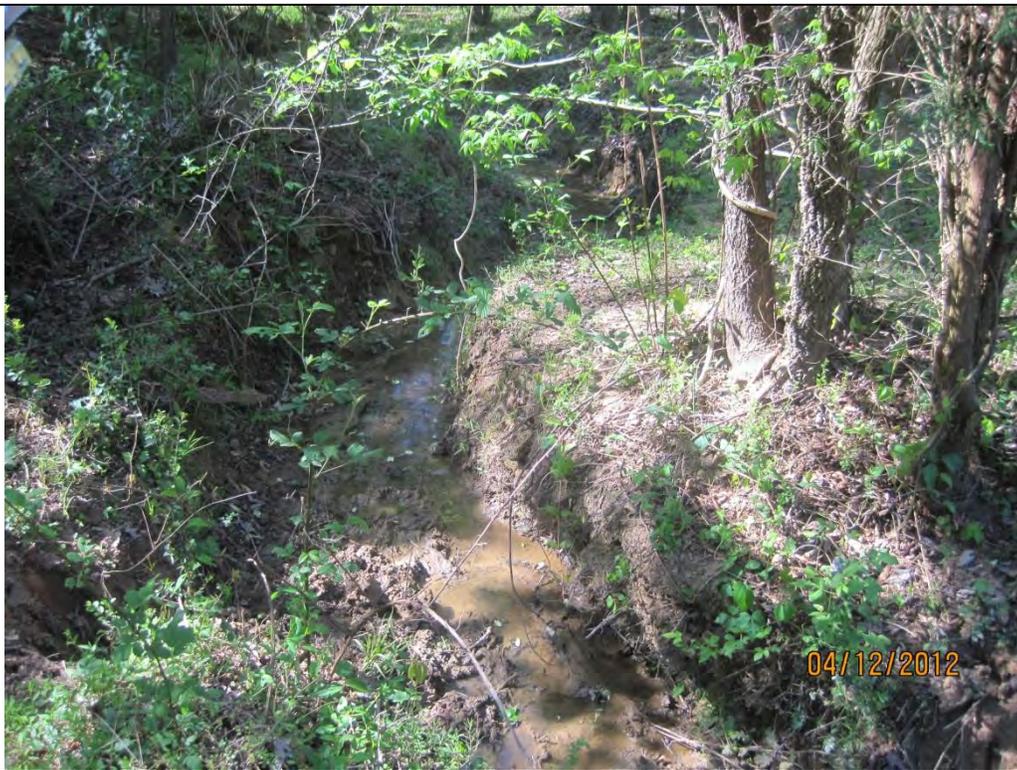
Photo 13: Reach 8 – Unstable degraded area looking downstream

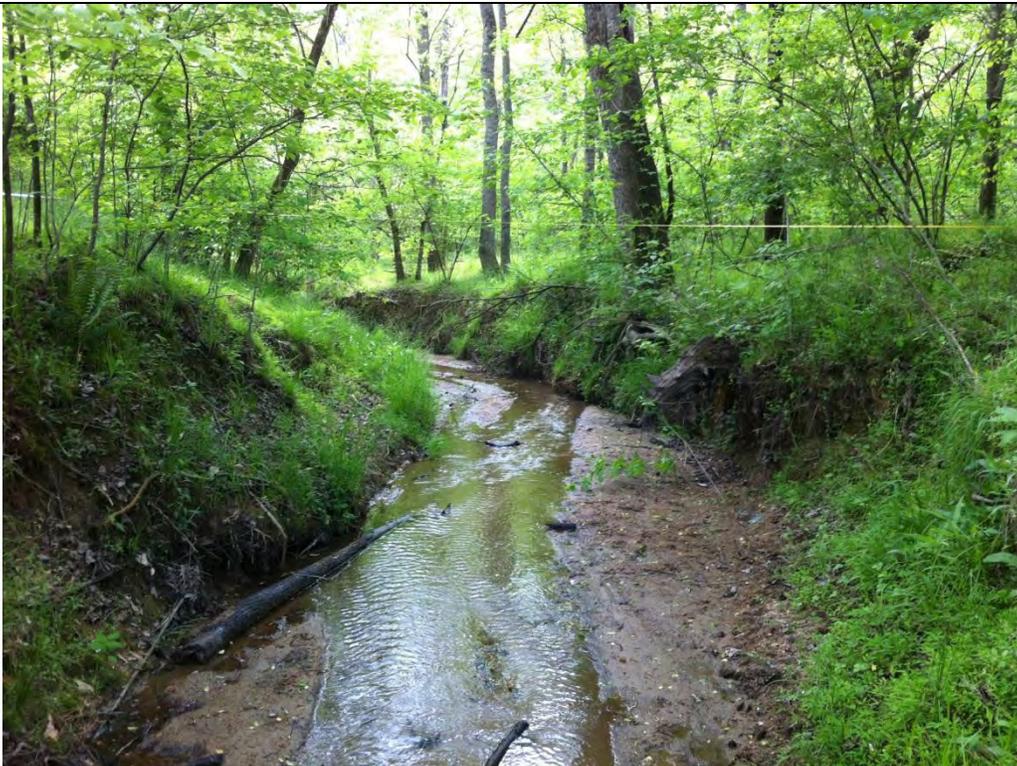
Photo 14: Reach 9 – Unstable degraded area looking downstream

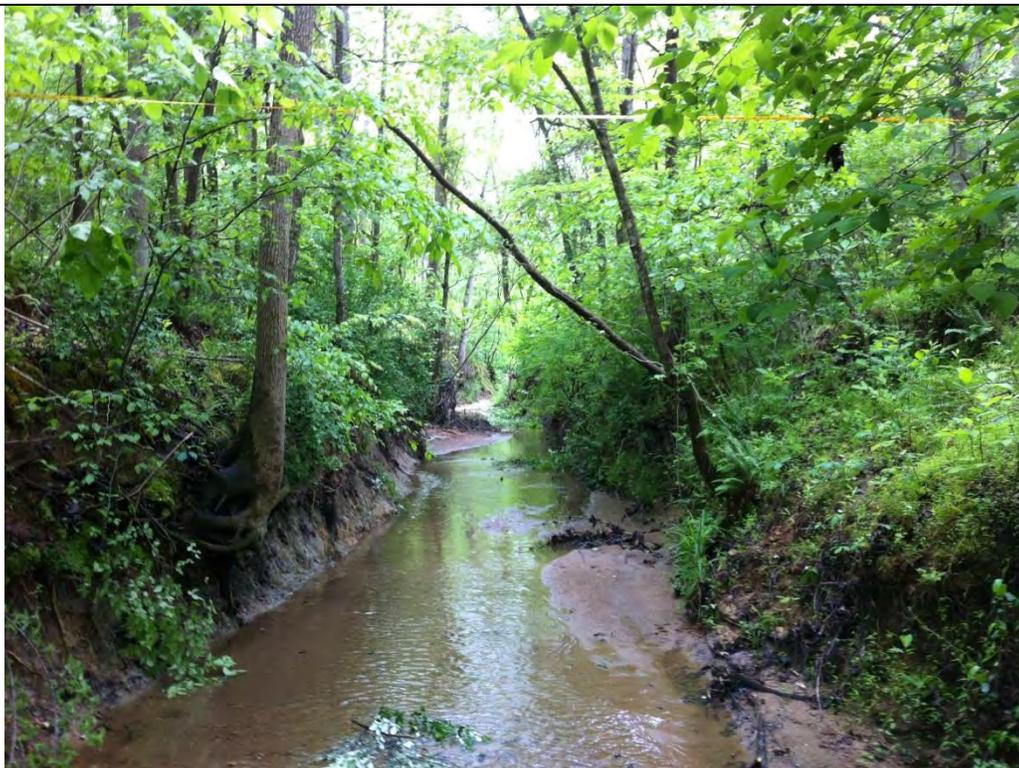
Photo 15: Reach 10 – Unstable degraded area looking downstream

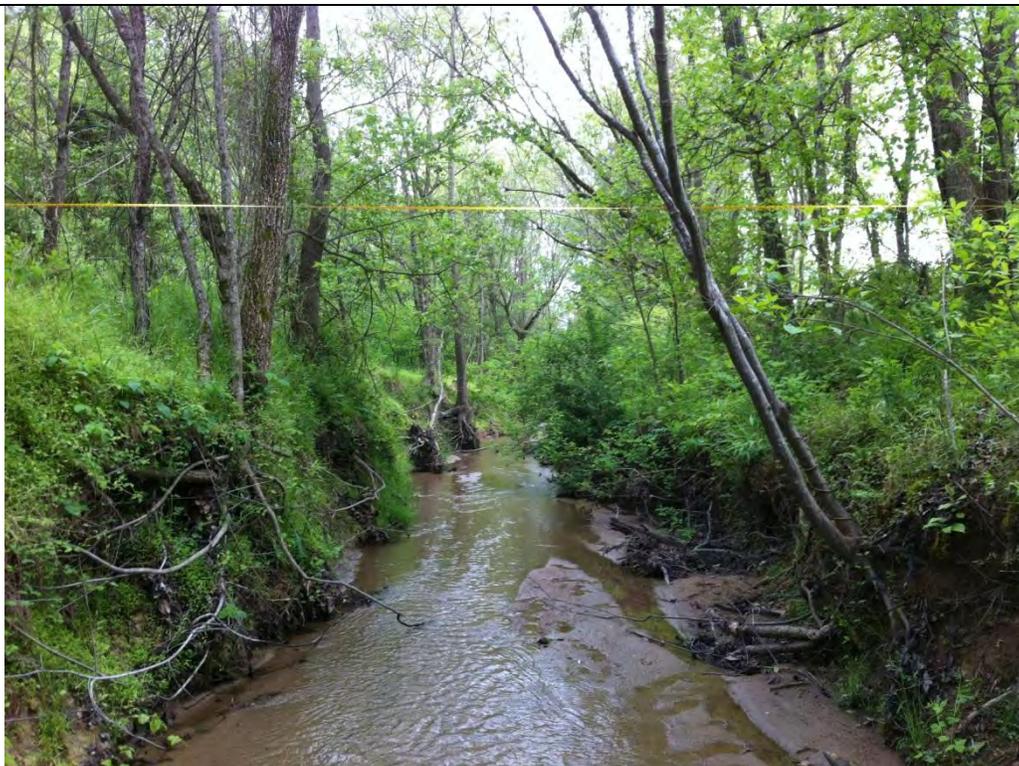
Photo 16: Reach 11 – Unstable degraded area looking downstream

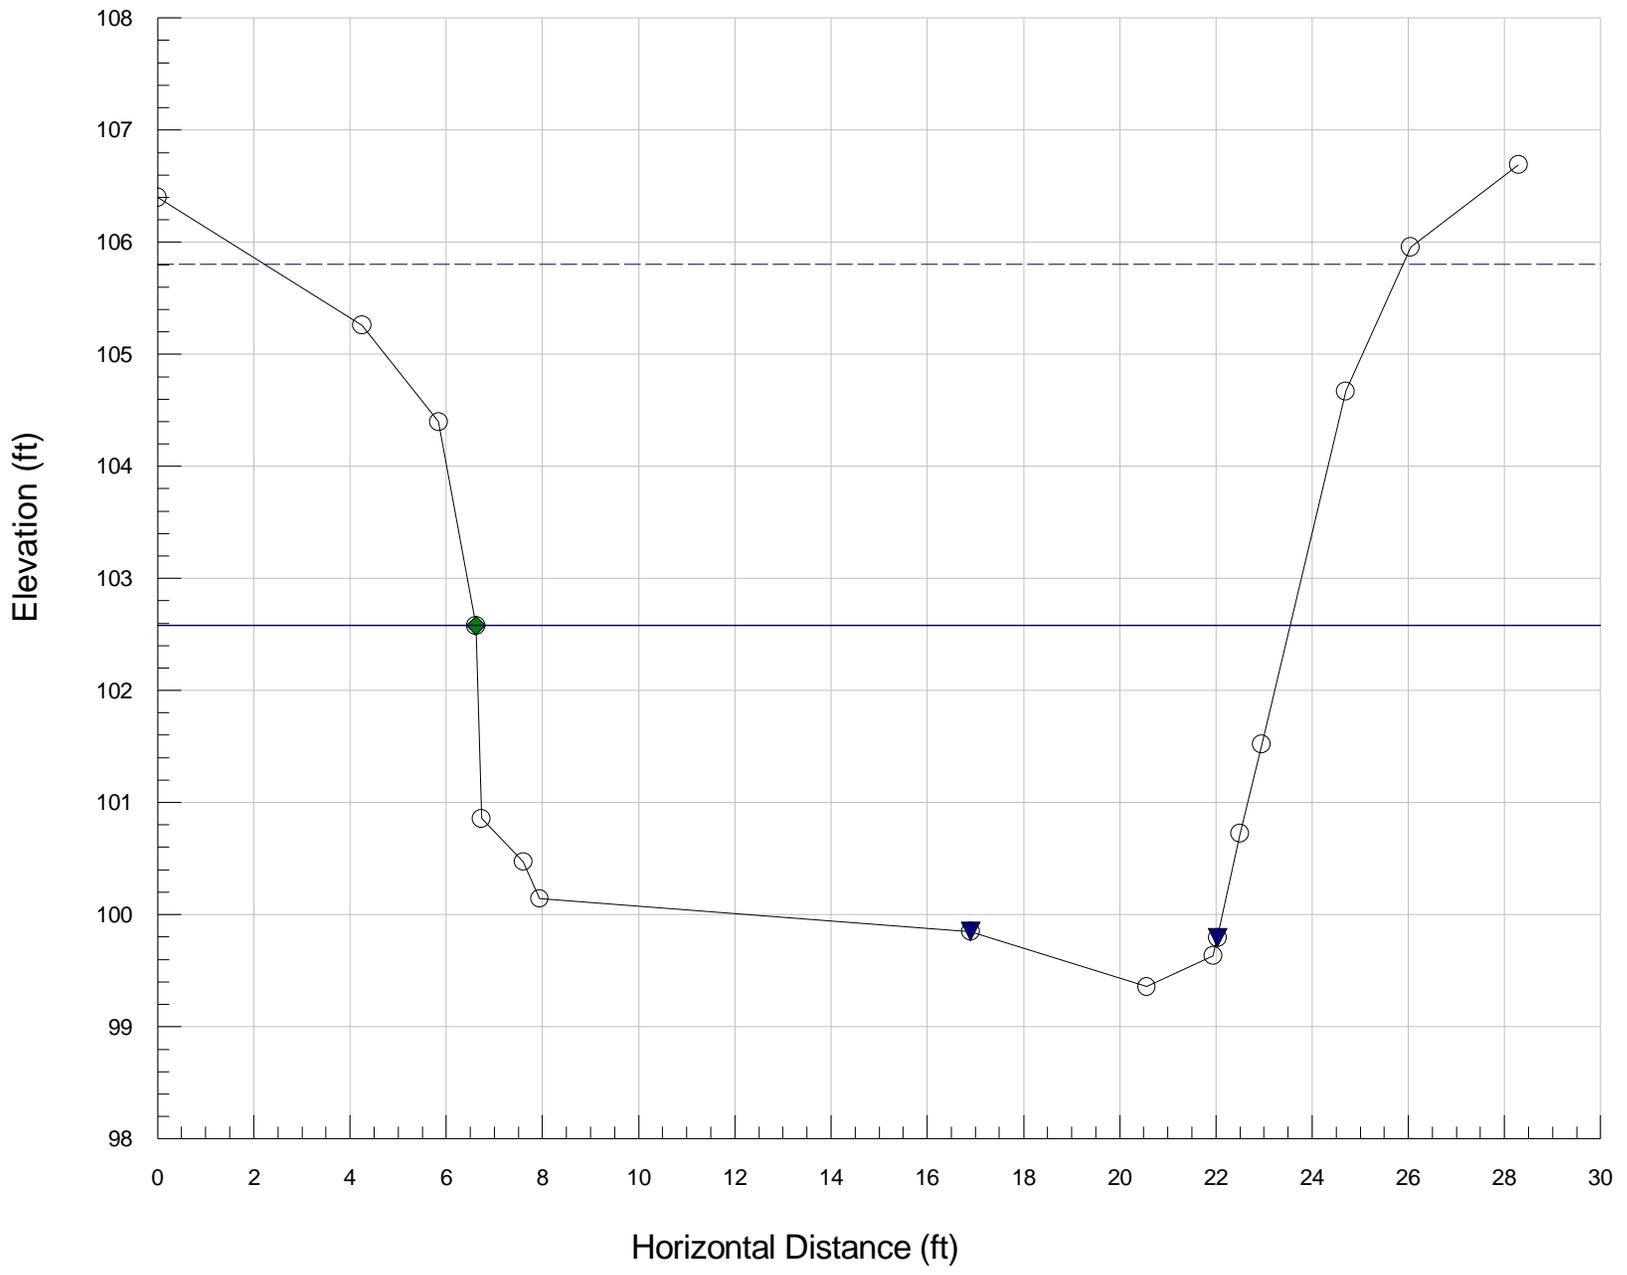
# Reach 11 - Cross Section 2 (Riffle)

○ Ground Points      ◆ Bankfull Indicators      ▼ Water Surface Points  
wbkf = 12.8      Dbkf = 2.55      Abkf = 32.6
