Rocky River Watershed Management Plan

**Completed by:
Charlotte-Mecklenburg Storm Water Services**

Date Completed: February 15, 2015

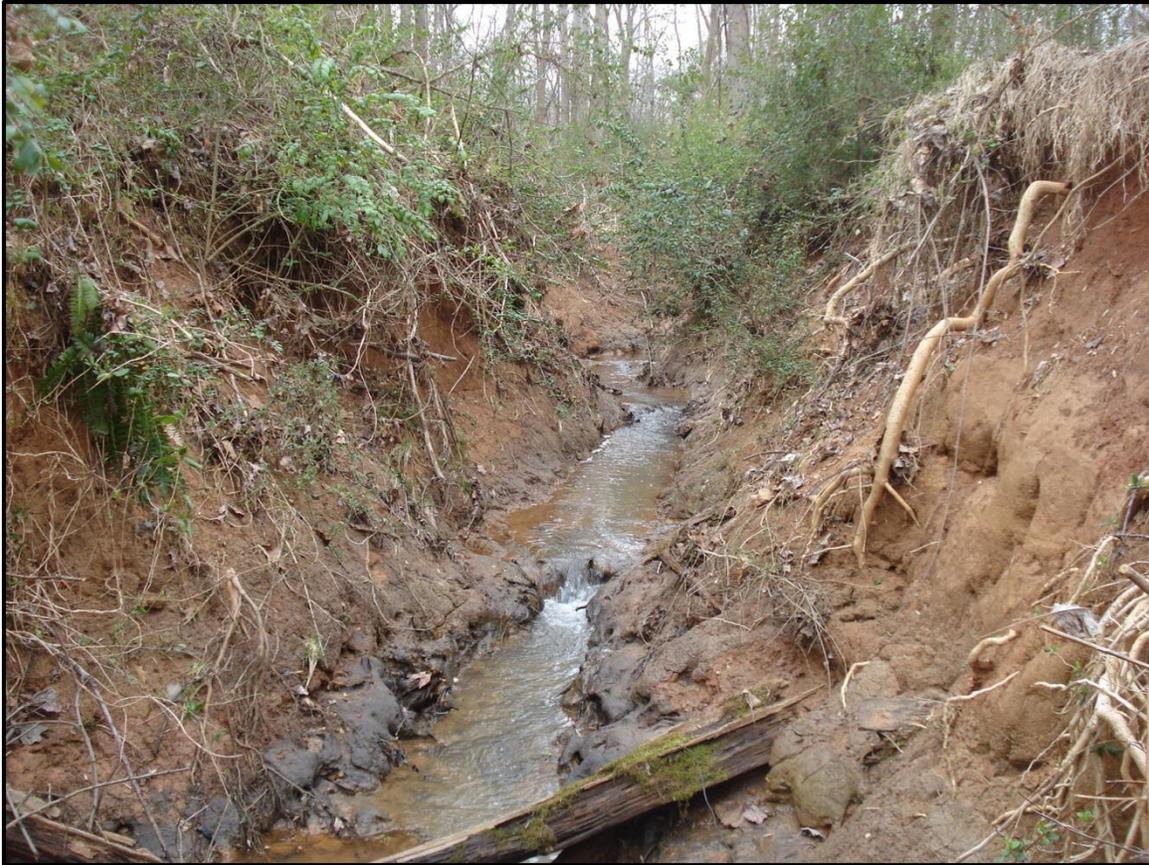
Figure 4 - Straightened tributary of Rocky River

Historically, most of the land in the Rocky River Watershed was used for agriculture. In the early to mid-1800’s Davidson College was founded and businesses were established in the watershed. Cornelius was later established in the late 1800’s. The construction of I-77 through the area and the recent growth of the Charlotte region resulted in a significant increase in land development activities in the watershed which has dramatically altered the landscape (see Figure 3). Most of the development has occurred along the South Prong of the Rocky River within Davidson’s jurisdiction. In addition to the recent changes brought about by urbanization, drastic changes to the stream system have occurred in the last century. At some point in the past, the stream was straightened, most likely by the U.S. Army Corps of Engineers, either to prevent flooding or to improve the land for agricultural uses (Charlotte-Mecklenburg Storm Water Services, 1997). Spoils piles from this process can still be seen along several of the stream reaches (Figure 4).

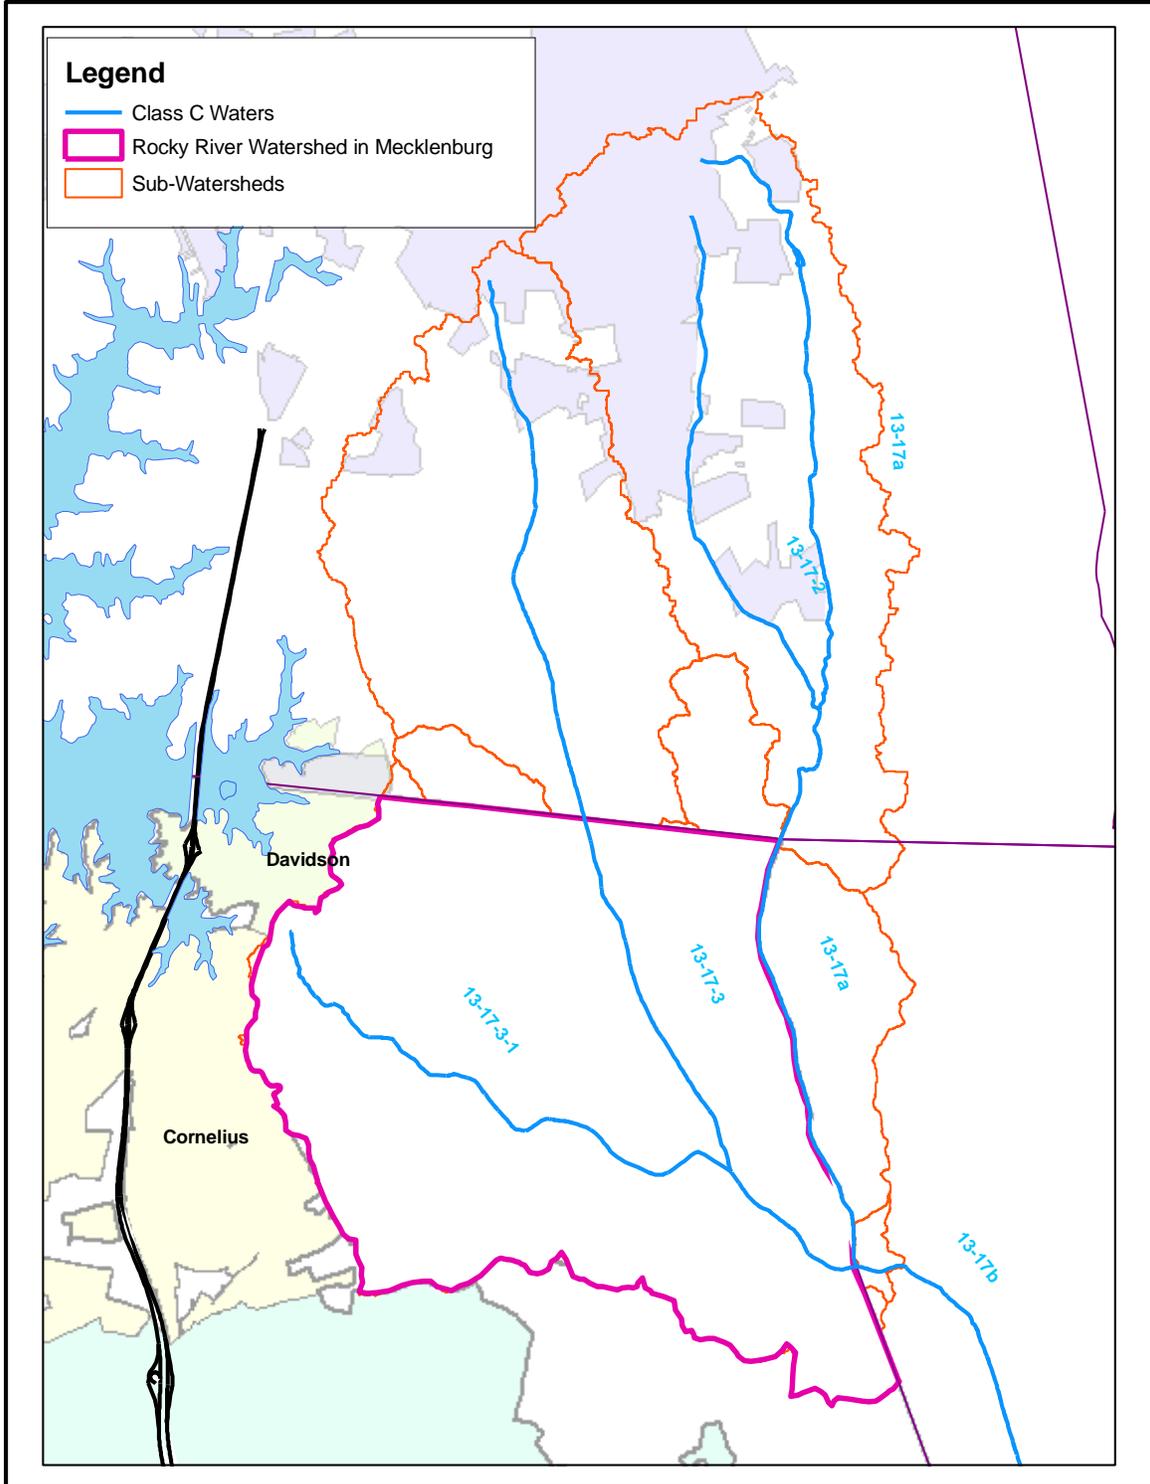
Figure 5 shows the main segments of the Rocky River and its tributaries color coded by Stream Class along with the Assessment Unit number (AU). All streams in the Rocky River are categorized as Class C waters. Table 2 lists stream classes appropriate for the Rocky River Watershed and the associated description. In North Carolina, surface water quality regulations are defined for particular classes of use support. For instance, Class C waters must support aquatic life and secondary recreation (infrequent human body contact), while Class B waters must support aquatic life and primary recreation (frequent human body contact or swimming). Individual streams, lakes, and reservoirs (or portions of each) are assigned one or more classes. All of the contributing streams to a body of water receive the same designation when they are not specifically defined. Each class has a set of regulations, including water quality standards associated with it. If chemical/physical water quality monitoring reveals that a stream is not meeting a water quality standard, then it is considered “Impaired”. If biological monitoring indicates a lack of abundance and/or diversity of aquatic life in a stream, then it is considered as having “Impaired biological integrity”. Impaired streams are placed on the 303(d) list and a restoration method is specified such as the development of a TMDL.

Figure 5 - Rocky River Creek Stream Classes and AU Numbers.

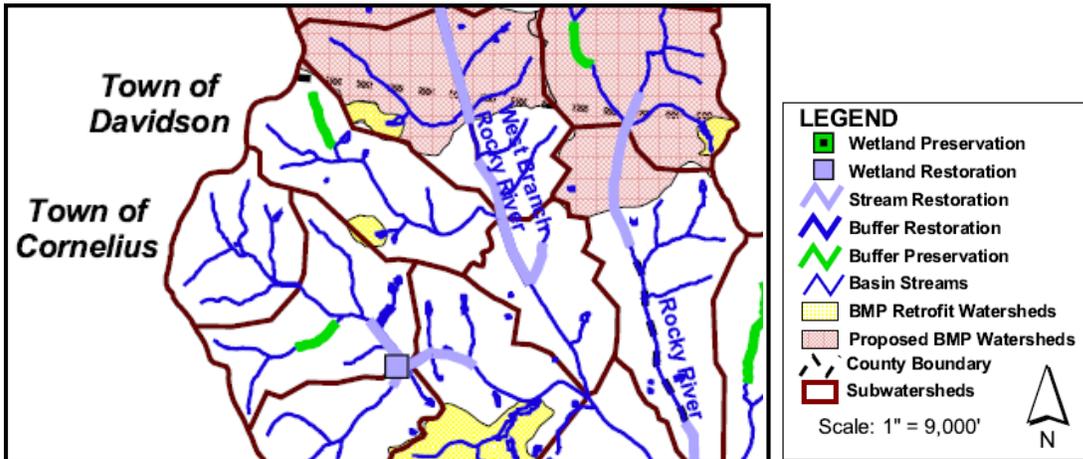
In 2004, CDM completed a planning initiative for the North Carolina Ecosystem Enhancement Program (NCEEP, 2004). The planning initiative focused on the Rocky River Watershed and the Clarke Creek Watershed. Furthermore, the document identified a 'Pilot Area' along the South Prong of the West Branch of the Rocky River, which includes most of downtown Davidson and some of Cornelius. The plan identified much of the watershed as having excessive erosion potential. The initiative included analysis and prioritization of restoration needs and opportunities in each watershed. The analysis, which consisted mostly of office level screening, involved the scoring of areas based upon GIS characteristics such as soils, vegetation, air photos, hydrology and land-use. A modeling component was also included in the study. From this study, much of the West Branch and South Prong of the Rocky River were identified for restoration as shown on

Figure 6. Almost none of Mecklenburg County was included in the areas NCEEP identified for BMP retrofits.

Figure 6 - Stream Restoration and BMP Sites Identified by NCEEP (2004)

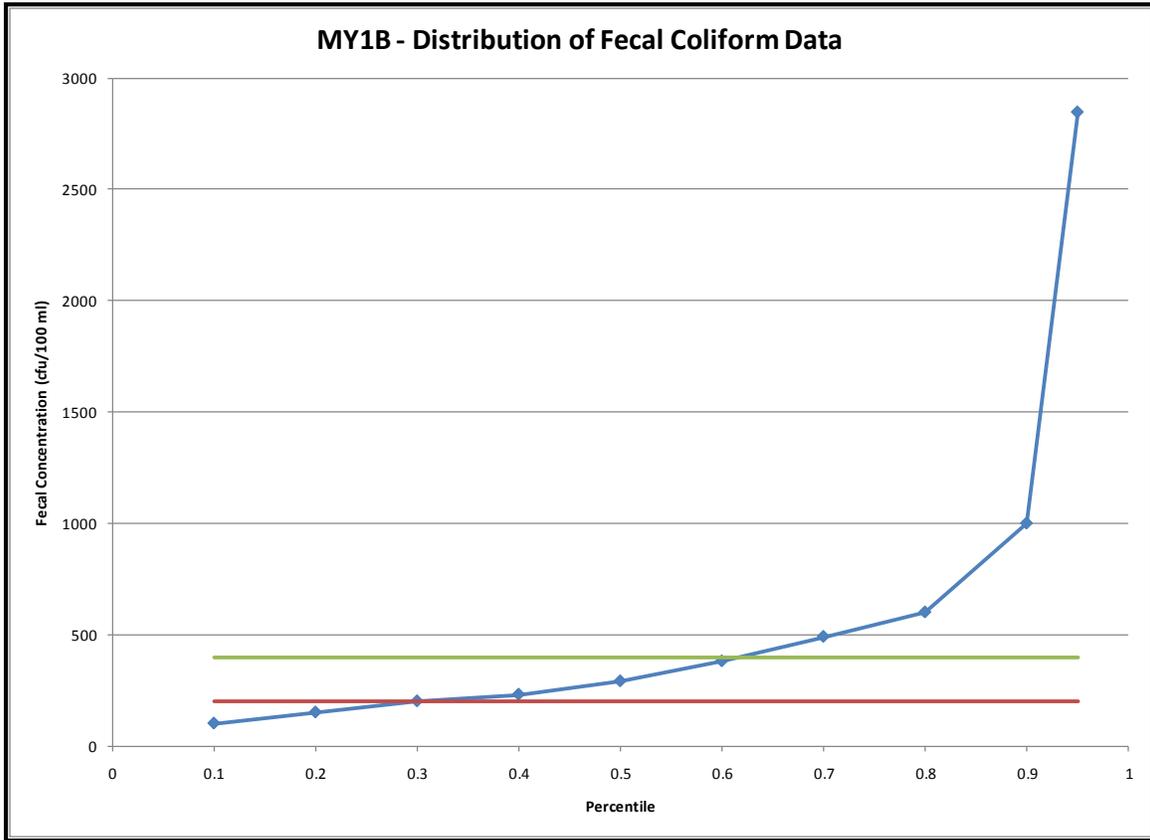
The distribution of the values for Fecal Coliform, Copper and Turbidity are presented as Figures 7, 8 and 9 respectively.

Figure 7 - Distribution of Fecal Coliform Data collected at MY1B

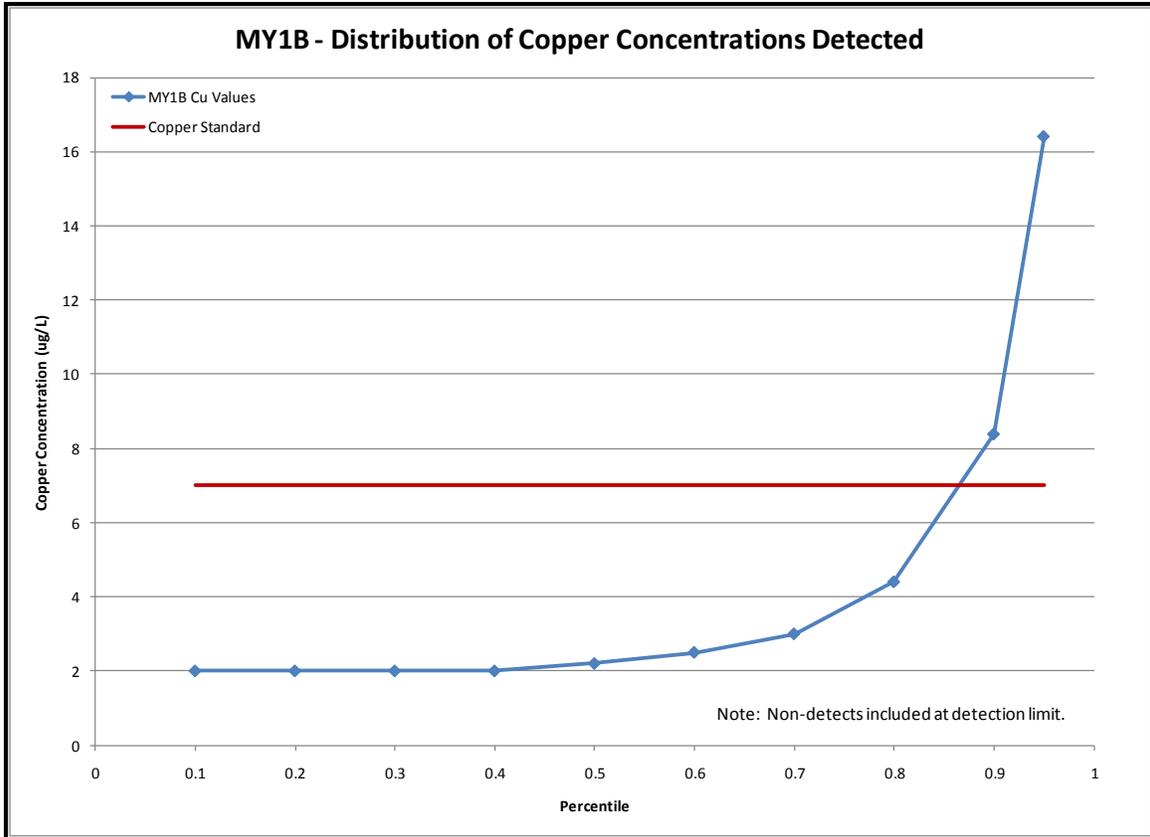
Figure 8 - Distribution of Fecal Coliform Data collected at MY1B

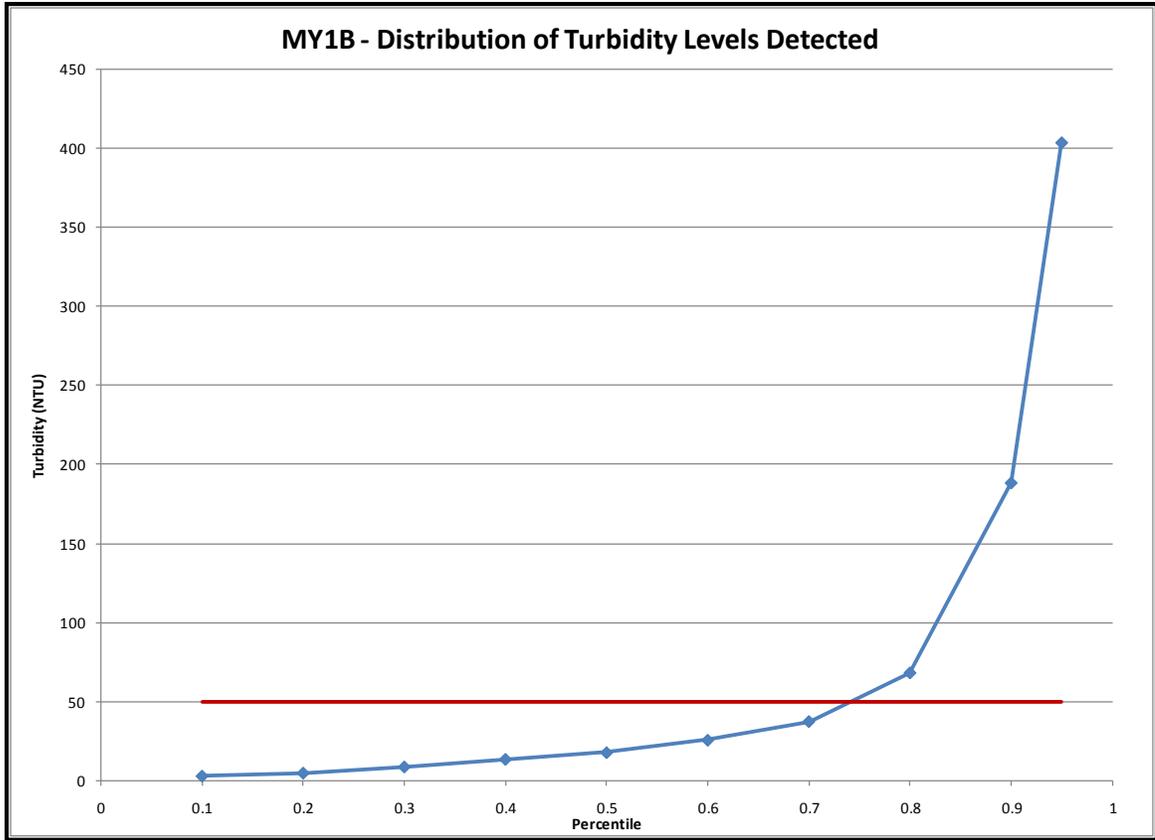
Figure 9 - Distribution of Turbidity Data collected at MY1B

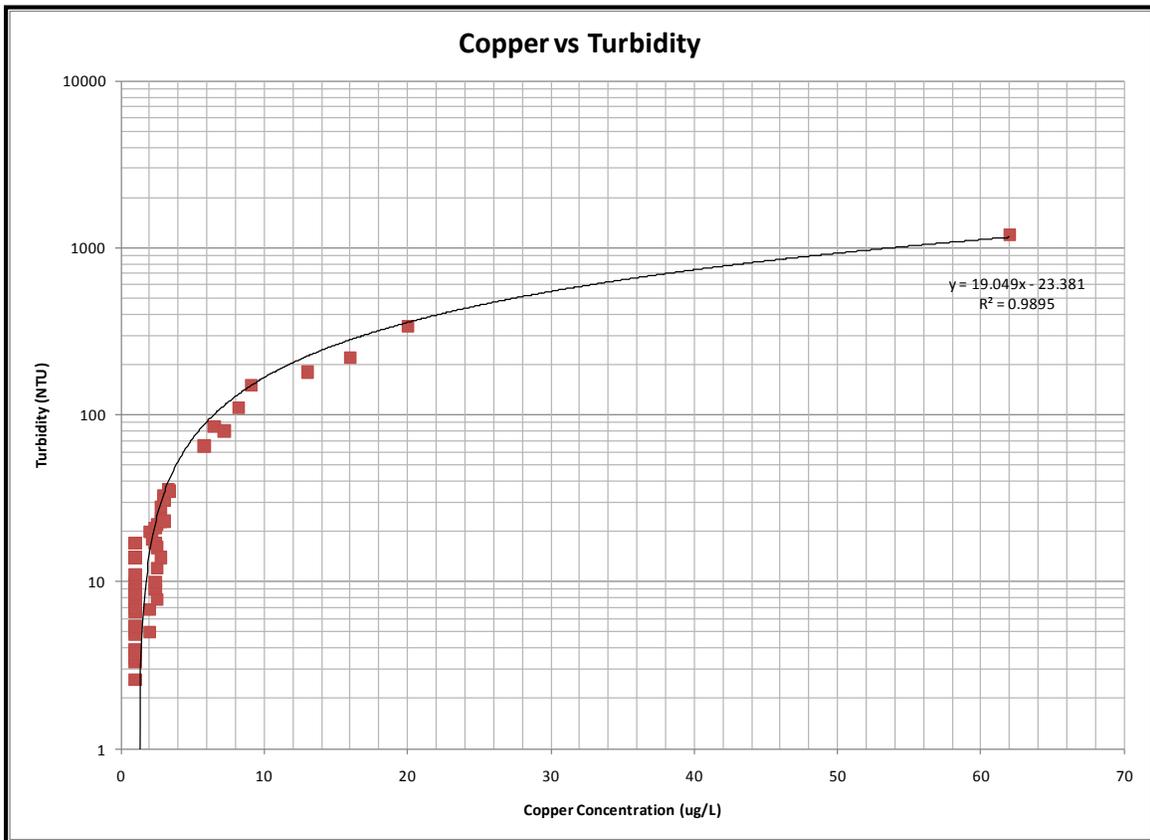
A very strong relationship between Copper and Turbidity was detected from the data collected at MY1B. Figure 10 shows the relationship for Copper and Turbidity from data collected from July, 2004 through September, 2010.

Figure 10 - Relationship between copper and turbidity at MY1B

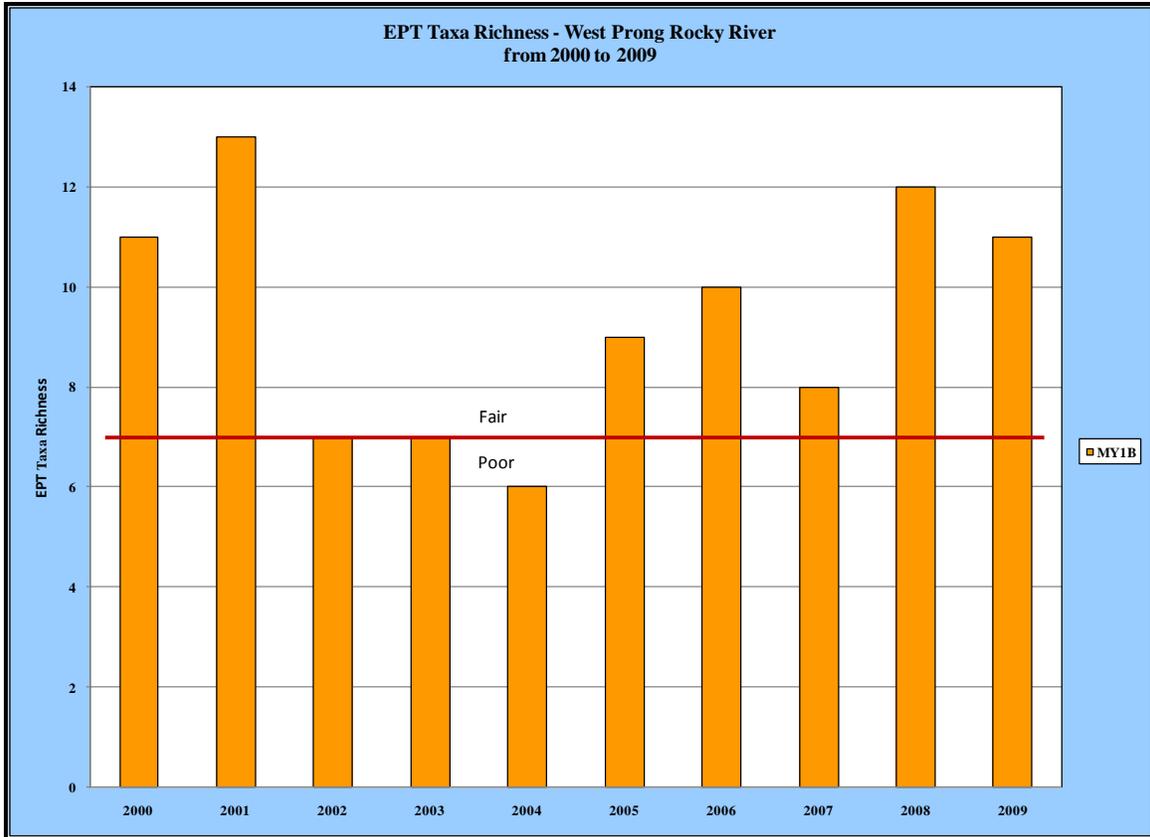
The benthic macroinvertebrates in the West Branch of the Rocky River are monitored annually by Mecklenburg County at Gilead Road (site MY1B). The EPT taxa richness was generally below 12 species for all samples taken since 2000 in the West Branch of the Rocky River. Figure 11 presents the benthic macroinvertebrate scores for the West Branch since 2000. As can be discerned from the graph, scores declined into the ‘Poor’ range during 2002-2004. Scores have rebounded somewhat in the mid to high ‘Fair’ range. These results are expected in a stream that lacks a stable habitat such as the Rocky River, which has a shifting sand bottom and lacks riffles and other stable substrate.

Figure 11 - Macroinvertebrate Scores from MY1B

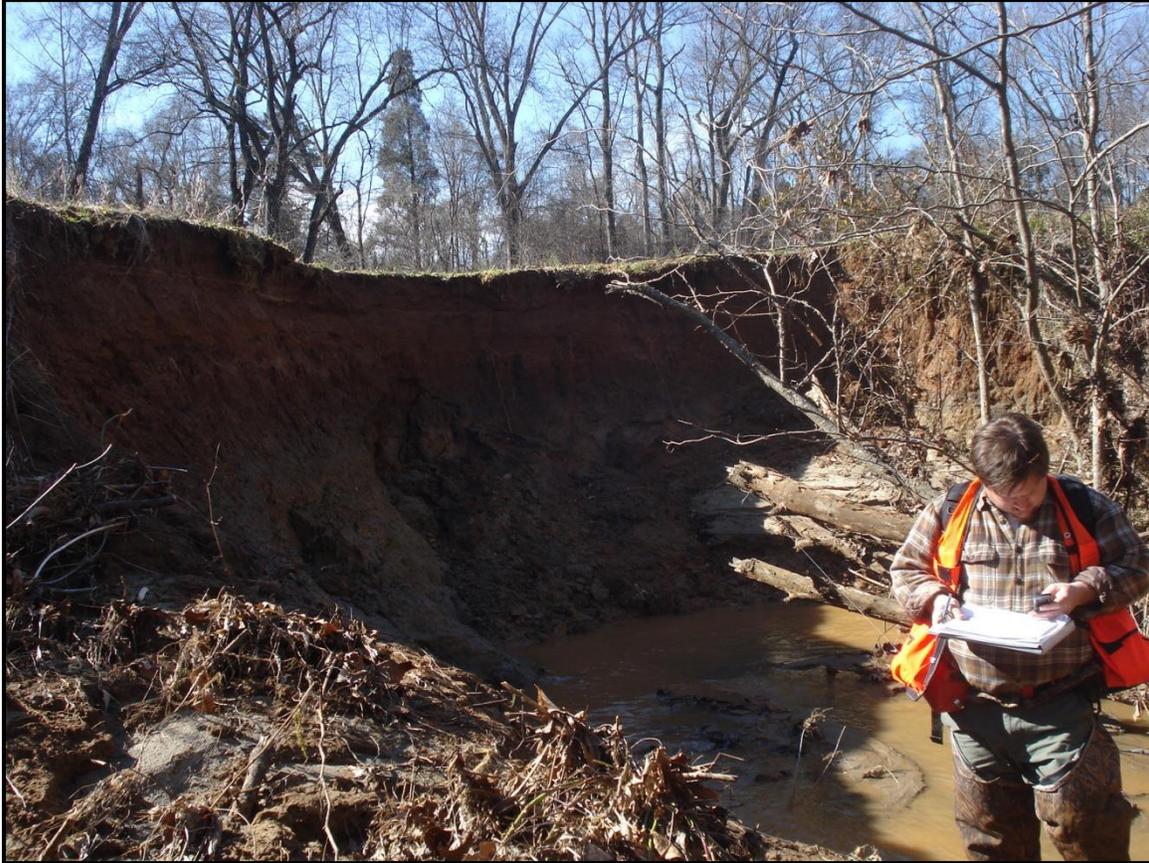
Systematic physical monitoring of the Rocky River watershed has not been conducted. As a part of the implementation of this watershed plan, routine physical monitoring will be conducted. Figure 12 shows a fairly typical location in the watershed with severe erosion and vertical banks.

Figure 12 - Severe Erosion along West Branch of the Rocky River

Analyses performed of the Rocky River by Tetra Tech in 2004 as part of the post-construction ordinance development process demonstrate a significant potential for further stream degradation. Tetra Tech predicted that approximately 15% of the Rocky River draining greater than one square mile was at risk for geomorphic instability and habitat degradation. It is important to note that the only portion of the Rocky River Watershed included in the analysis was that portion draining more than a square mile.

straightened in the past, which has caused an inherently instable stream channel. Particularly when the altered stream channel is exposed to increased flows from development.

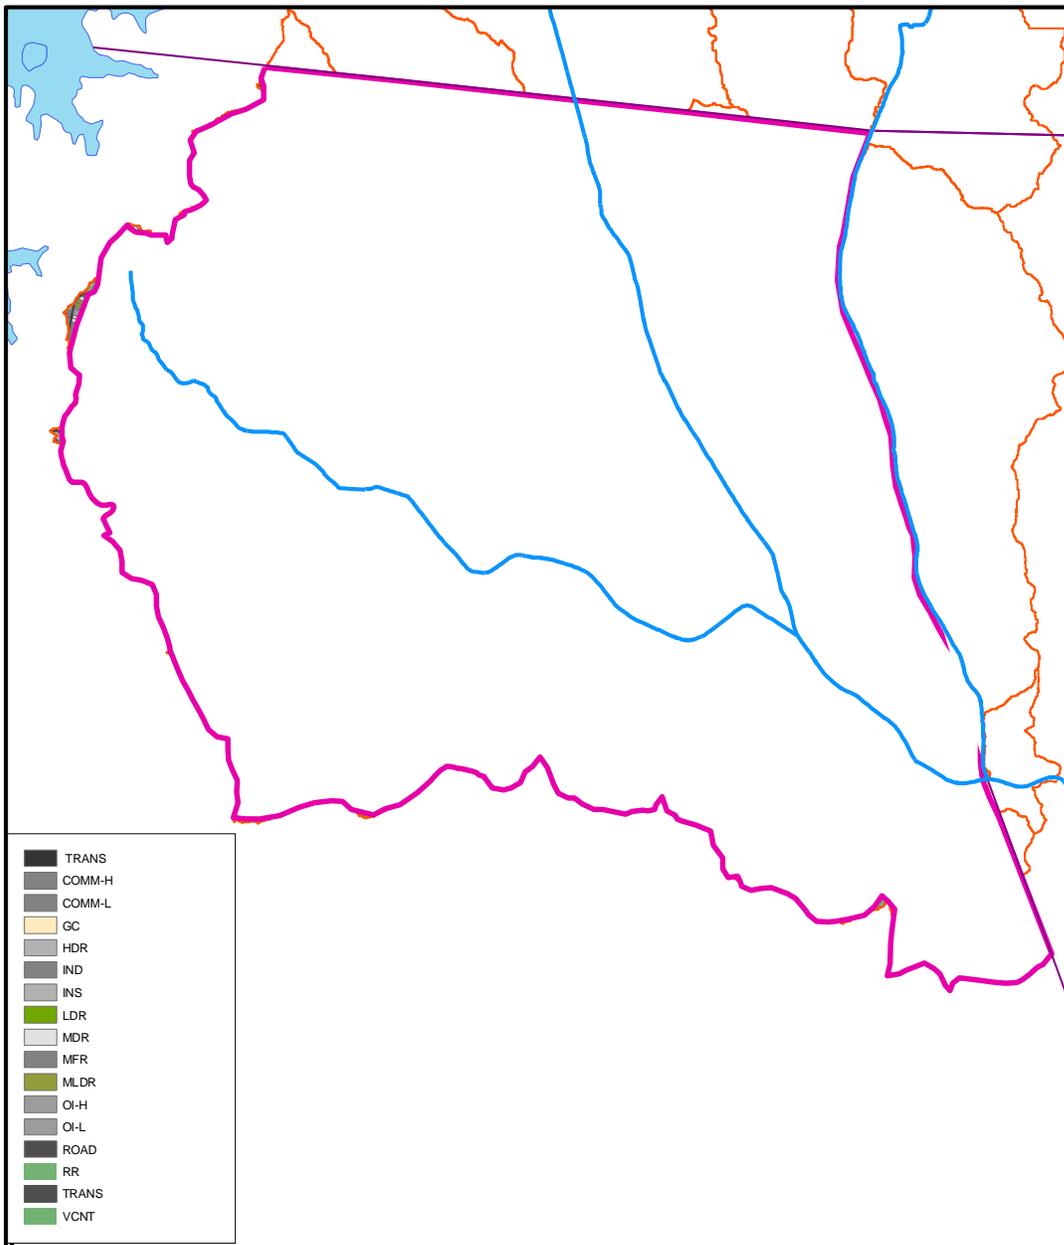
The land-use/land-cover data set used for this Watershed Management Plan was initially developed by Tetra Tech Inc. (2004) for the post-construction ordinance development process. The data set was developed through interpretation of a combination of parcel information, aerial photographs, and tree canopy data. The process is more thoroughly described in Tetra Tech Inc. (2004). Development has occurred in the watershed since the original data set was produced therefore the original land use/land cover data set was changed and updated to reflect current conditions as of 2010. The process used was a manual checking of parcel data along with recent aerial photography. The land-use data set provides a distribution and classification of all land-uses in the Mecklenburg County portion of the Rocky River Watershed. The land-use categories represented in the Rocky River Watershed are presented in Table 4 and the distribution of the land-uses for the Rocky River Watershed is shown in Figure 13.

Figure 13 - Distribution of the Land-uses within the Rocky River Watershed

The distribution of the land-uses for the Rocky River Watershed is shown in Figure 13.

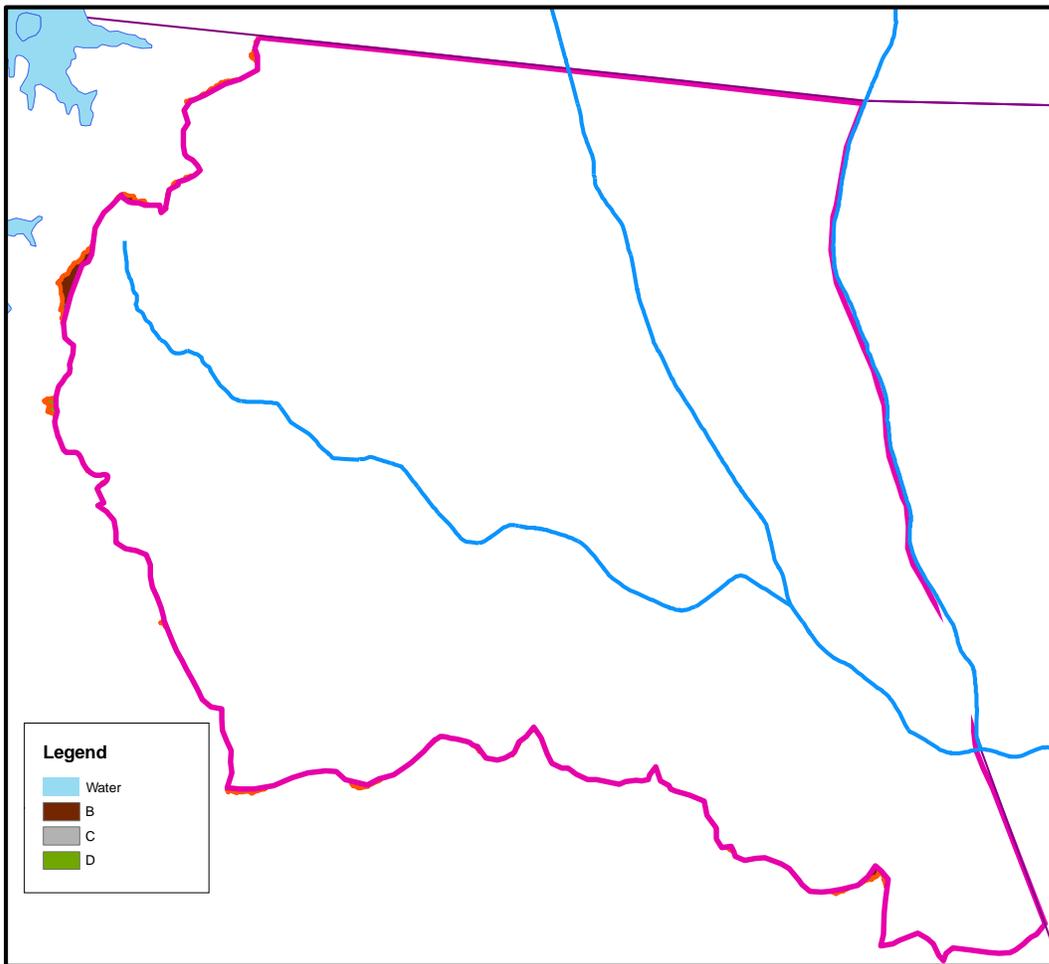
The distribution of soils within the Rocky River Watershed was determined through the Soil Survey of Mecklenburg County (USDOA – SCS, 1980). The hydrologic soil types found in the Rocky River Watershed are almost exclusively B and C. A description of each soil type and distribution within the watershed are shown in Table 5. Figure 14 shows the location of the hydrologic soil groups in the Rocky River Watershed.

Figure 14 - Distribution of Hydrologic Soil Groups in Rocky River Watershed

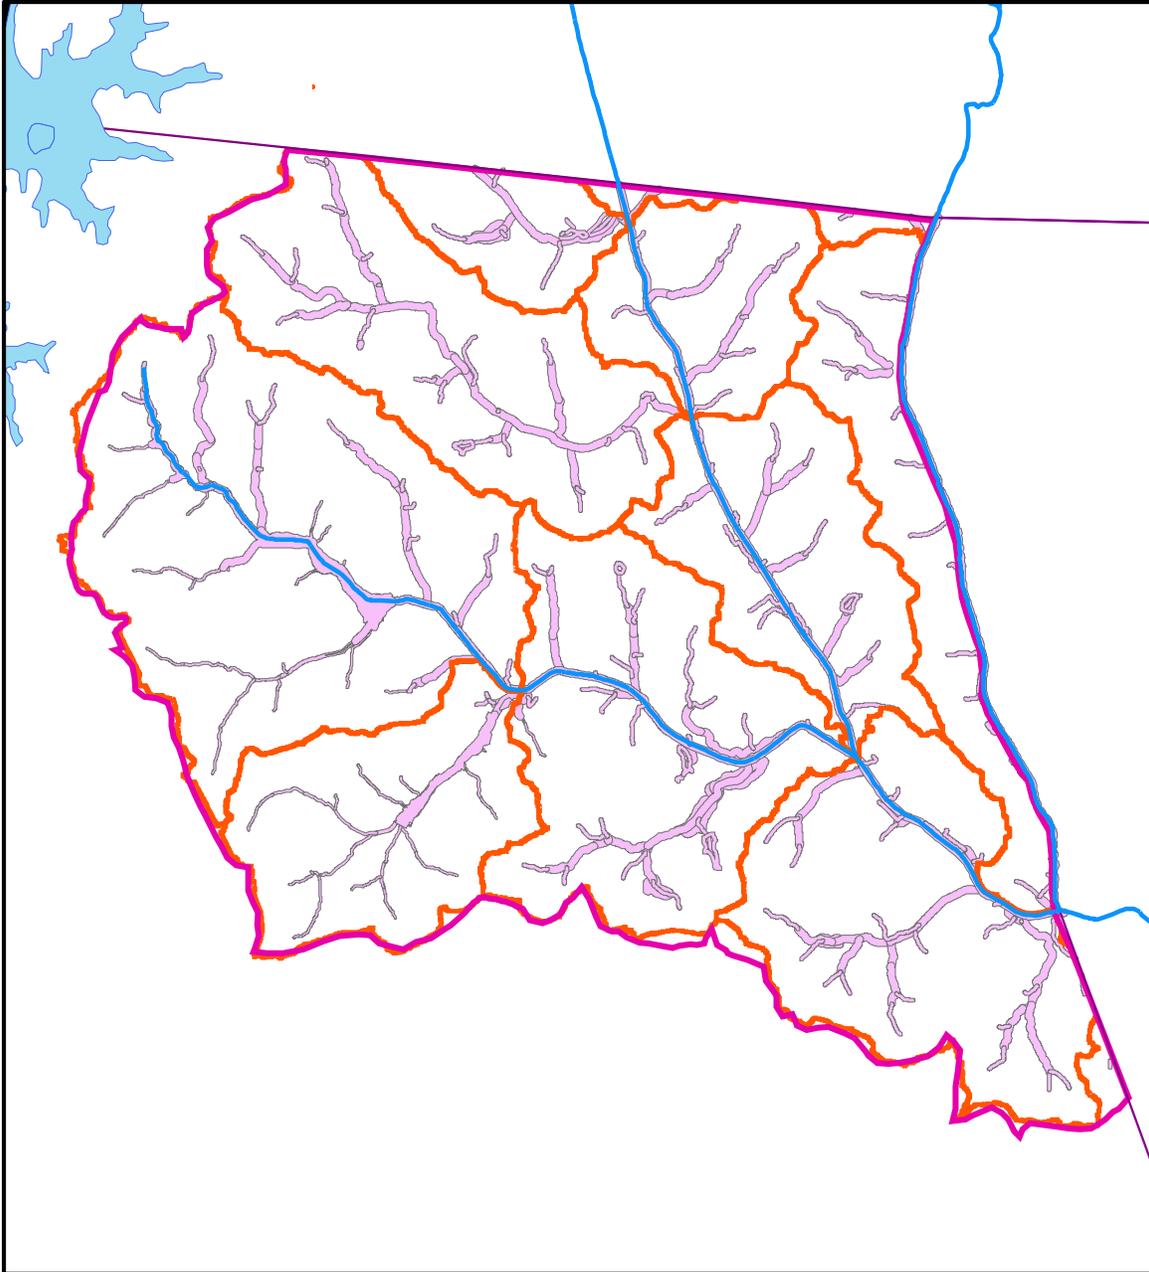
Figure 15 - Approximate Extent of Rocky River Watershed S.W.I.M. Buffers

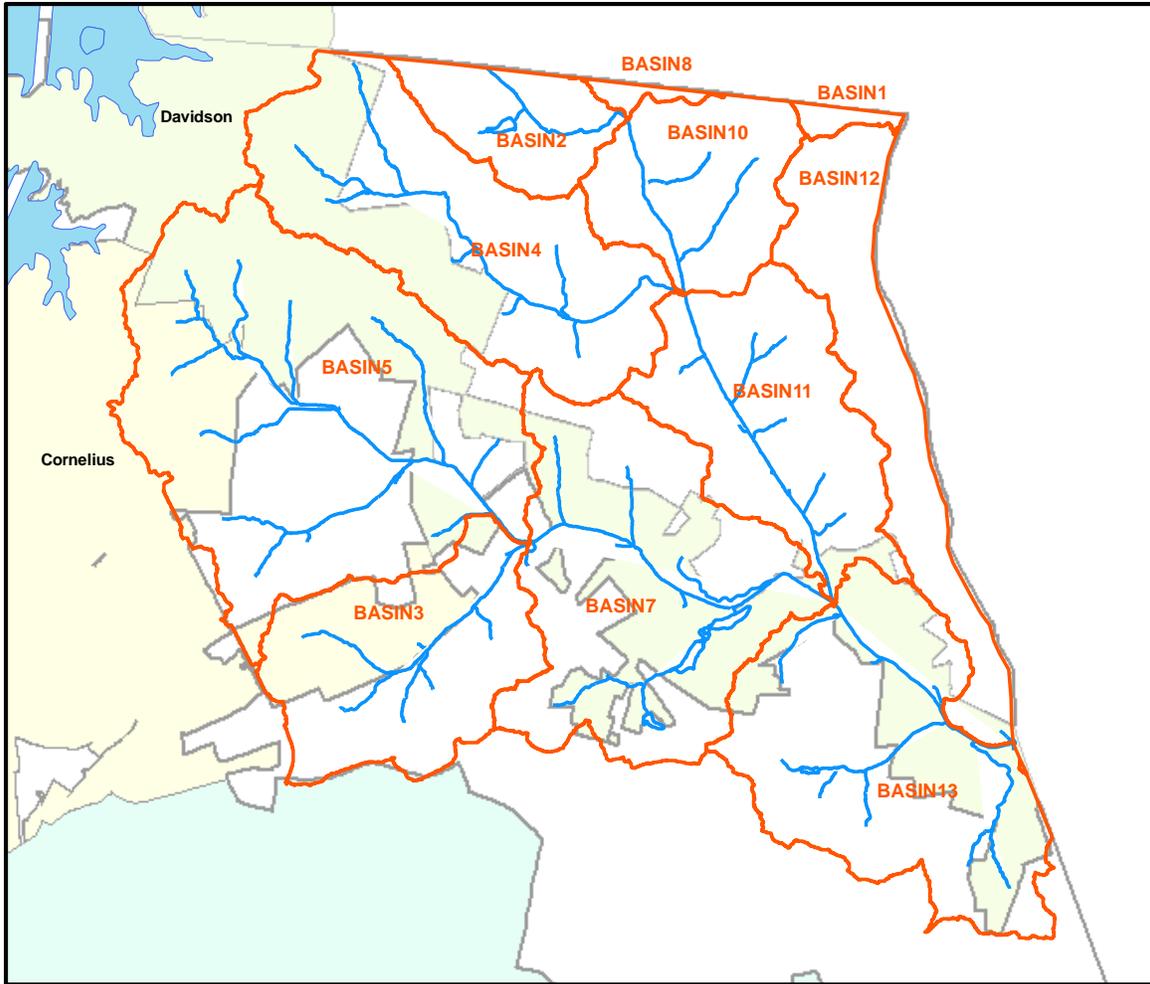
The land-use data for the Rocky River Watershed was sub-divided into catchments using GIS software. The catchments were delineated using the Watershed Information System (WISe) with an approximate drainage area of 100 acres per catchment. Catchments with very small drainage areas (<1 acre) were merged into nearby catchments to reduce the number of reporting units. A total of 131 catchments were delineated for the Rocky River Watershed. Figure 16 shows the distribution of the catchments in the Rocky River Watershed.

Figure 16 - Rocky River Watershed Catchments

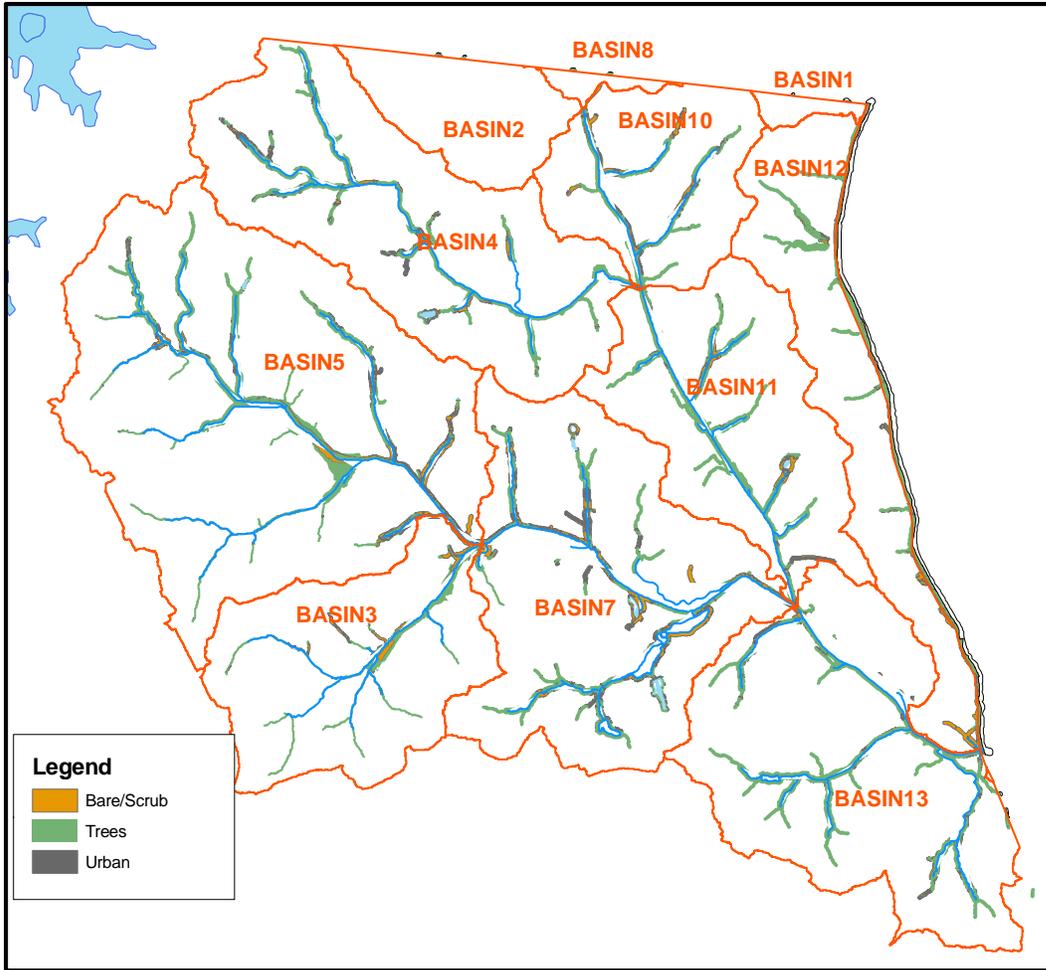
The percent of impacted buffer in the Rocky River Watershed was also characterized. The characterization was completed using tree canopy data for Mecklenburg County intersected with the FEMA floodplain delineation and the Post Construction Buffer and Watershed buffer coverages. The resulting GIS dataset, which depicts the presence or absence of tree canopy within stream buffers, was intersected with the catchment coverage to determine the percent of un-forested buffer within each catchment. Figure 17 shows the distribution of forested and un-forested buffer within the Rocky River Watershed.

Figure 17 - Distribution of Forested and Un-forested Stream Buffers in the Rocky River Watershed

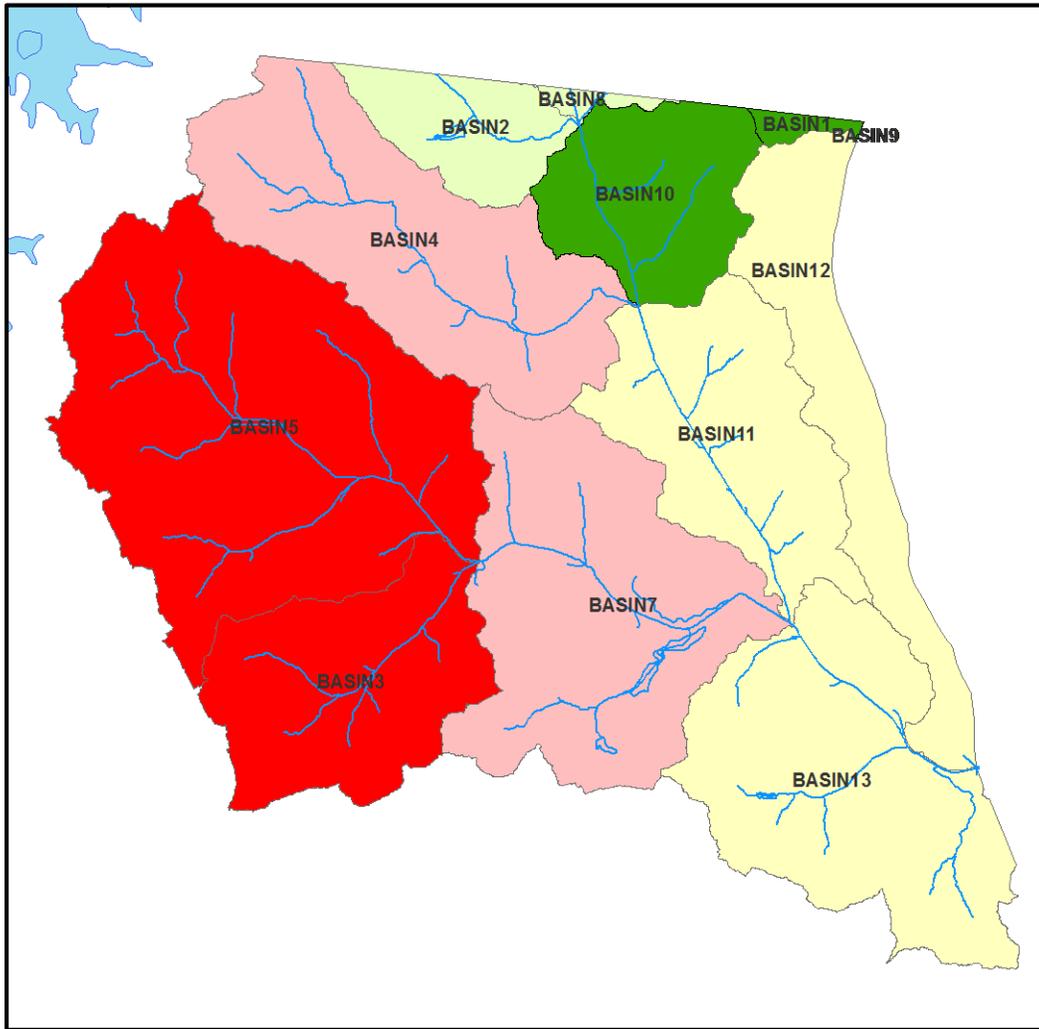
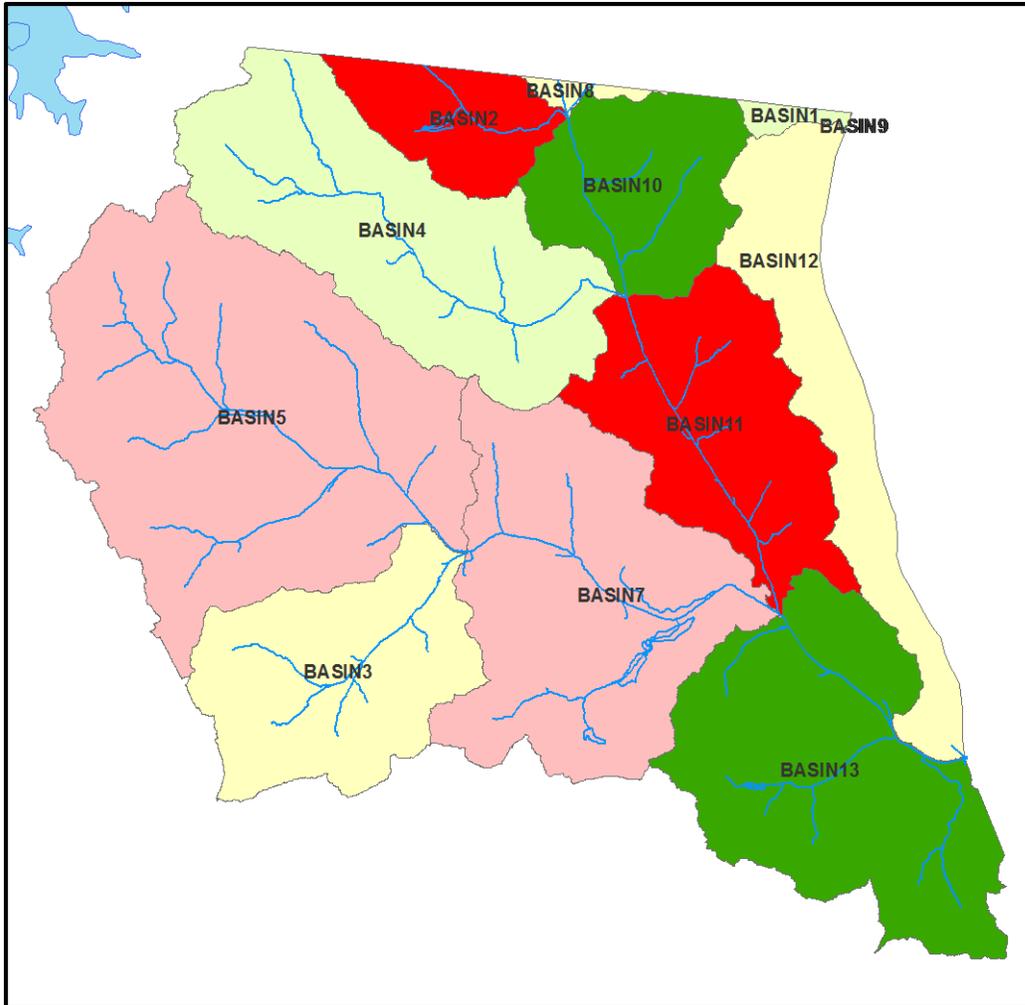
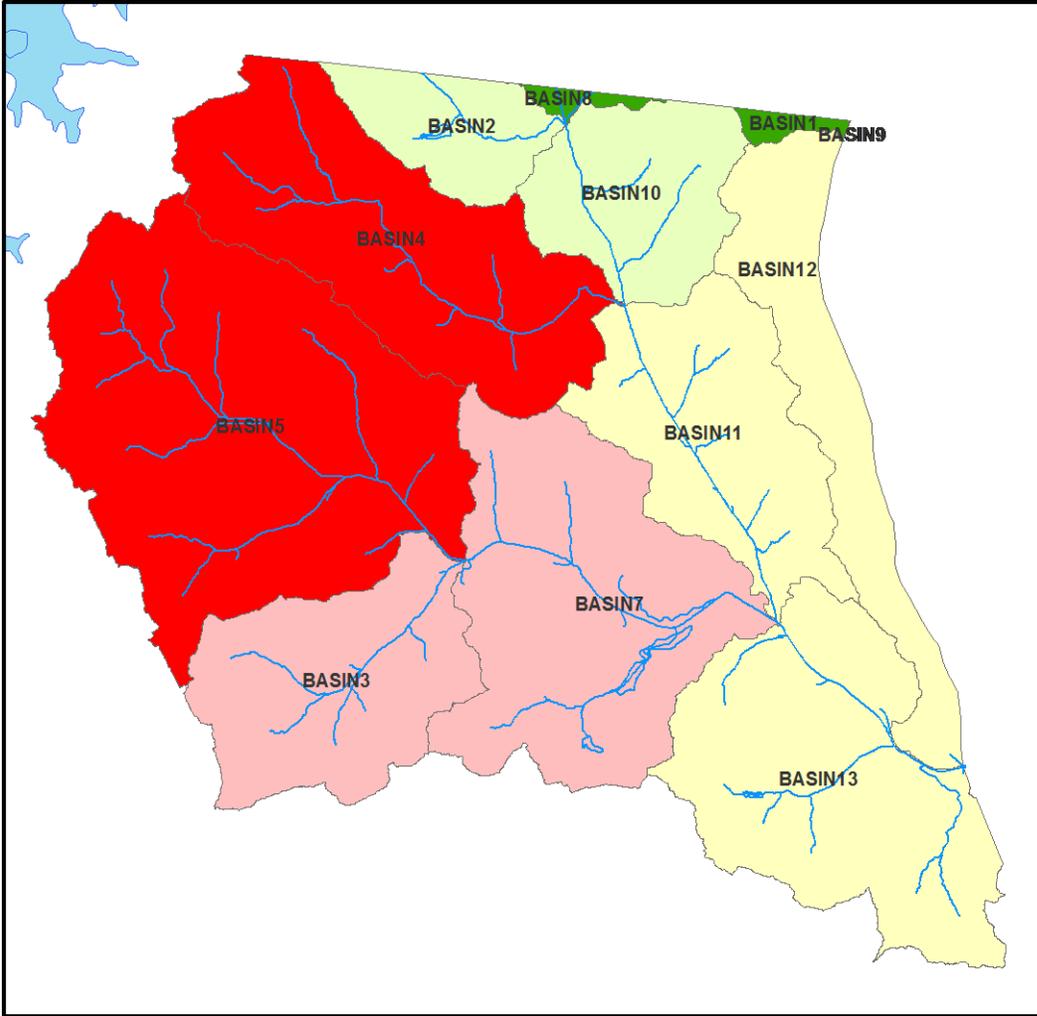
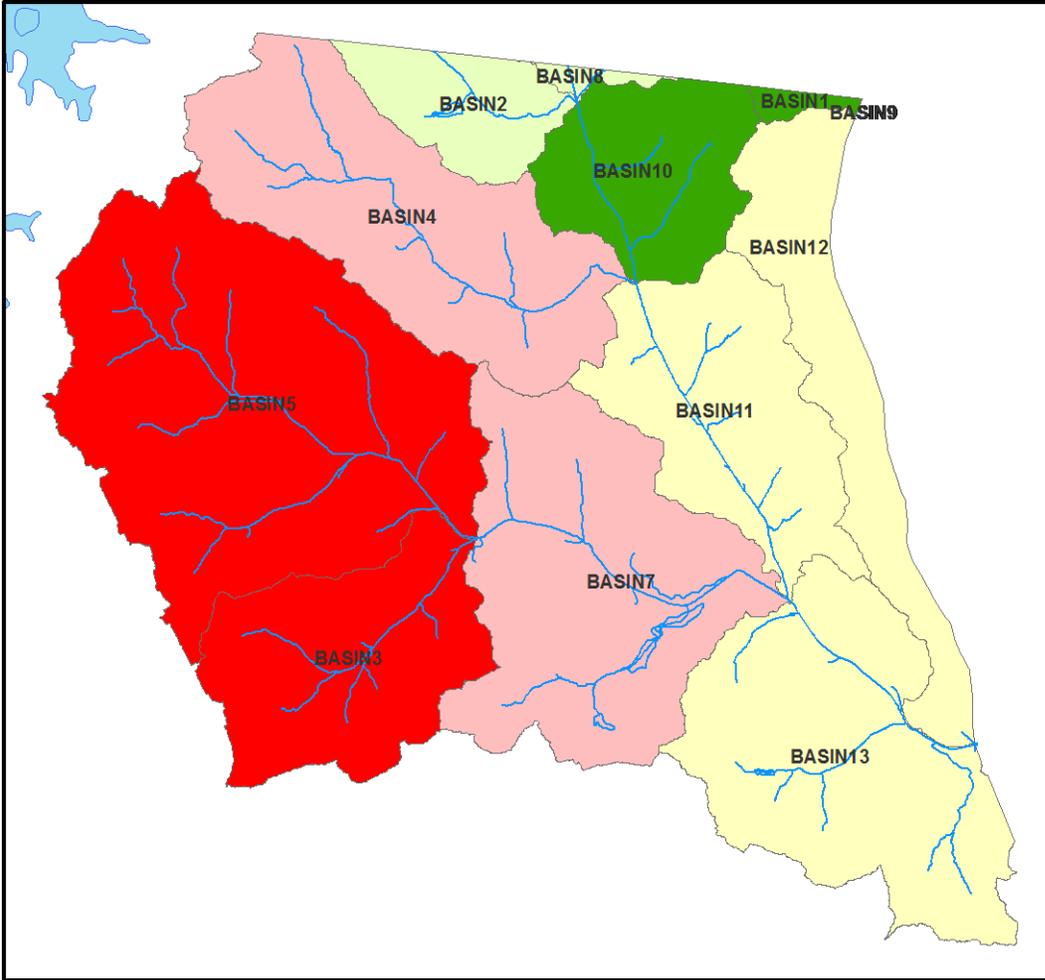
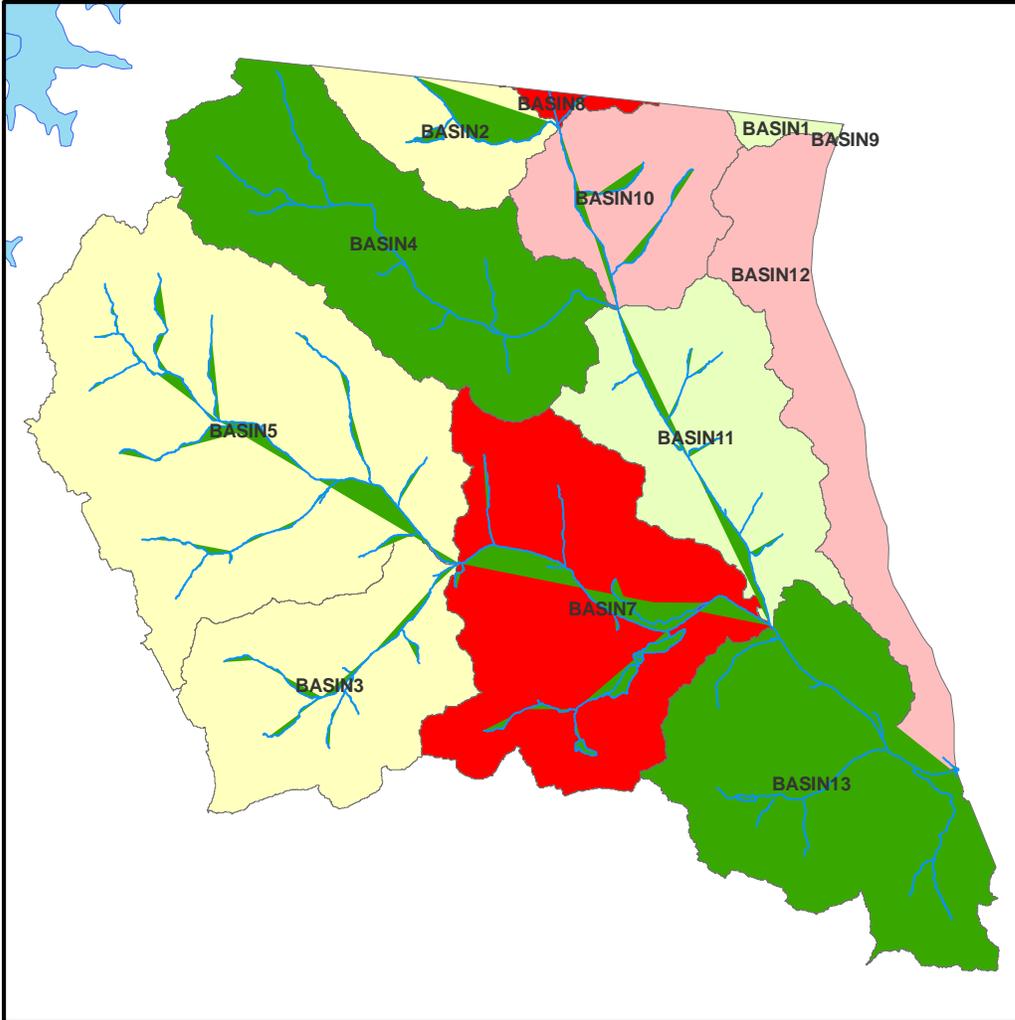
Figures 18 – 22 present the overall ranking based upon the results of the upland characterization for Fecal Coliform, TSS, Copper and Imperviousness and Buffer Impact. Note that hotter colors (reds and yellows) indicate increased levels of impairment.
