Rocky River Watershed Management Plan

**Completed by:
Charlotte-Mecklenburg Storm Water Services**

Date Completed: February 15, 2015

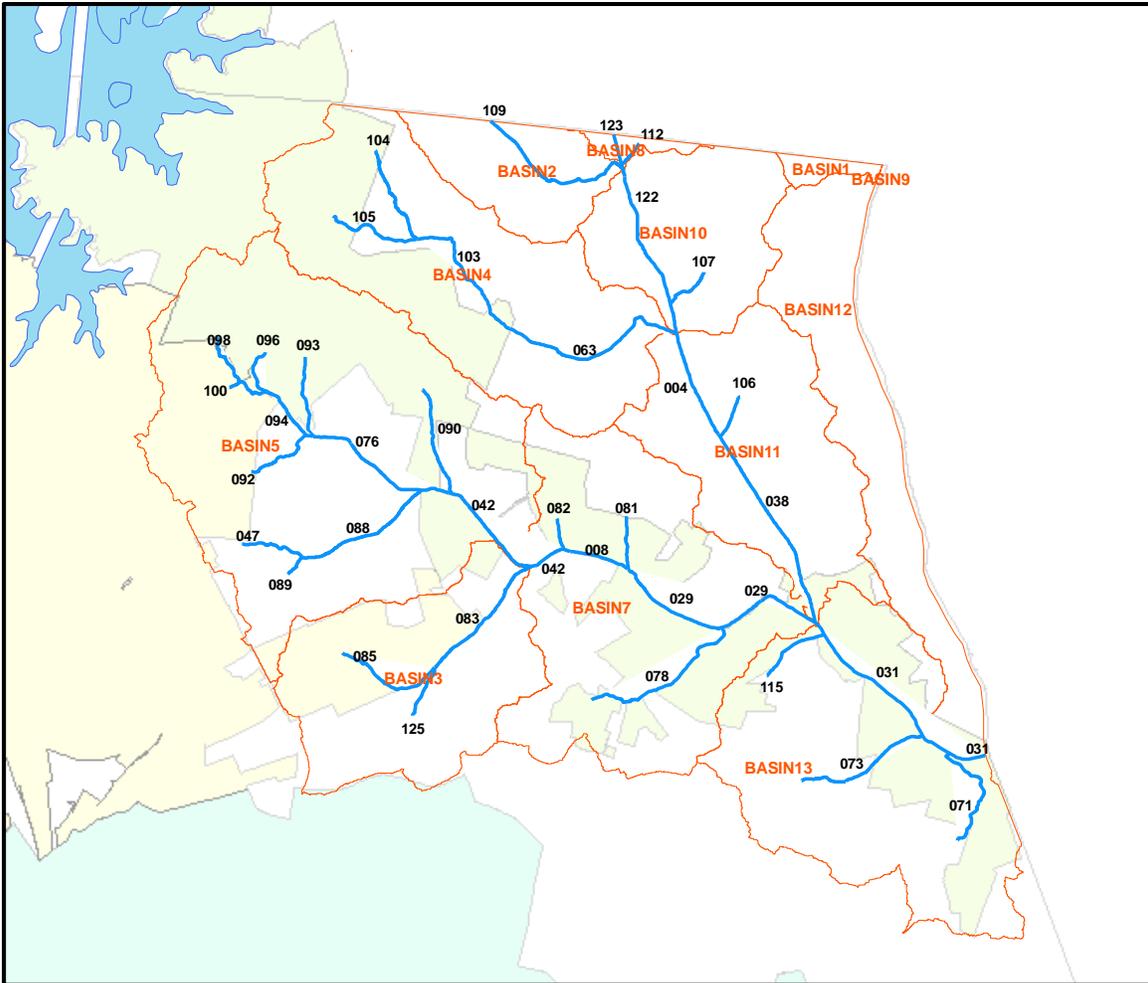
divided into 45 separate reaches (37 of which were able to be assessed) (Figure 23). For the purposes of this study the definition of a reach was a discrete segment of stream that consistently exhibits a set of physical features that appear to be significantly different from its contiguous upstream and downstream segments. Nine basins were chosen for assessment that appeared to represent a range of stream conditions and land uses found throughout the watershed. Because perennial streams were to be assessed, only streams receiving 100 acres or greater of drainage were chosen, which resulted in 37 individual reaches approximating 22.5 miles of stream for direct assessment.

Figure 23 - Stream Assessment Reaches

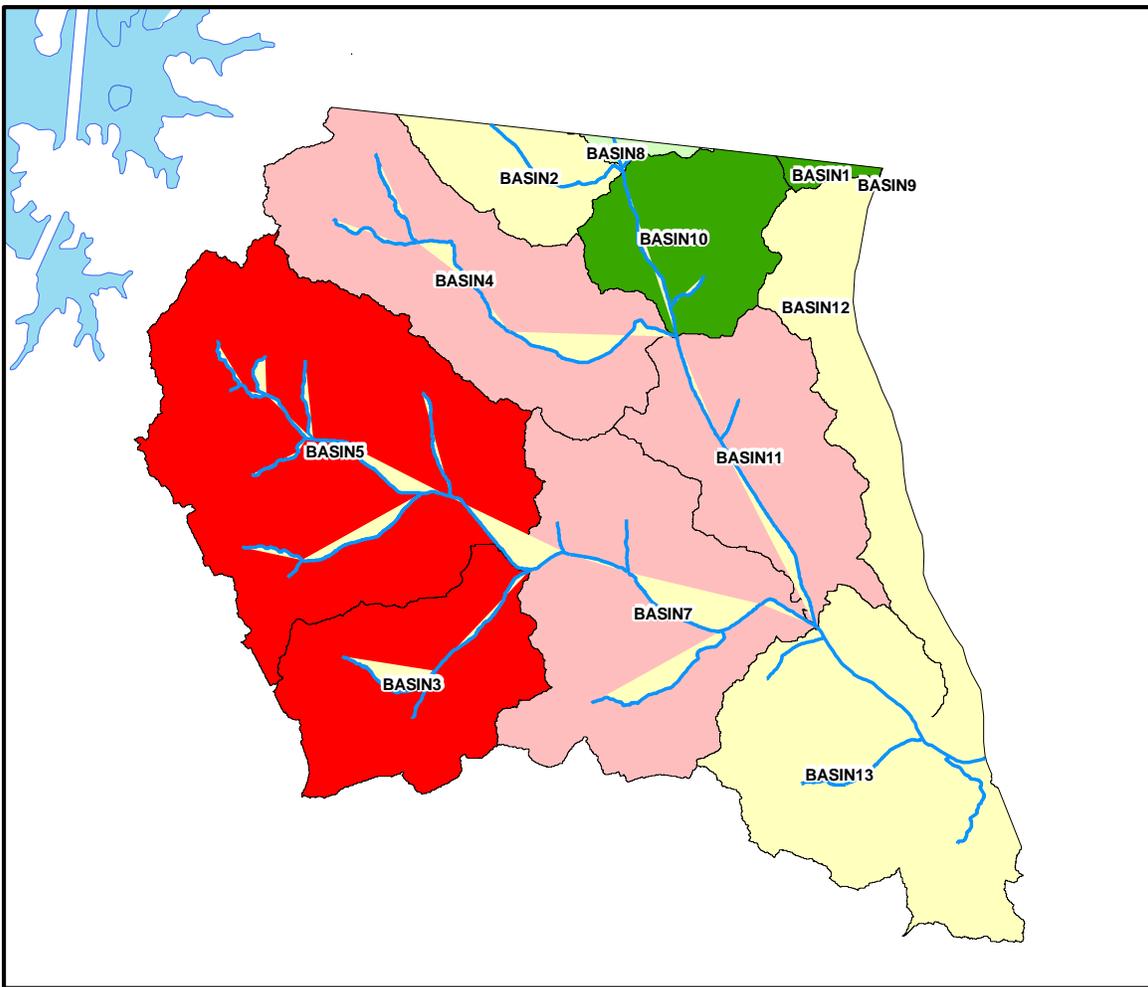
Based upon the upland pollutant load analysis, BMP retrofit efforts should be concentrated on or downstream of the most impacted basins. The 2 most impacted basins were focused upon for this plan. Figure 25 shows the extent of these priority basins within the Rocky River Watershed. Specifically, Basin5 and Basin 3 ranked as the most impaired basins due to upland sources of pollution. The following Section discusses each priority basin in detail.

Figure 24 - Priority Basins in the Rocky River Watershed

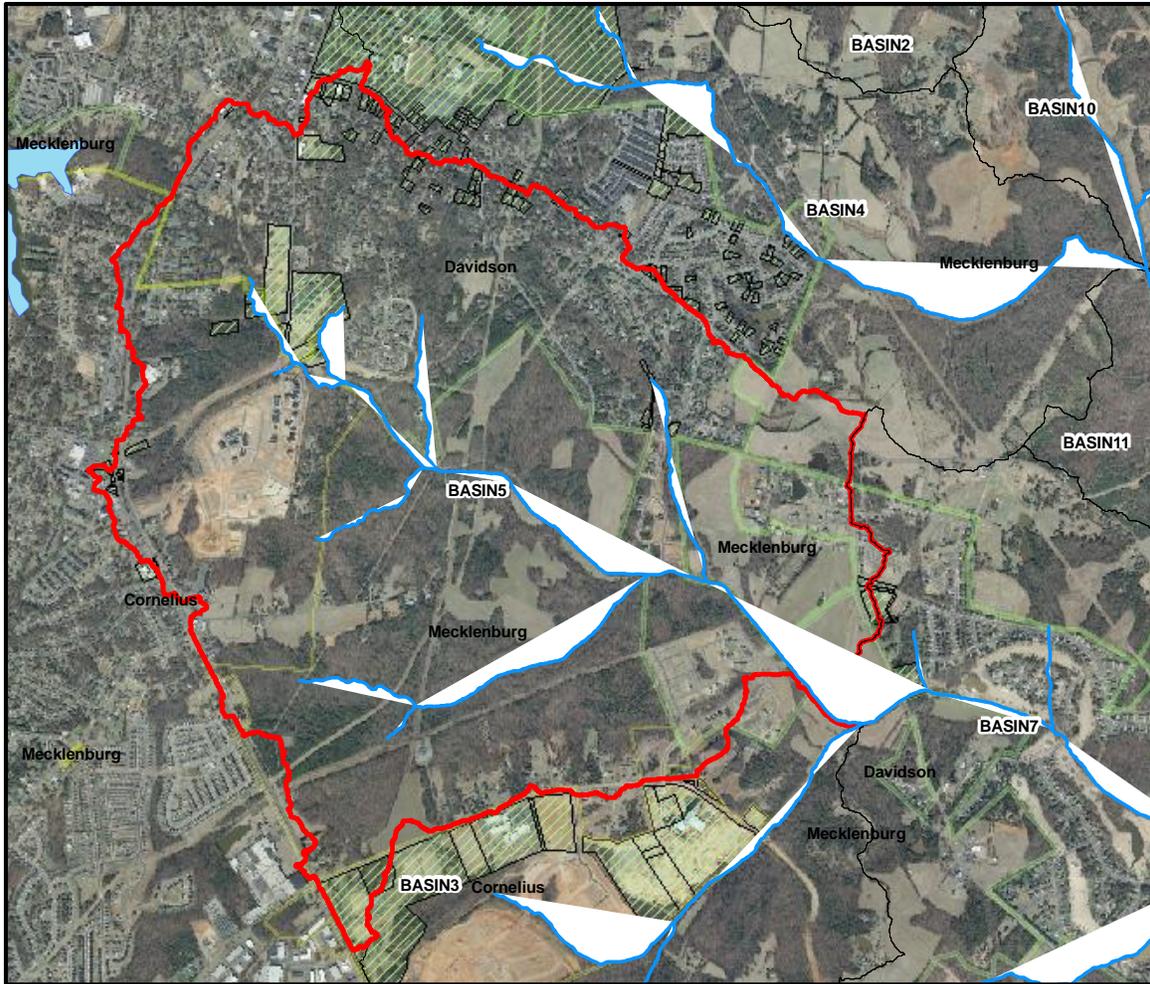
some of the downtown business center of Davidson and multifamily in Cornelius. Public property in the watershed is limited, however some of the headwaters of the South Prong are publicly held. BMP retrofits will likely be challenging in this Basin as will stream restoration because of the dominance of private ownership of the land surrounding the stream. Figure 26 shows a detailed view of Priority Basin 5 with public parcels in green hatching.

Figure 25 - Detail of Priority Basin 5

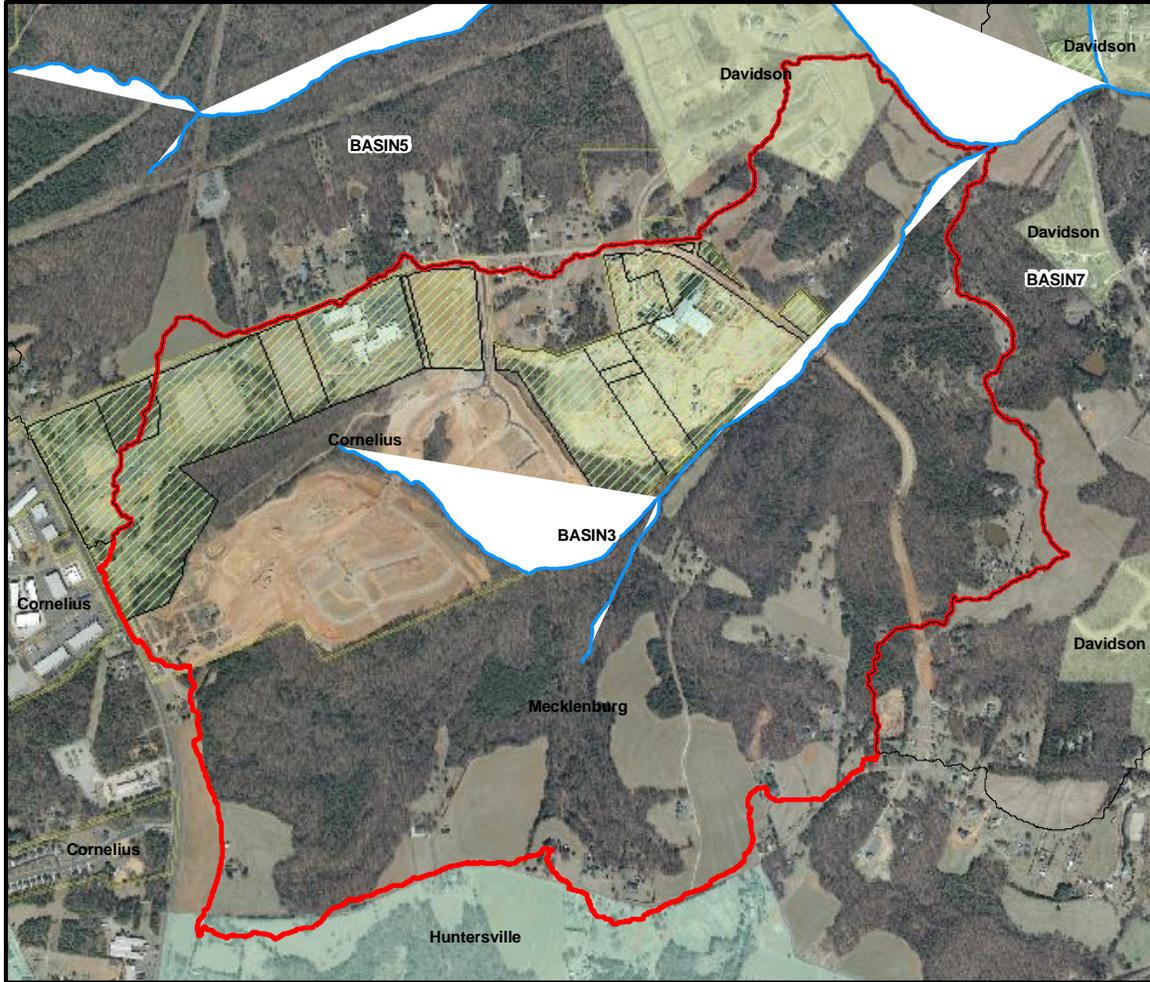
Priority Basin 3 is comprised of portions of Cornelius and Cornelius’ ETJ. The primary reason for the high priority designation for Basin 3 is the presence of significant institutional land use in the basin as well as the high density residential development occurring in the watershed. Figure 27 shows a detailed view of Priority Basin 3 with public parcels identified in green hatching. The presence of a significant amount of public parcels in the watershed will simplify BMP retrofits and encourage stream restoration and buffer reforestation.

Figure 26 - Priority Basin 3

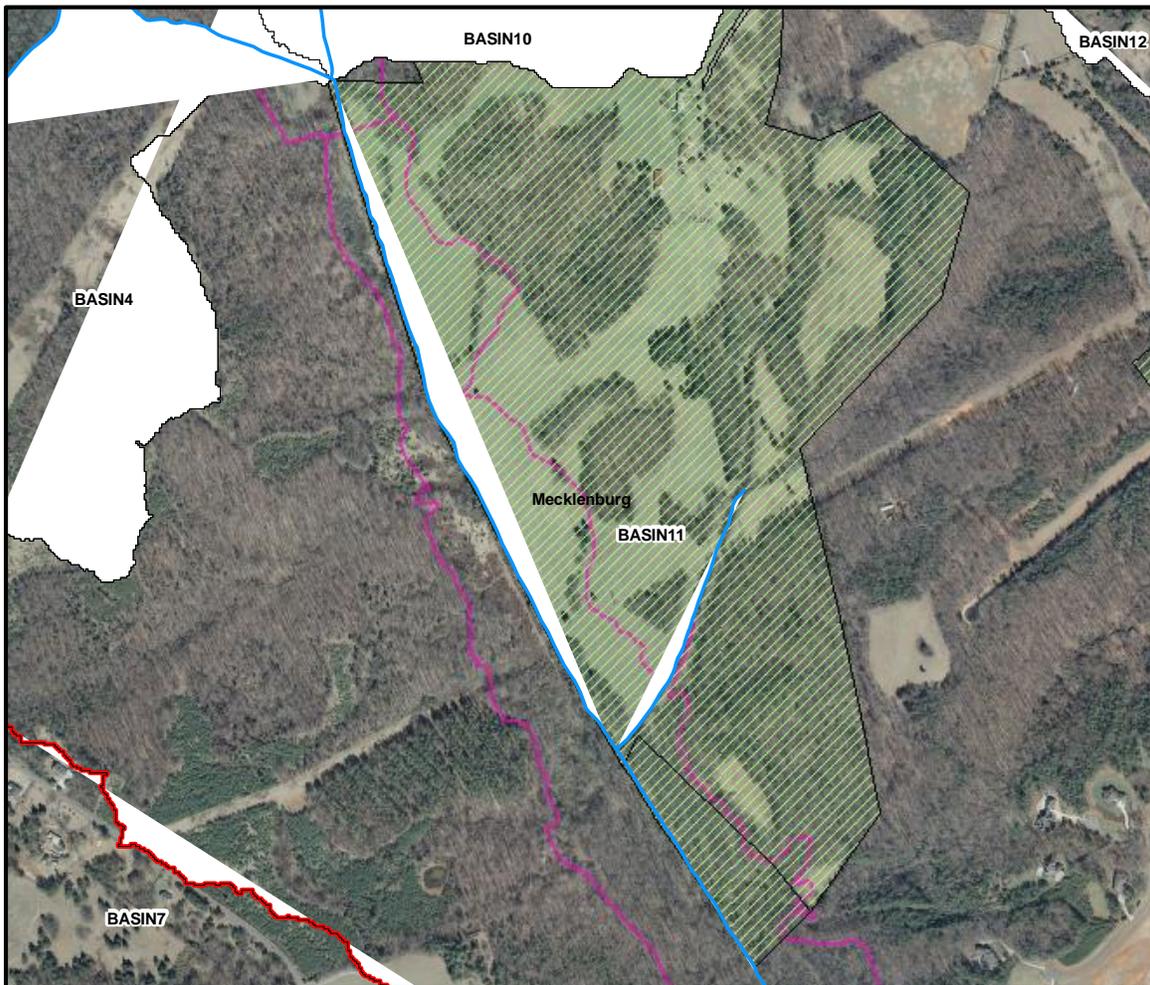
An excellent buffer restoration opportunity exists within the Rocky River Watershed within Davidson’s ETJ. It is located on public property (Mecklenburg County Owned) along the major system segment of the West Branch of the Rocky River. Figure 28 shows a detail of the area. There are approximately 20 acres of un-forested FEMA Floodplain on the property that should be re-forested.

Figure 27 - Buffer Restoration Opportunity in the Rocky River Watershed

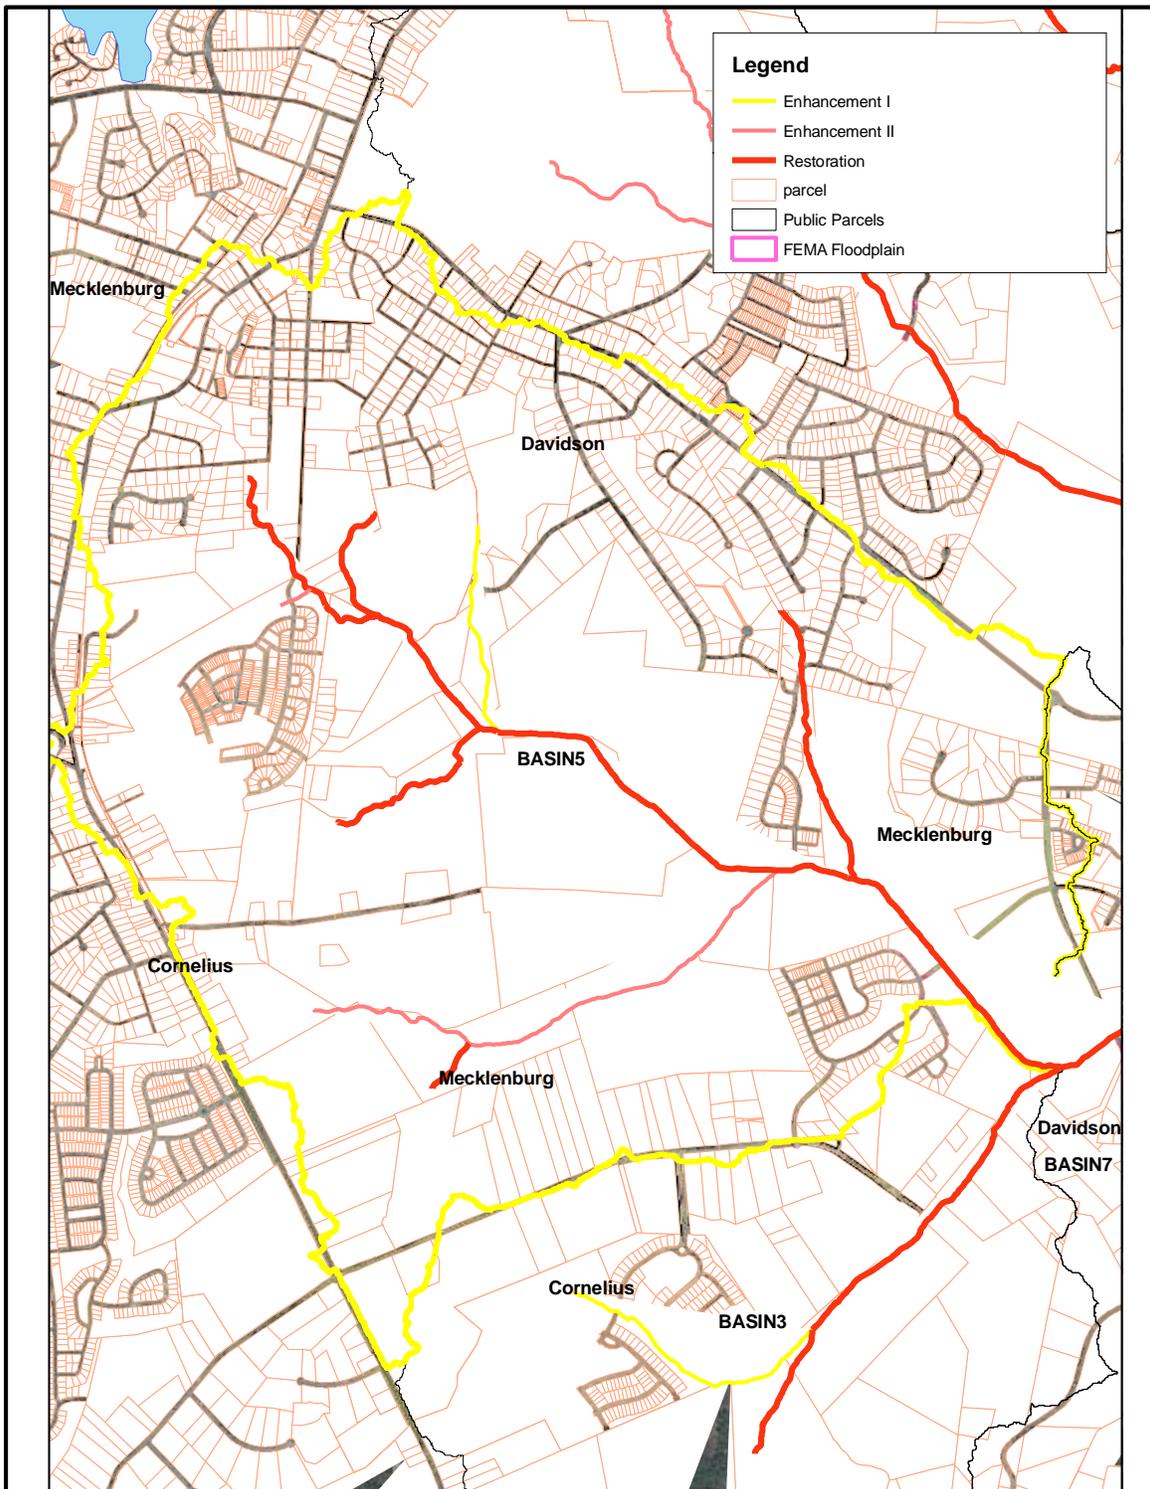
Basin 5 was the highest ranked basin with respect to in-stream erosion rates. Basin 5 is a headwater catchment of the South Prong of the Rocky River. It contains portions of Davidson, Cornelius and Davidson’s ETJ. It also contains significant major and minor system assets that are all in need of either restoration or enhancement. Basin 5 was also the highest ranked basin for BMP retrofits, which indicates that it is the most impaired catchment in the watershed and therefore the most in need of repair. Unfortunately, there are very limited public parcels in the catchment and those that exist are in the extreme upstream areas. However, most of the stream frontage in the watershed is owned by a relatively small number of large-lot property owners. These property owners should be approached as soon as possible to establish their willingness for allowing restoration work to be conducted on their property and to grant easements. Figure 29 shows a detailed view of the streams in Basin 5 along with the parcel boundaries and aerial imagery.

Figure 28 - Detail of Basin5

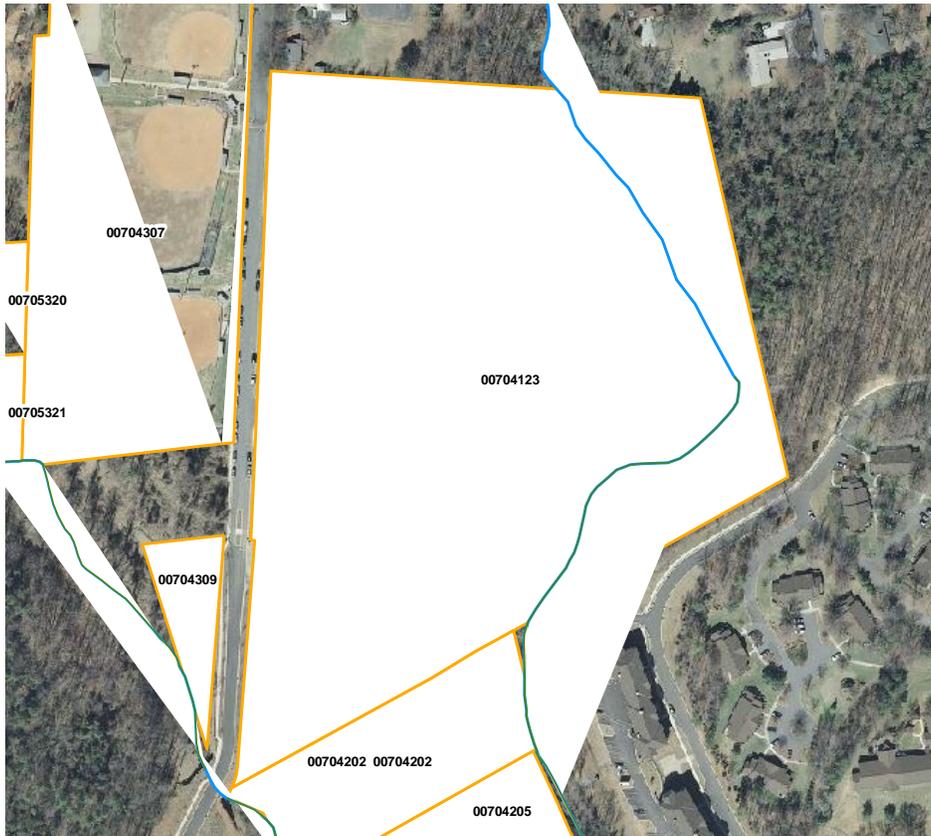
Parcel 00704123, Focus Area 1

Parcel: 007-04-123
Owner: Charlotte/Mecklenburg Board of Education
Description: Existing school site has former sediment basin that would be a relatively simple retrofit (presuming storm water is routed to it). Stream is highly impacted from school storm water runoff, however areas upstream of school are stable.
Cost: \$100,000
Priority: High

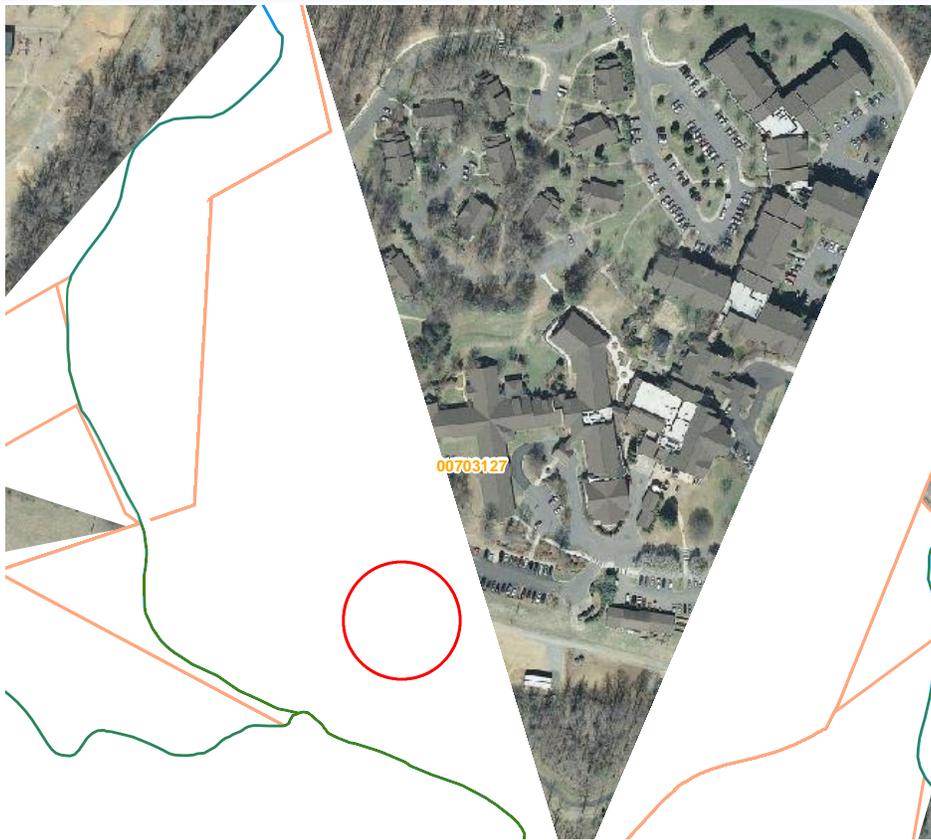
Parcel 007-03-127

Parcel: 00703127
Owner: The Pines at Davidson
Description: Multi-family residential site that is currently partially treated with bioretention/stepped wetlands. Existing drainage to the south of the site is not currently treated. Opportunity for simple retrofit device.
Cost: \$125,000 (does not include property)
Priority: Medium

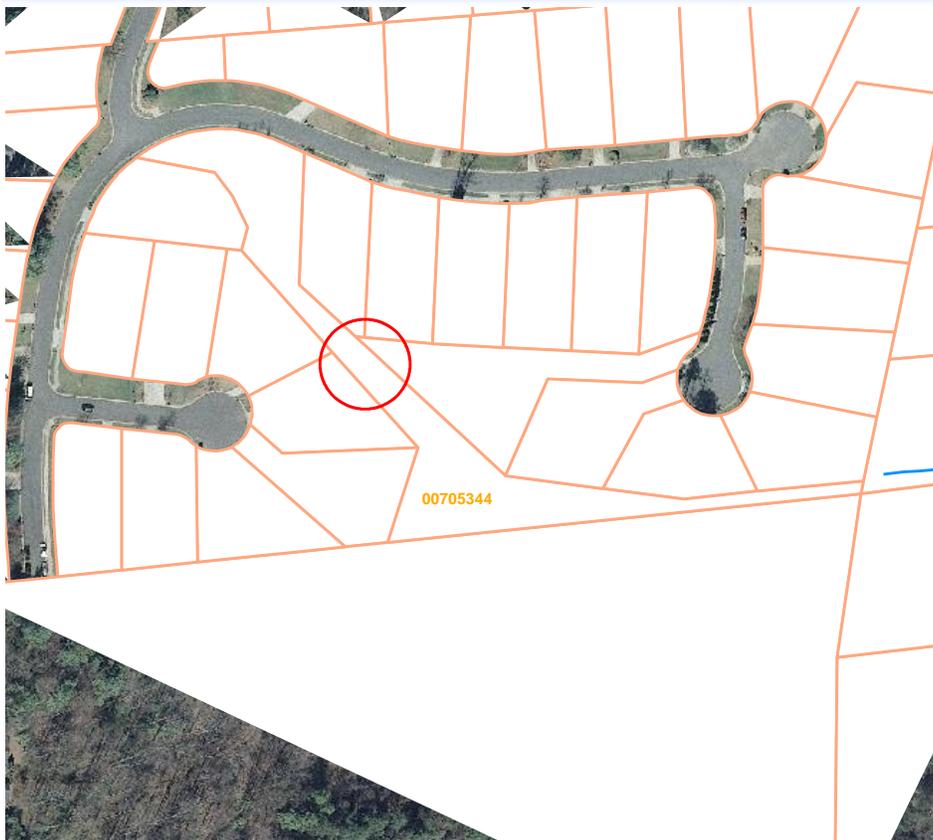
Parcel 007-05-344

Parcel: 00705344
Owner: Town Heights HOA
Description: Single family residential neighborhood with a centrally located drainage feature. Several storm water pipes converge as noted. Wetland plants (cattails) are present. Site could be converted into a functional pocket wetland.
Cost: \$100,000 (does not include property)
Priority: Medium
