Premature Storm Drainage System Repairs and Replacement

Stewart Edwards
Program Manager
Design Management Team
Charlotte-Mecklenburg Storm Water Services

April 8, 2015

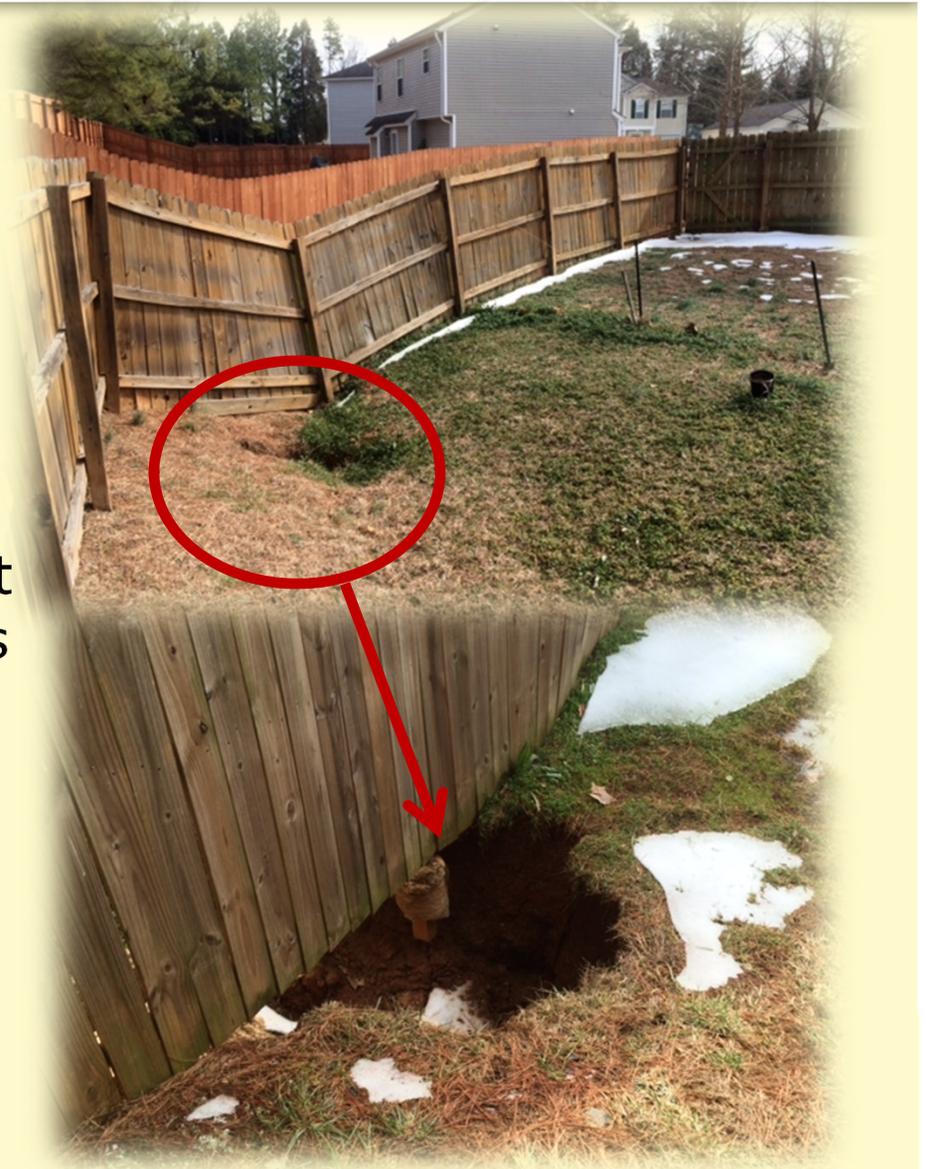
Oasis Lane Belmeade Green Subdivision Built 2006

- Separated joints, broken pipe, poor compaction
- Sinkholes formed
- Shoring will be needed to protect the foundations of nearby homes
- Estimated \$250,000 repair costs
