CHARLOTTE-MECKLENBURG UTILITIES
CHARLOTTE, NORTH CAROLINA

SERVICE LATERAL CONNECTING TO
CURED-IN-PLACE PIPE LINING (CIPP)

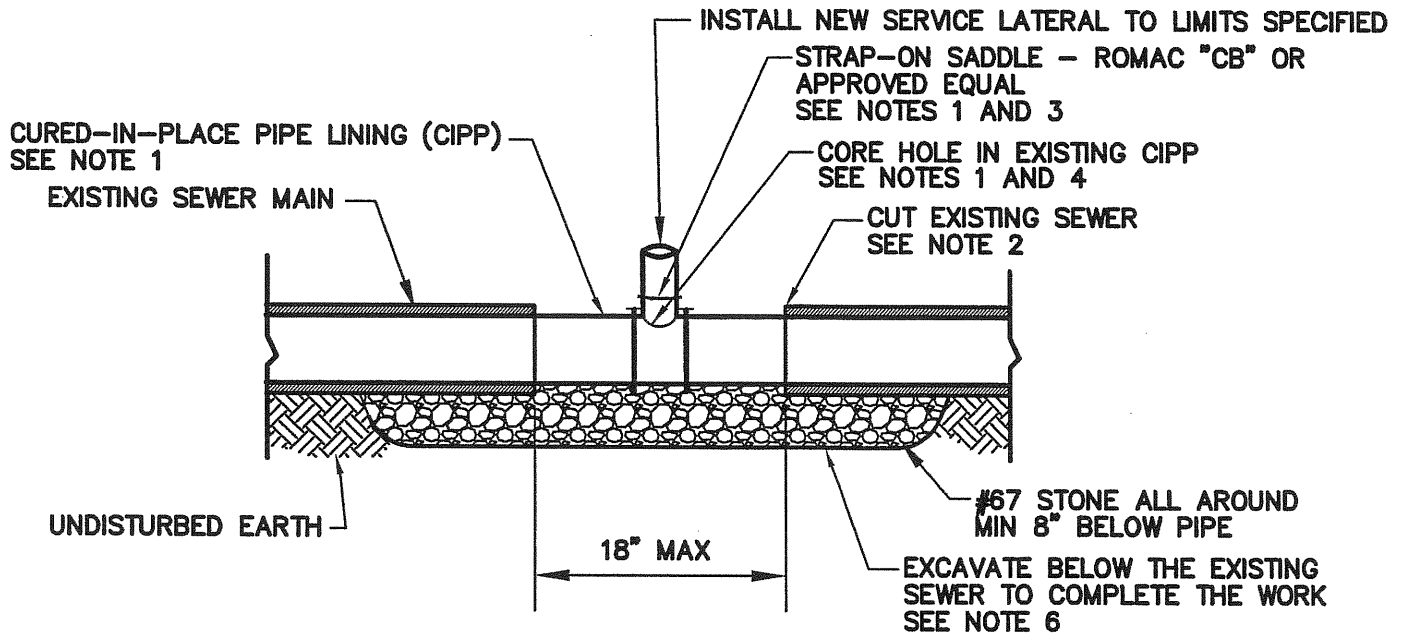
1. REFER TO THIS DETAIL TO CONNECT NEW SERVICE LATERALS AFTER THE SEWERS HAVE BEEN LINED WITH CIPP.
THIS DETAIL SHALL ALSO BE USED WHEN RECONNECTING SERVICES FOLLOWING PIPE BURSTING. IN THAT SITUATION, ALL REFERRECS TO CIPP IN THIS DETAIL SHALL BE HDPE.

2. NEATLY CUT THE EXISTING SEWER WITH A CUTTER SPECIFICALLY DESIGNED FOR CUTTING THAT SPECIFIC PIPE MATERIAL TO EXPOSE THE CIPP. FOR VCP AND CONCRETE SEWERS, USE A CHAIN CUTTER TO NEATLY SCORE THE PIPE AND THEN BREAK THE PIPE AWAY. REGARDLESS OF THE CUTTER USED, USE EXTREME CAUTION TO PREVENT DAMAGE TO THE CIPP. REPAIR ANY DAMAGE AS APPROVED BY THE ENGINEER.

3. STRAP-ON SADDLE SHALL BE A ROMAC "CB" SADDLE AS MANUFACTURED BY ROMAC INDUSTRIES, INC. OR APPROVED EQUAL. ANY PROPOSED EQUAL SHALL BE SUBMITTED TO THE ENGINEER FOR REVIEW AND APPROVAL. SADDLE SHALL BE PROVIDED FOR THE SPECIFIC TYPE OF LATERAL PIPE BEING INSTALLED.

4. CAREFULLY REMOVE THE EXISTING LATERAL TO LIMIT DAMAGE TO THE CIPP, INCREASE THE OPENING IN THE CIPP AS NECESSARY AND TO PROVIDE A CIRCULAR OPENING, BRUSH THE CIPP IN THE OPENING SMOOTH TO REMOVE ALL BURRS, INSTALL STRAP-ON SADDLE, AND REPLACE LATERAL TO THE SPECIFIED LIMITS. WHERE POSSIBLE, IMPROVE THE CONFIGURATION OF THE CONNECTION.

5. IF THE CIPP IS DAMAGED FROM OVERCUTTING THE NEW SERVICE CONNECTION, THEN THE NEXT LARGER SIZE HOLE SHALL BE CUT AND A SERVICE SADDLE WITH A BELL REDUCER SHALL BE INSTALLED FOR CONNECTING BACK TO THE NEW SERVICE DIAMETER.

6. SUPPORT THE EXISTING SEWER DURING THIS WORK AS NECESSARY.
7. DEFECTS IDENTIFIED FROM THE POST-CIPP CCTV INSPECTIONS SHALL BE REPAIRED BY THE CONTRACTOR TO THE SATISFACTION OF THE ENGINEER.
